**Fire Building Feasibility Study Committee**  
**Tuesday, April 22, 2025, at 10:00 am**  
**Station 2**  
**28 Blackstone Street, Bellingham, MA 02019**

## Program and Space-Use Analysis Matrix

## FIRE COMPANY #1 - EXISTING CONDITIONS ASSESSMENT

## FIRE COMPANY #2 - EXISTING CONDITIONS ASSESSMENT

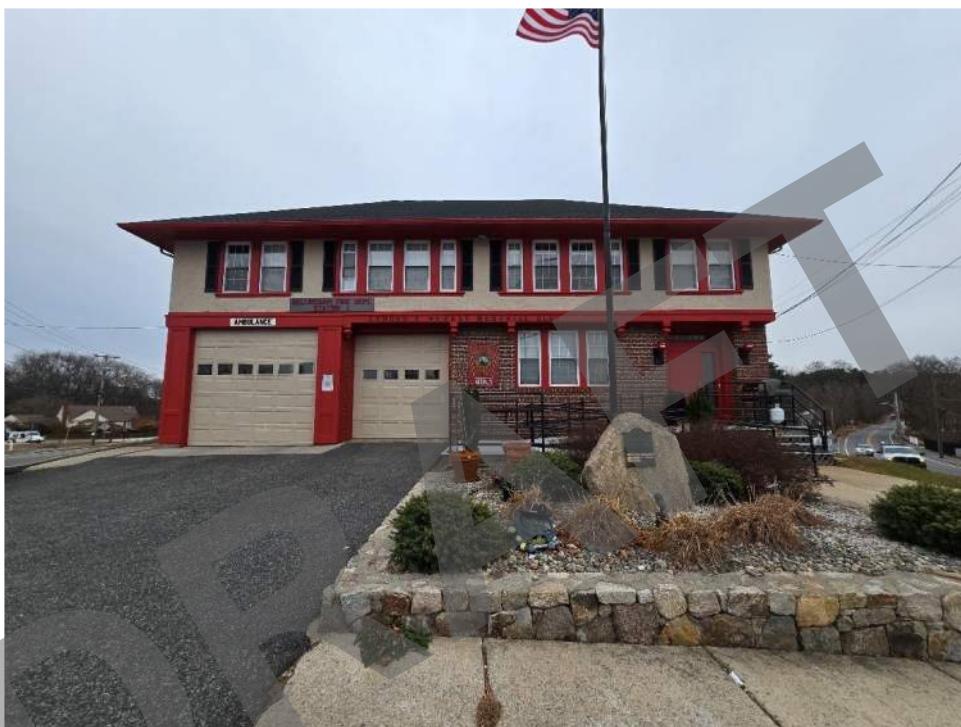
Photo 1: West façade & apron.

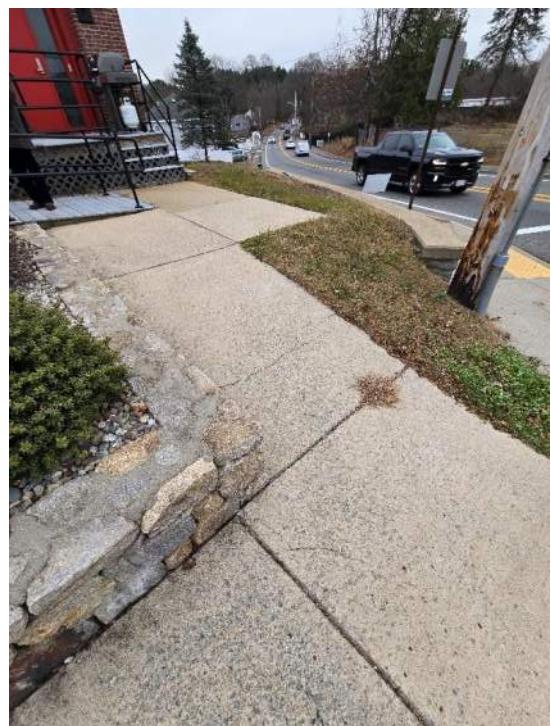
Photo 11: Sidewalk at Entry.

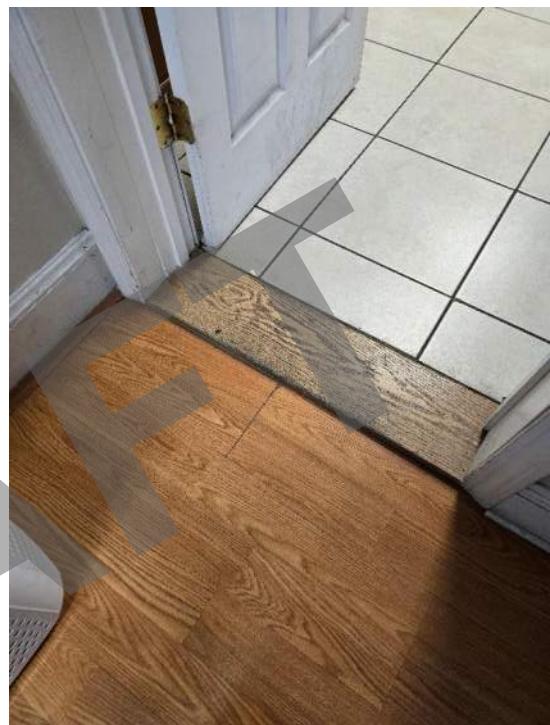
Photo 29: Male Toilet/Shower threshold.

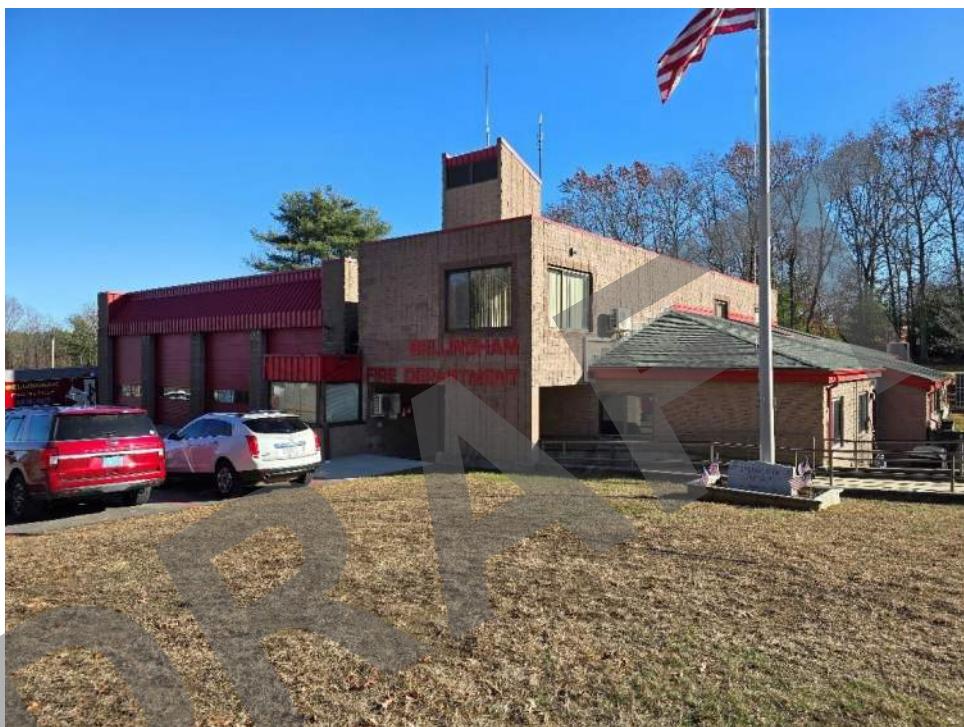
Photo 1: Northwest façade.

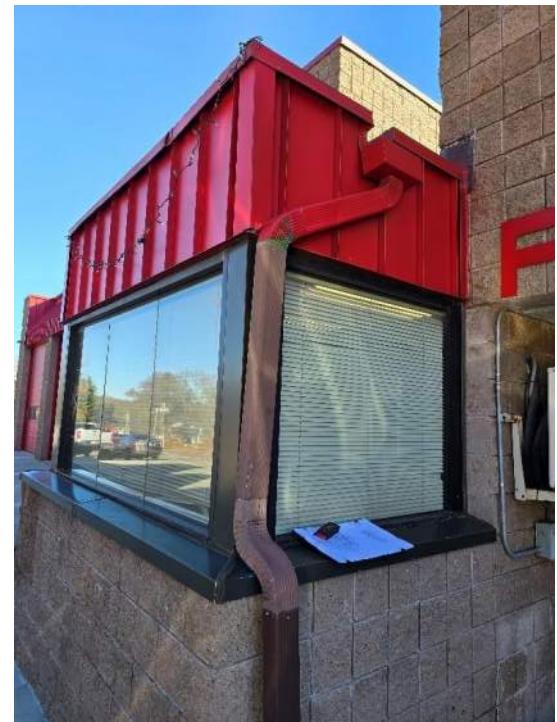
Photo 3: Partial Northwest façade.

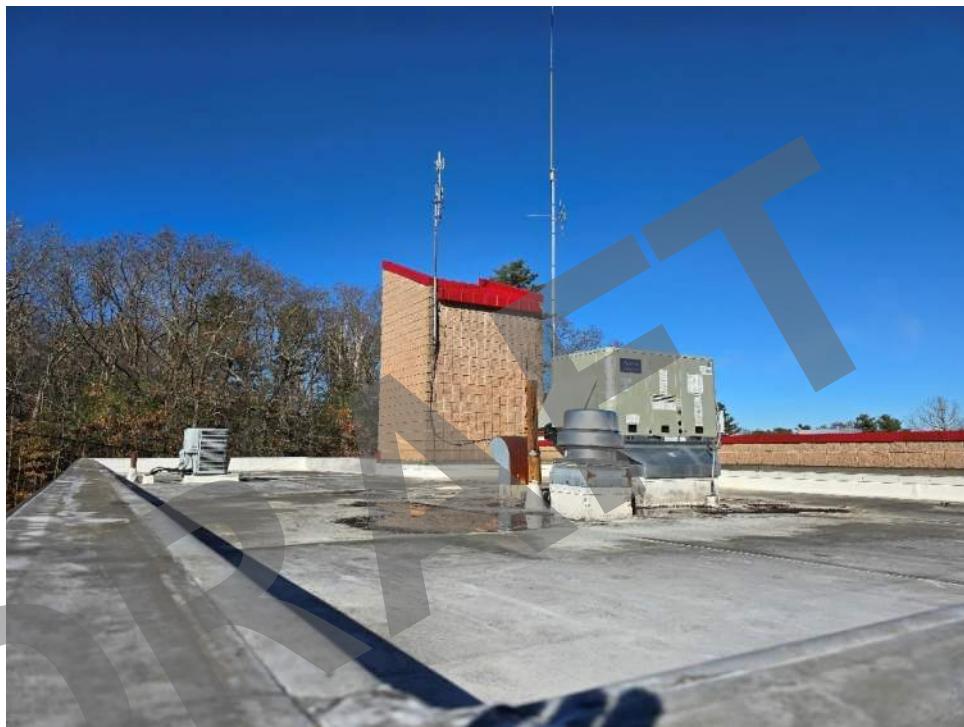
Photo 10: Main roof (membrane).

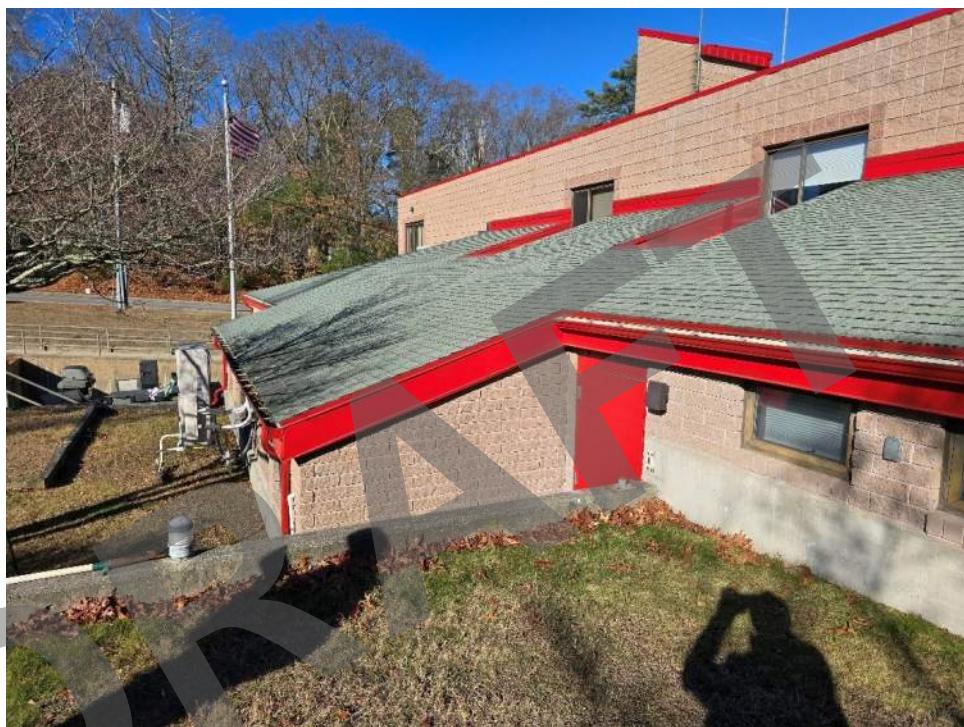
Photo 12: Asphalt Shingle Roof

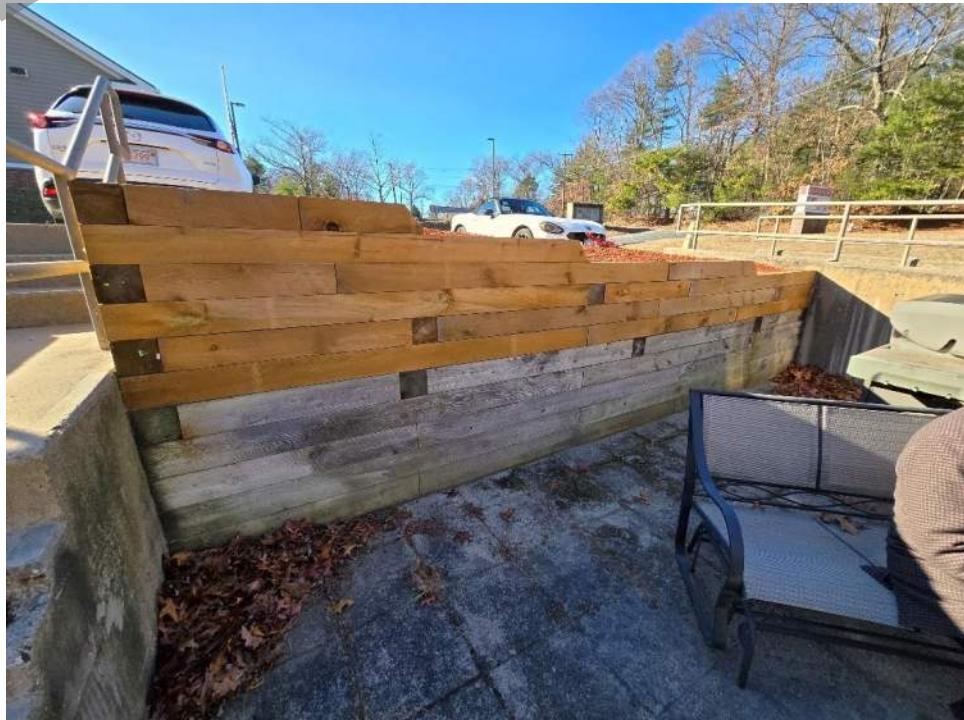
Photo 13: Sunken patio retaining wall.

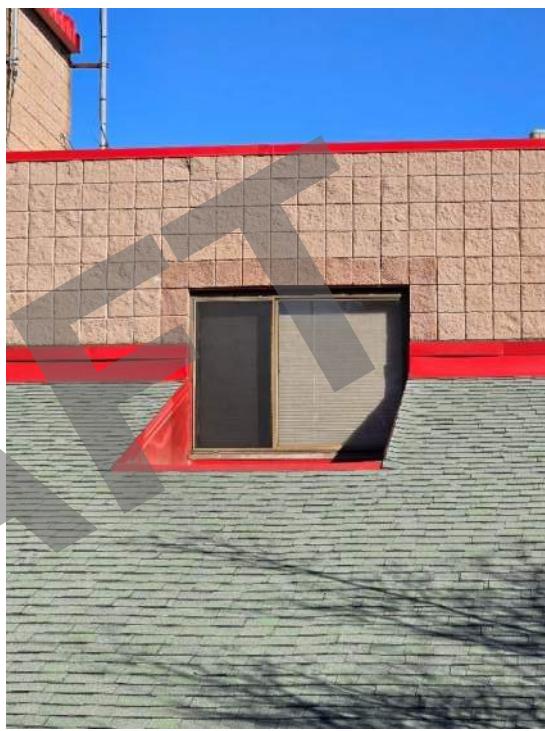
Photo 19: Upper-level window well.

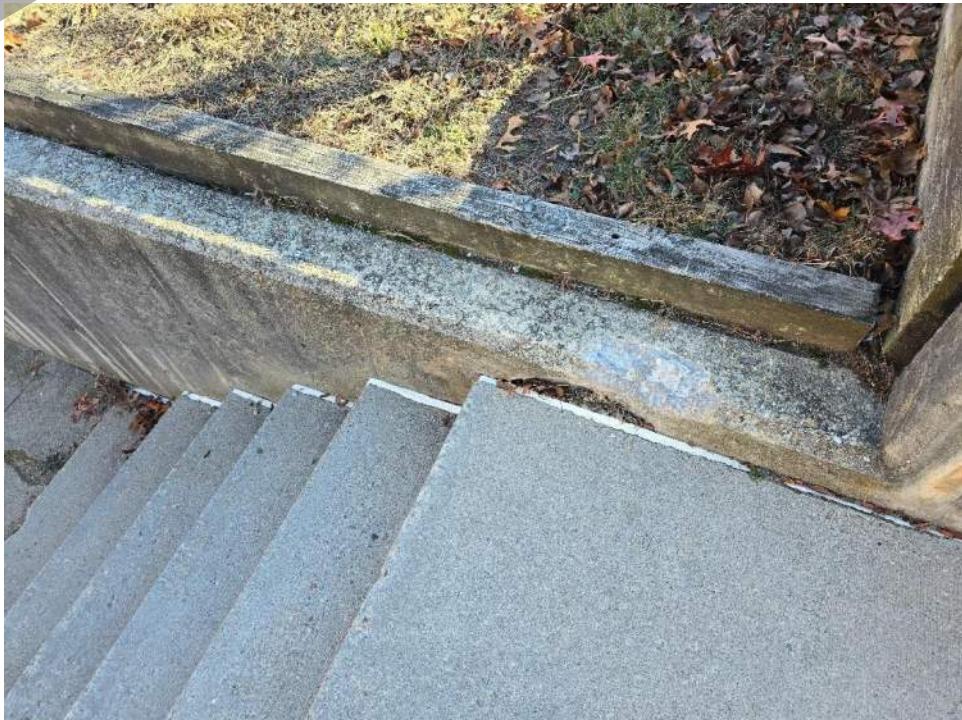
Photo 27: Exterior concrete stair.

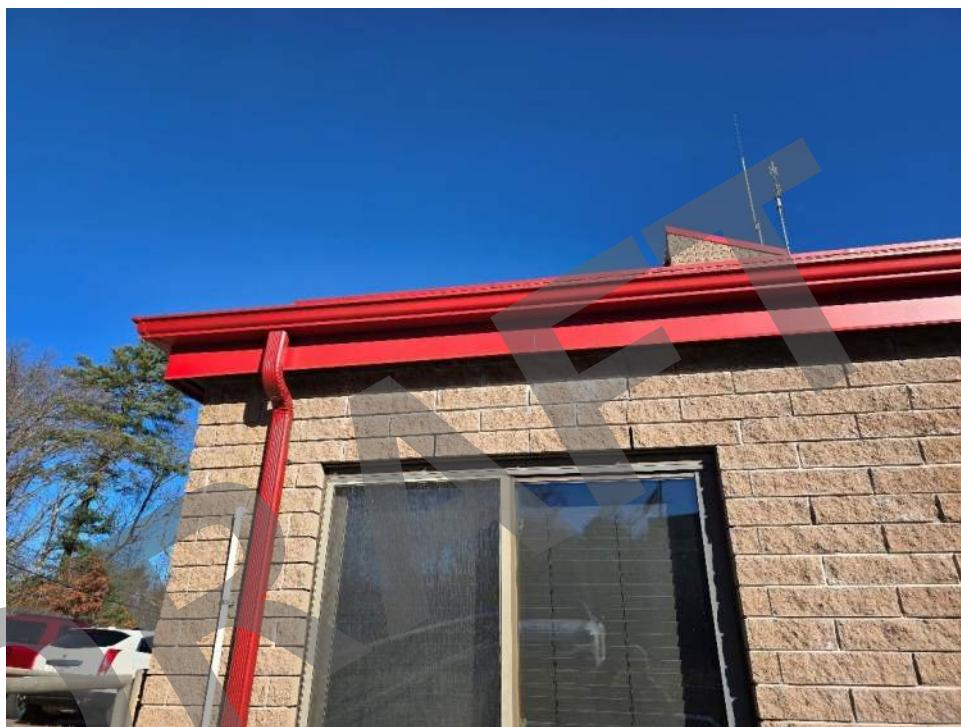
The building envelope is in fair condition and mainly consists of fluted concrete masonry units. A split face tan block makes up most of the façade and is accented at recessed areas with a smooth reddish concrete masonry unit. The apparatus bay appears to be constructed of load bearing masonry and the property card indicates a steel structural frame at the remainder of the building. It is assumed that insulation is in the cavity space at the stud-framed walls and that the main apparatus bays are uninsulated mass walls. Neither condition meets the minimum R-value per the Massachusetts energy code. Exterior masonry is in good to fair condition. Some minor efflorescence was noted along the West façade and multiple elevations were either missing weep holes or weep holes were left open. Multiple patches at the watch room have been previously completed with mismatched masonry colors.

Photo 28: Masonry cracking above windows.

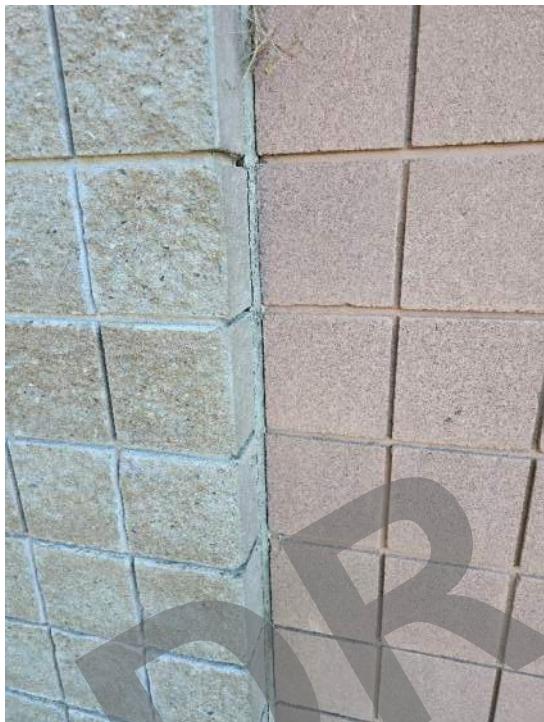
Photo 30: Failing masonry soft joint.

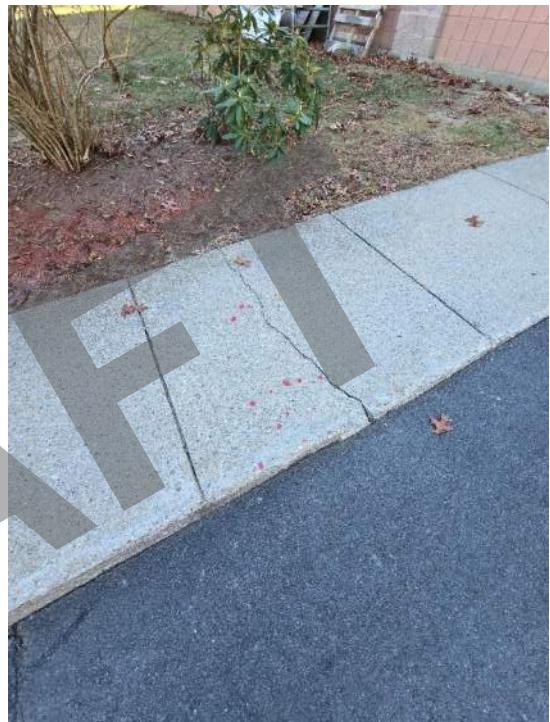
Photo 31: Cracking sidewalk.

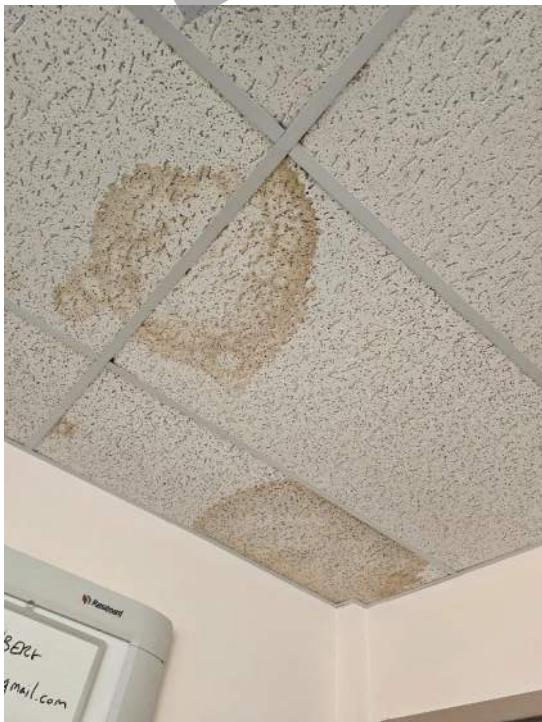
Photo 34: Training Room stained ceiling tiles.

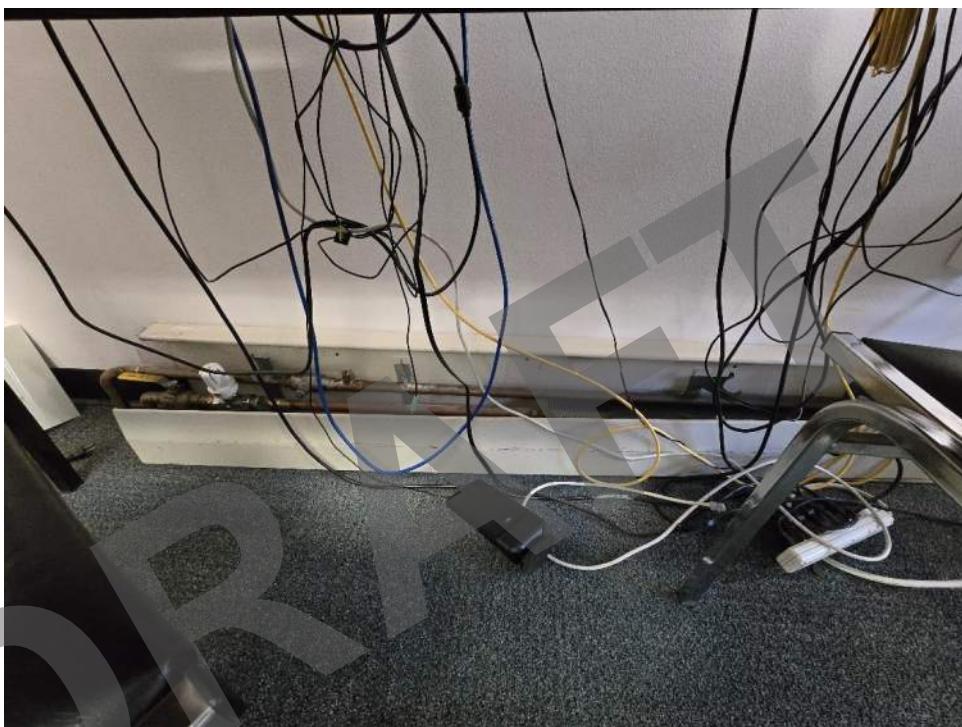
Heating and cooling are provided by a combination of roof and ground-mounted Heat pumps. Ductless mini split units serve the bunk rooms. All units are roughly 10-15 years old and appear to be in working condition. Baseboard heating in the Training Room appears to be modified and it is unclear if these units are functioning.

Photo 36: Training Room radiant baseboard heaters.

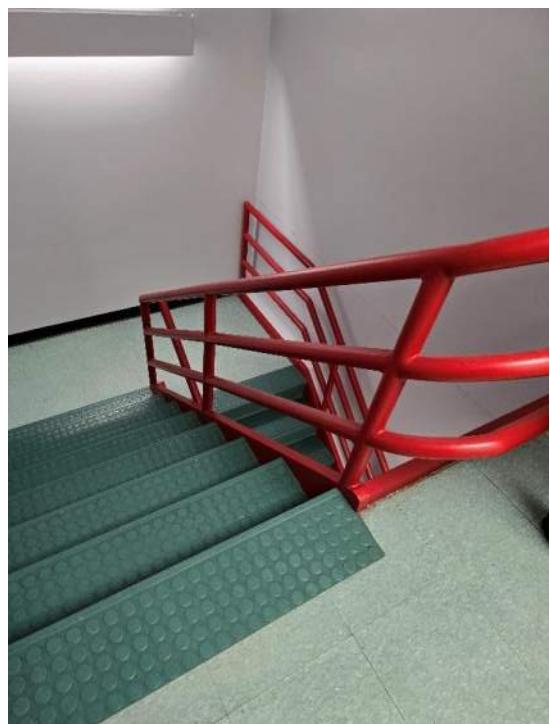
Stairs throughout the interior and exterior of the building have guardrails and handrails, however, most do not meet all conditions of the code to be considered compliant. The main stair has multiple issues; It does not have the required continuous handrail with top and bottom extensions, is too narrow to meet minimum egress width requirement, and only exhibits a 36" tall guardrail. The small stair at the Women's Dormitory has similar defects and is not considered code compliant. Although an inherent fire rating exists at the masonry walls between the apparatus bay and adjacent support spaces, the former hose tower does not have a rated floor-ceiling assembly which could allow the spread of flame and smoke between floors.

Photo 50: Main Stair.

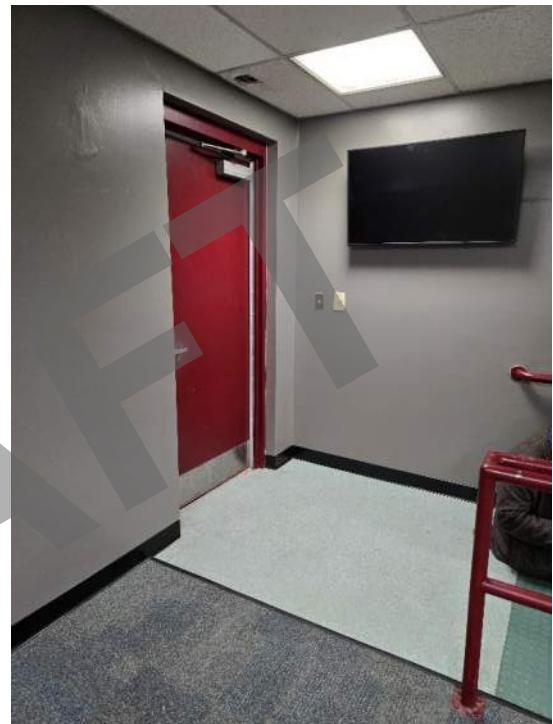
Photo 63: Exit Door  
(within Female Bunk Room).

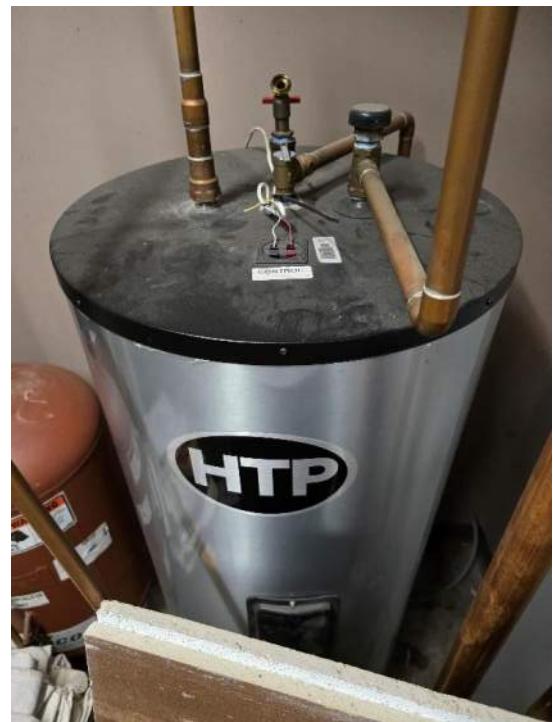
Photo 76: Hot water heater  
(natural gas).

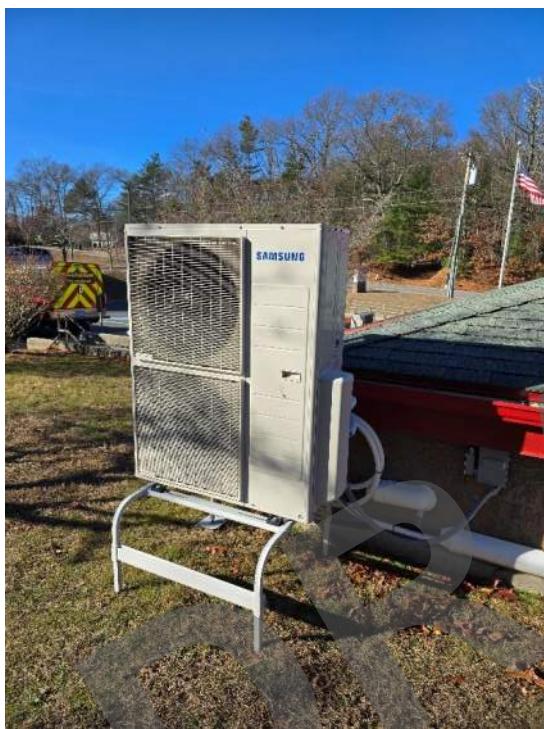
Photo 77: Multi-Split Heat Pump

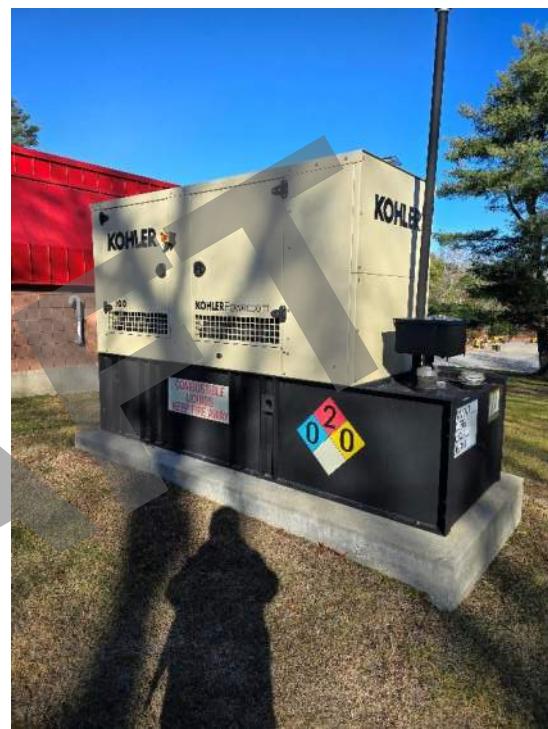
Standby power is provided to the entire building by a 100 kW MTU diesel generator. The generator is located outside on the South of the building and has an integral subbase fuel tank and weather enclosure.

Photo 78: Generator

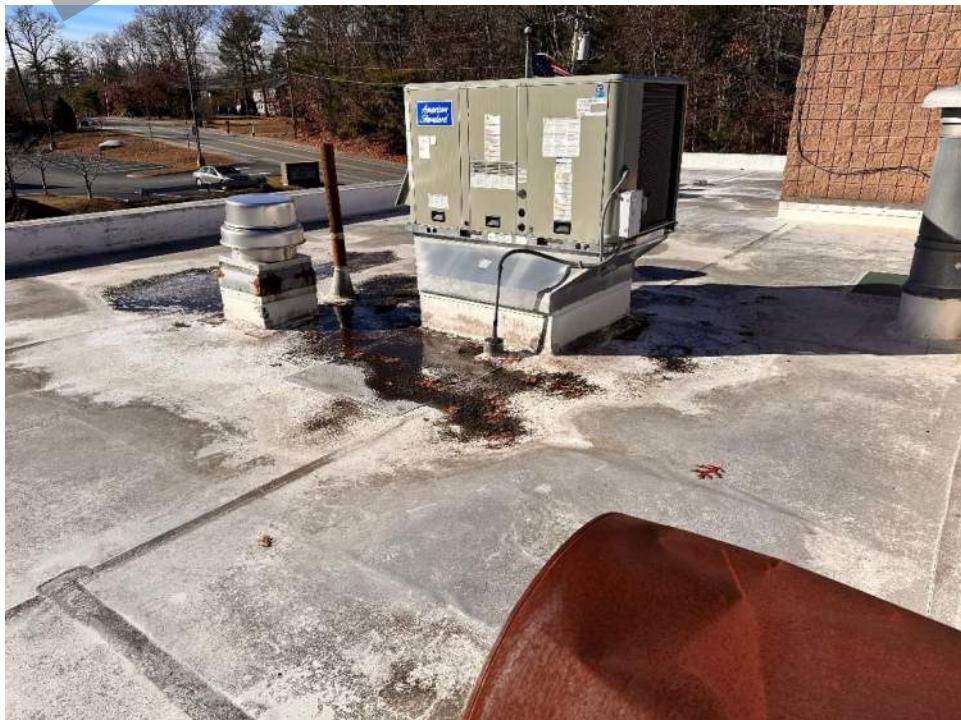
Photo 79: Rooftop Unit

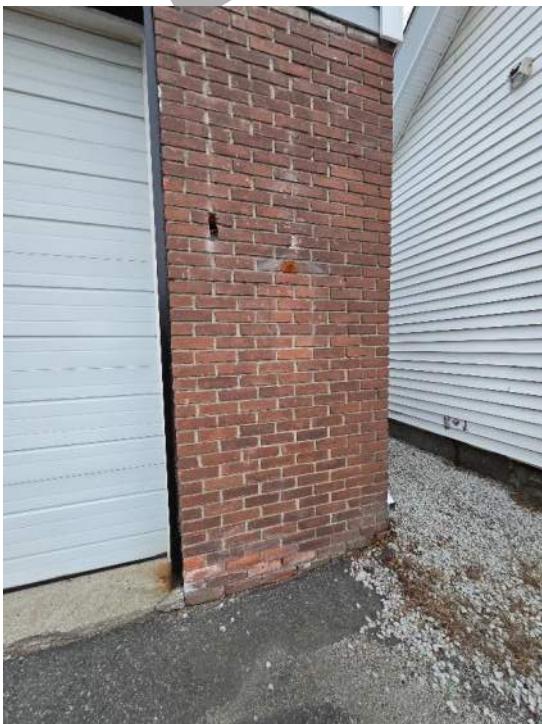
The building envelope is in fair condition. The main façade is made up of a mix of 4" brick veneer to the top of the garage door and wood siding up to the roof line. The wood siding is in fair condition. Minor masonry repair and repointing is recommended at the exterior brick. The other facades appear to be constructed of an uninsulated single-wythe concrete masonry unit (CMU). The CMU was observed to have multiple areas along the North side where previous water infiltration was evident. It is unclear if the water infiltration was still occurring.

Photo 7: Masonry cracking.

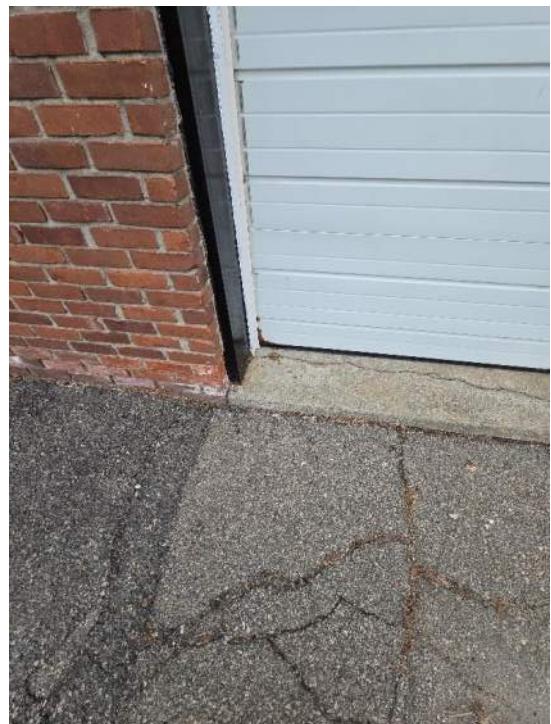
All windows appear to be vinyl with wood trim and are in fair condition. Exterior doors are a residential style "raised panel", also in fair condition. The single overhead sectional door is in fair to poor condition. Rust was observed along the bottom edge. The door operator is a residential chain-style and not conducive of rapid response times.

Photo 8: Overhead door threshold.

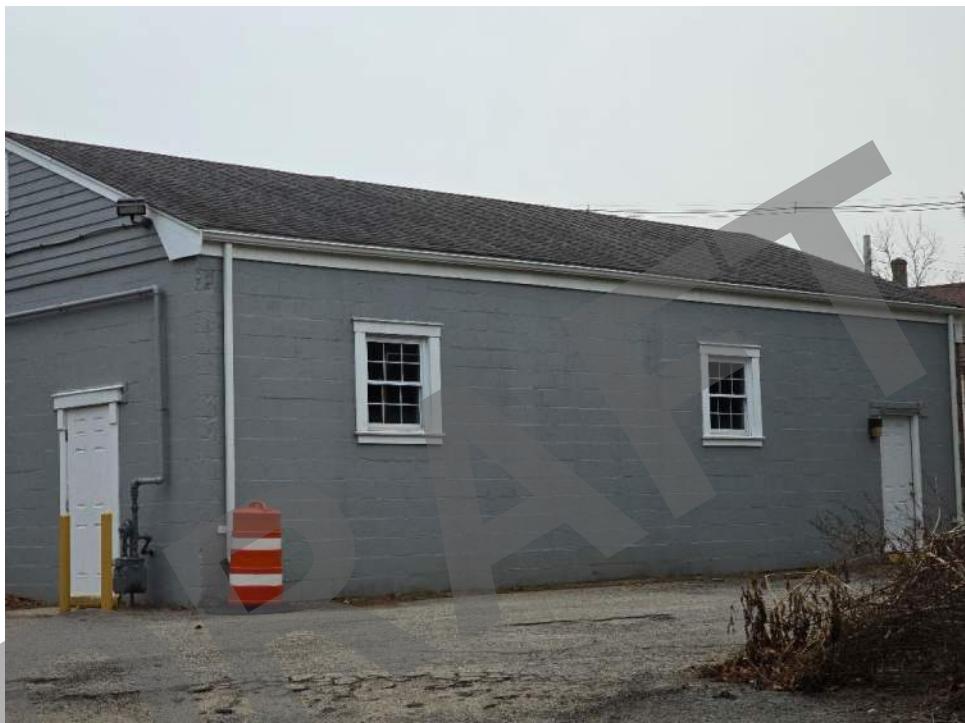
The roof consists of an architectural asphalt shingle gable-style roof with gutters and downspouts on the North and South. The roof appears to be reasonably new. Downspouts empty directly onto the drive aisle and into the gravel alleyway between the garage and the Community Center. This could cause potential icing issues around the swing doors and across the apron. The attic is assumed to be insulated at the ceiling plane; however, this was inaccessible and not observed.

Photo 9: Asphalt shingle roof.

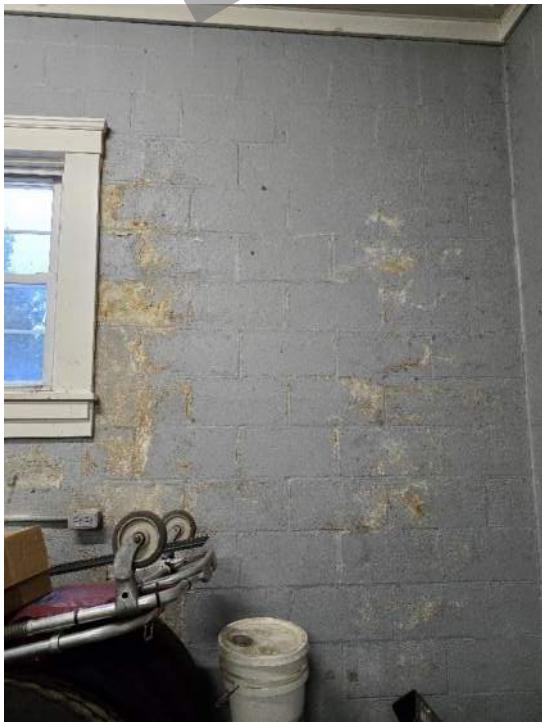
Photo 14: Exterior masonry wall staining.

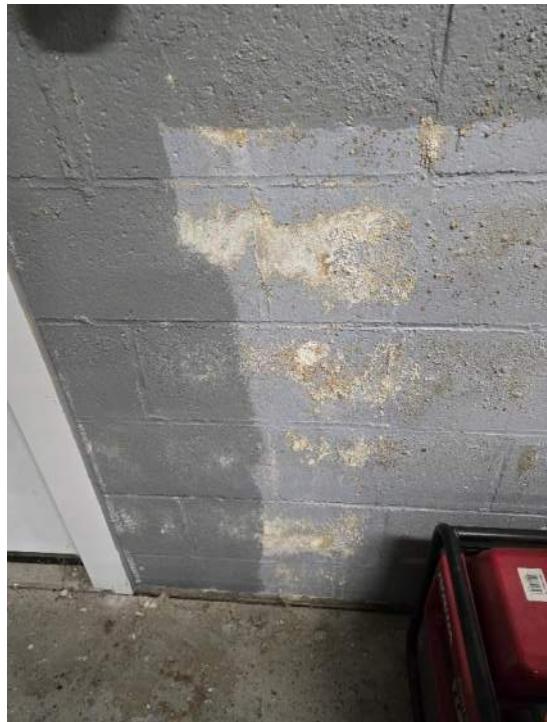
Photo 15: Exterior masonry wall staining.

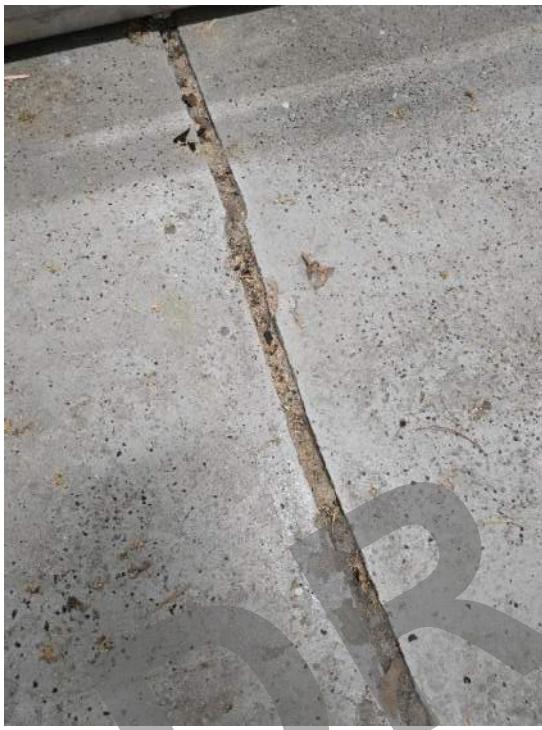
The garage area is open and full of training equipment and overflow storage from the main stations. An exposed concrete slab is in fair condition; however, control joints are deteriorated and full of debris. The walls are painted CMU in fair to poor condition. The aforementioned water infiltration has caused the paint to peel and spall. The ceiling is a painted gypsum board in good condition.

Photo 16: Concrete slab control joint.

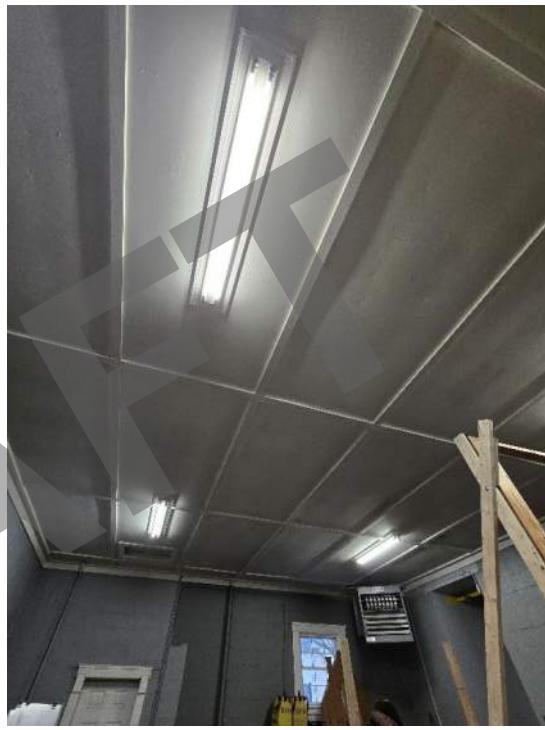
Photo 17: Garage Bay lighting.
