**TITLE: A Tree Died in Bellingham, 7/10/2025**

Narrative to accompany WPA Request for Determination of Applicability application for 287 Lakeshore Drive in Bellingham, Massachusetts, 02019

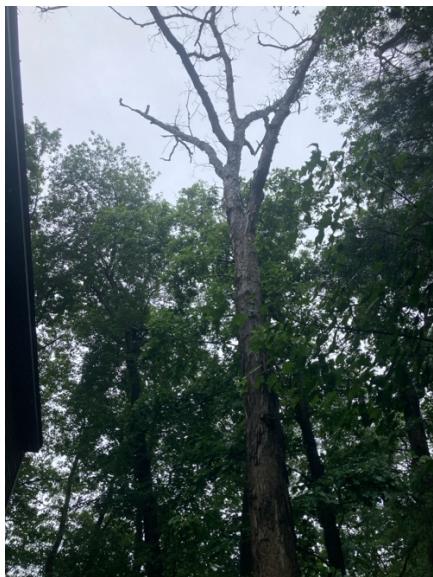
This is a picture of the oak taken on July 10, 2025. Her diameter near the bottom is 25.8 inches.

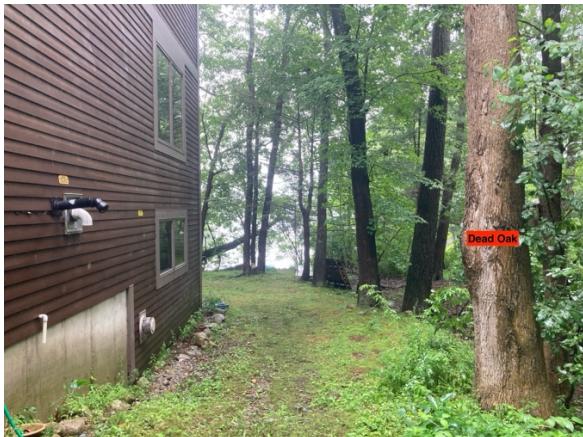
The tree is close to our house (12 feet) and has a slight tilt towards it, becoming a safety hazard.

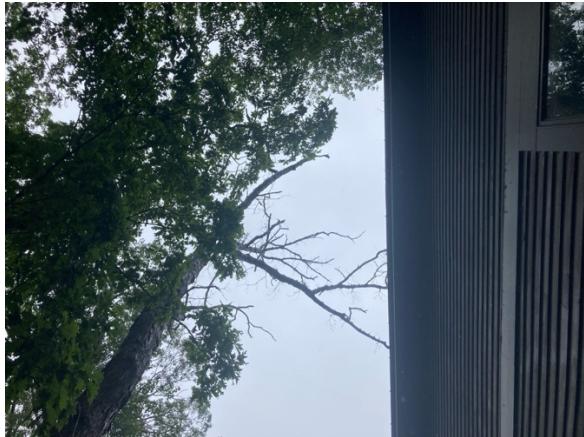
The dead limbs overhang the house:

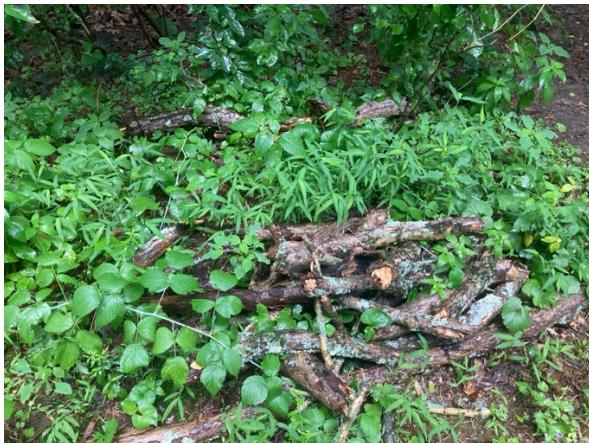
The dead oak tree has already dropped numerous limbs which have fallen on our roof. I have collected and stacked them in a pile since January 2025.

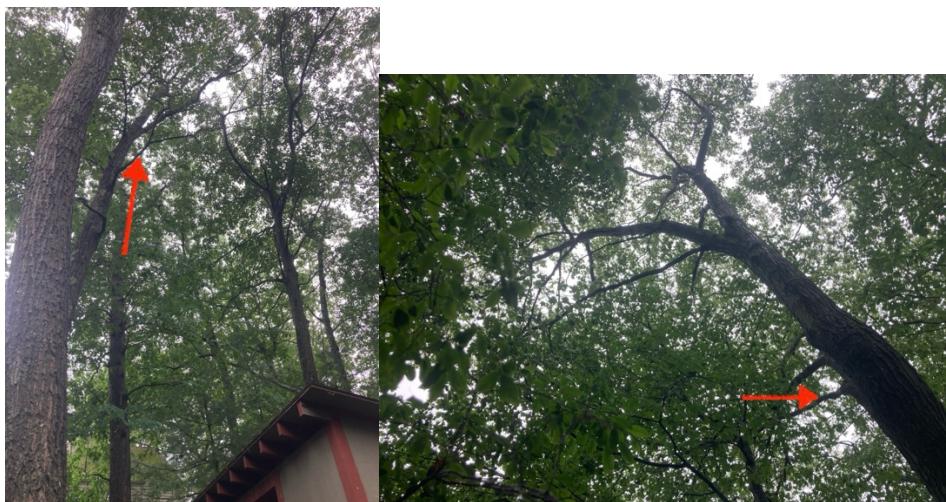
In addition to the removal of the dead oak, we would like to have the tree climber safety prune by removing dead limbs from several trees. These trees are located between 15 and 70 feet of Lake Hiawatha and 50 to 100 feet from the intermittent stream. Example pictures located below with red arrows pointing to dead limbs.
