# **NOTICE OF INTENT**

## **HARTFORD AVENUE WATER TREATMENT PLANT PFAS UPGRADES**

### **BELLINGHAM, MA**

February 2025

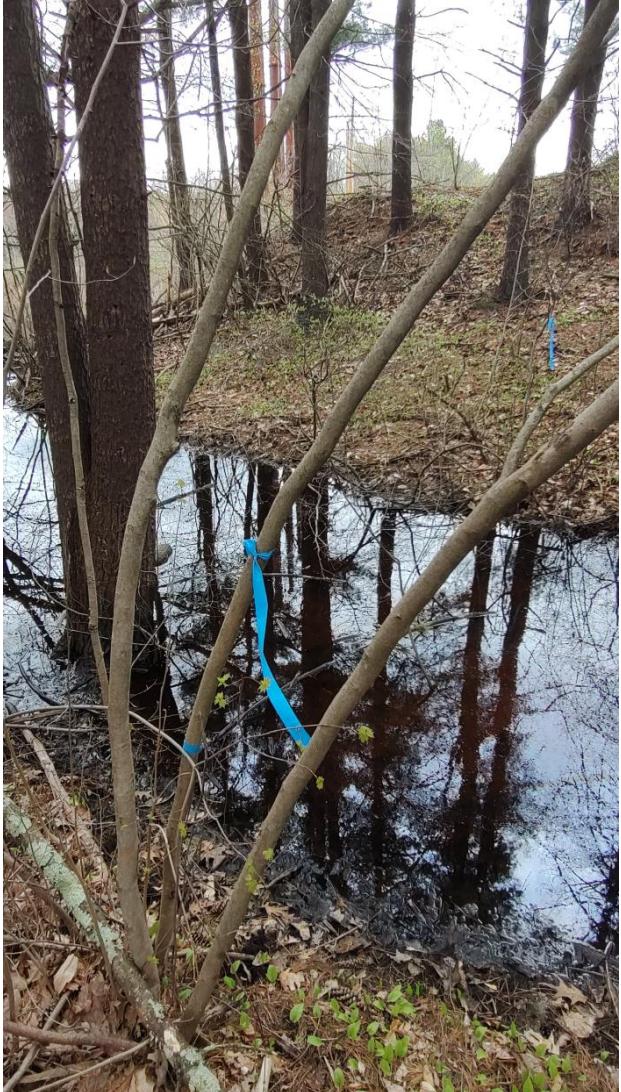
Wetland at Plot AA3-W

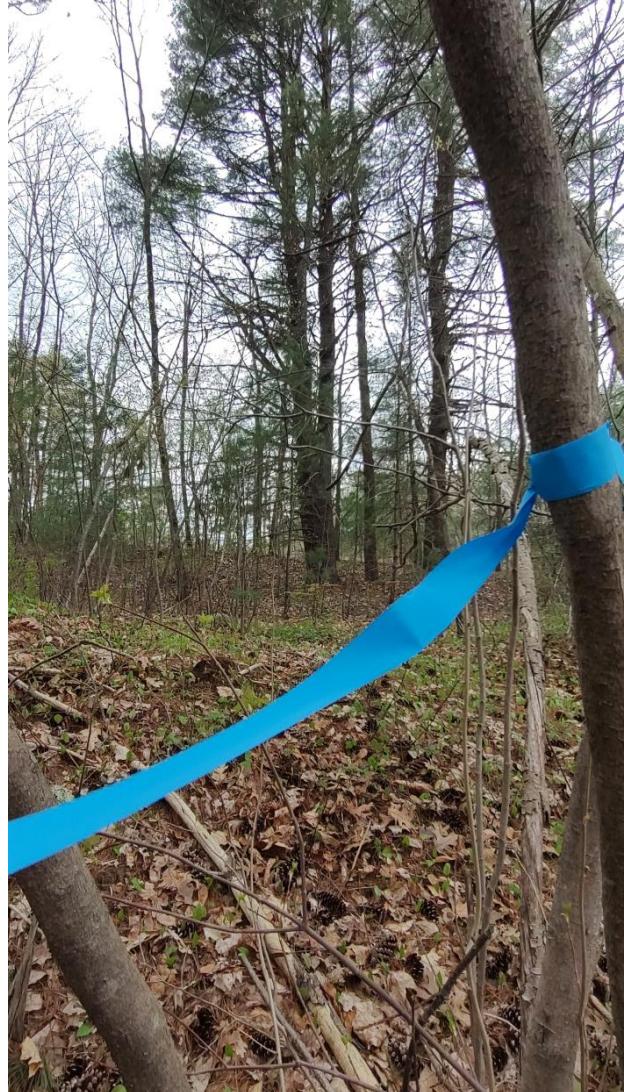
Upland at Plot AA3-U

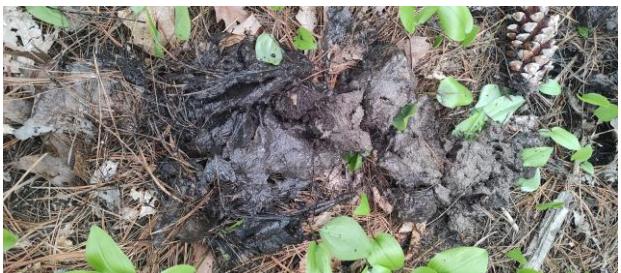
Soil at Plot AA3-W

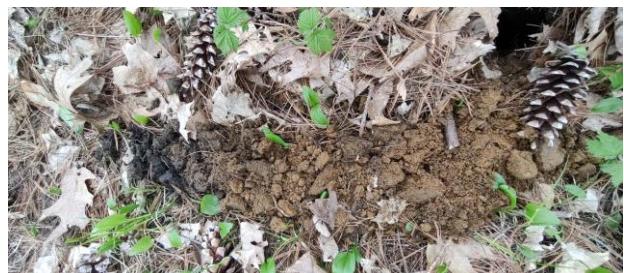
Soil at Plot AA3-U

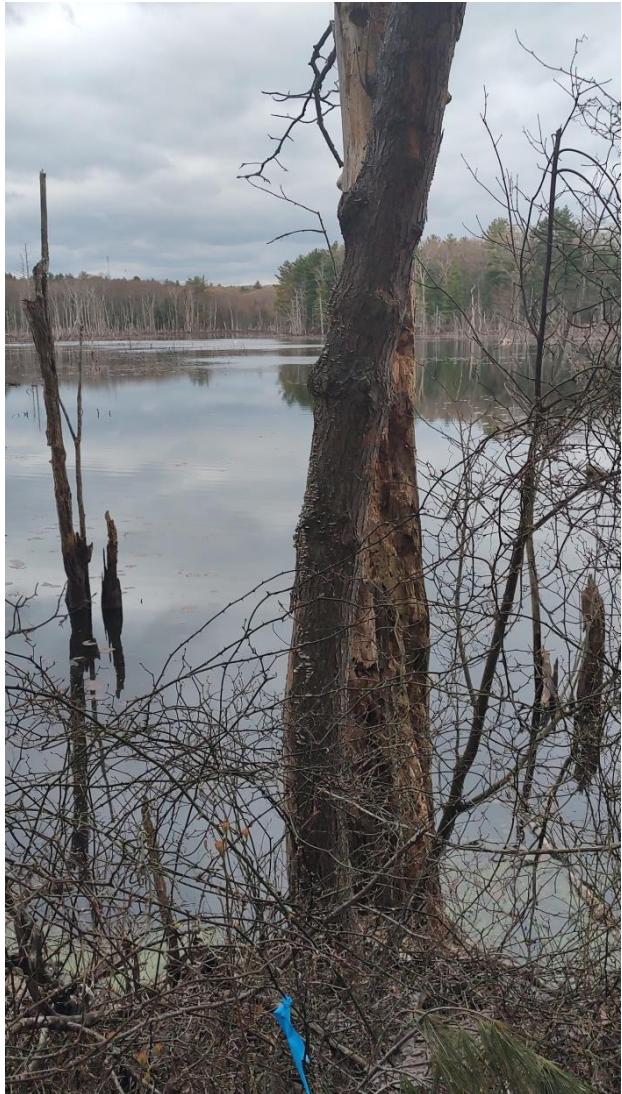
Wetland at Plot BB6-W

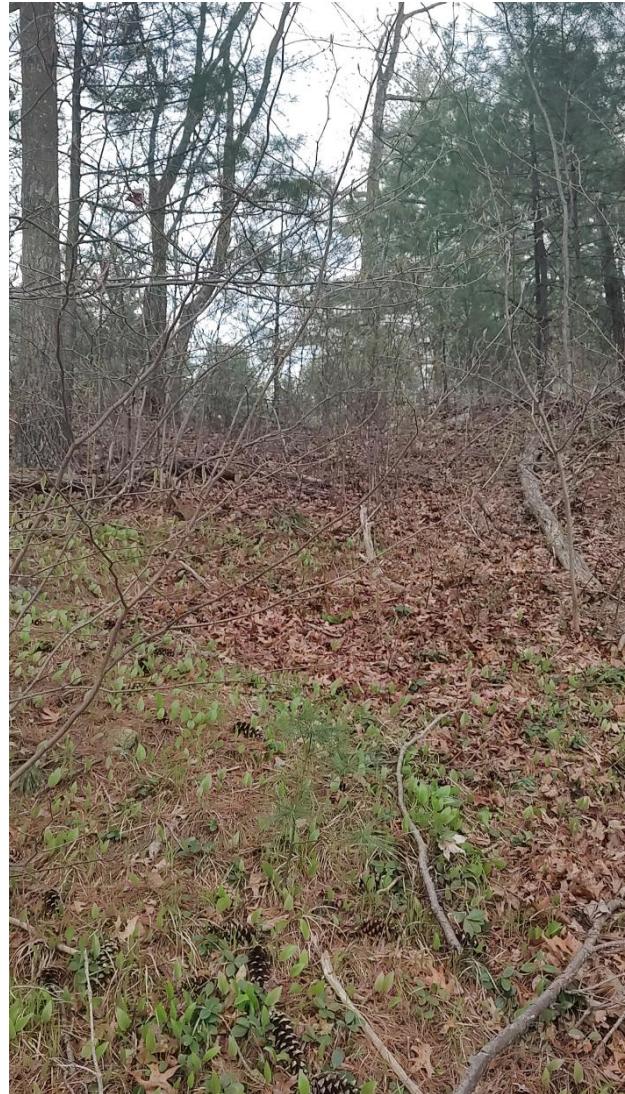
Upland at Plot BB6-U
