Re: Prospect Hill Development Site

Subject: Overcoming “River” Presumption

Stream Photo Documentation Locations

EXISTING CONDITIONS PLAN PROSPECT HILL VILLAGE BELLINGHAM, MASSACHUSETTS

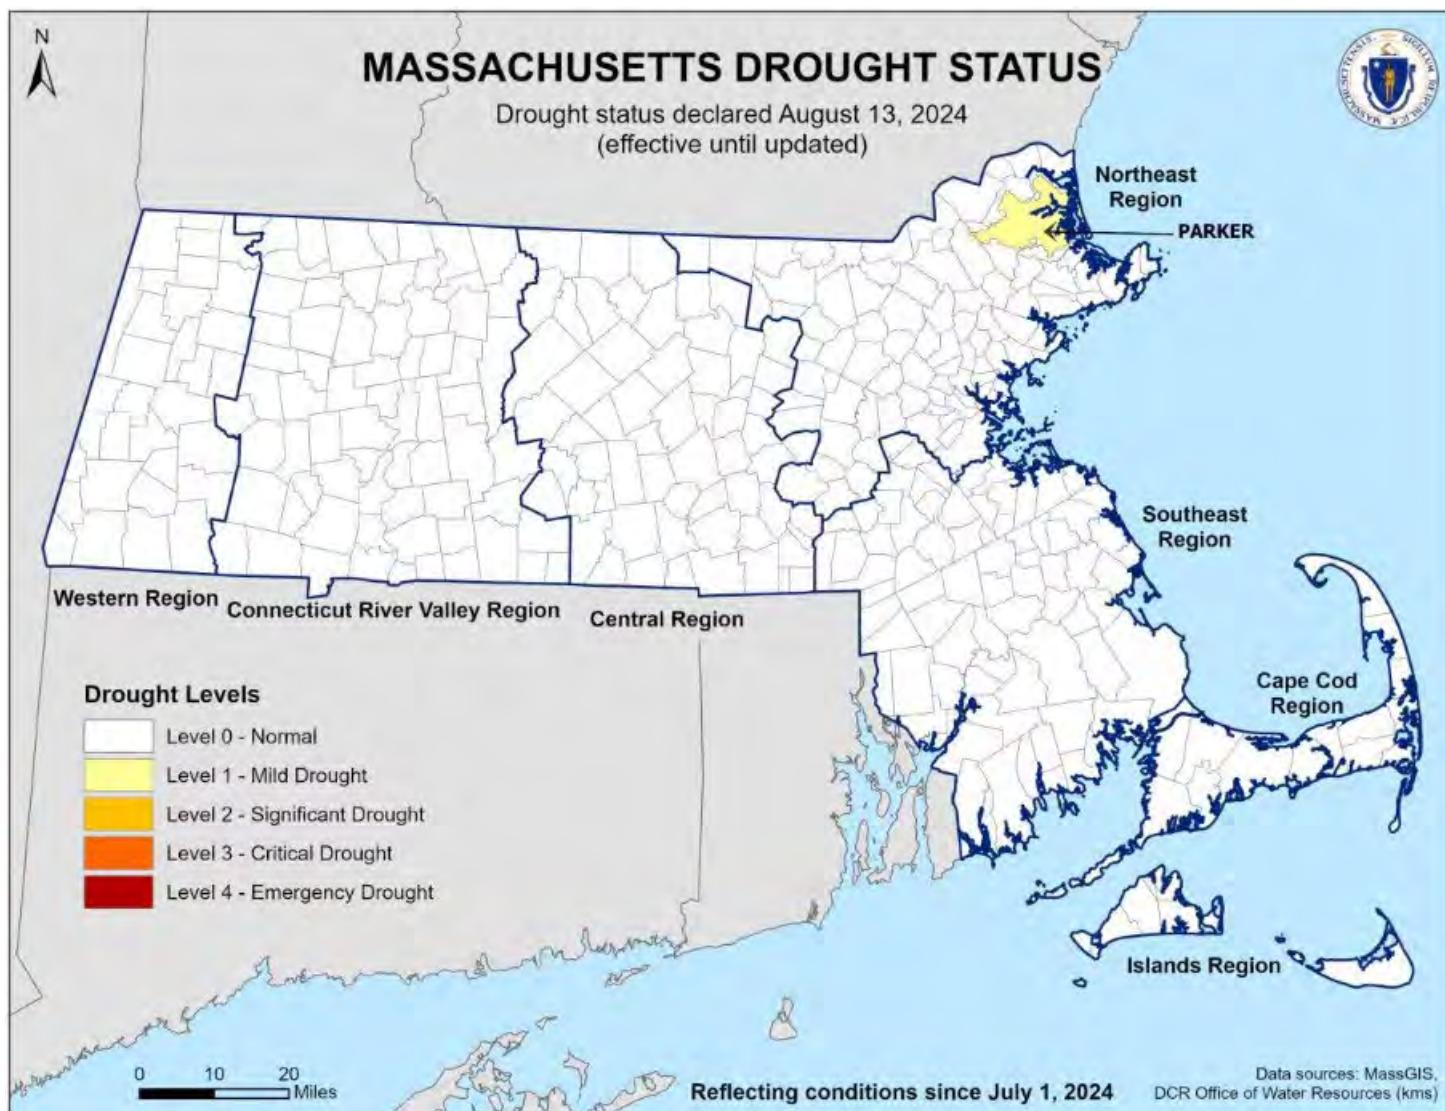
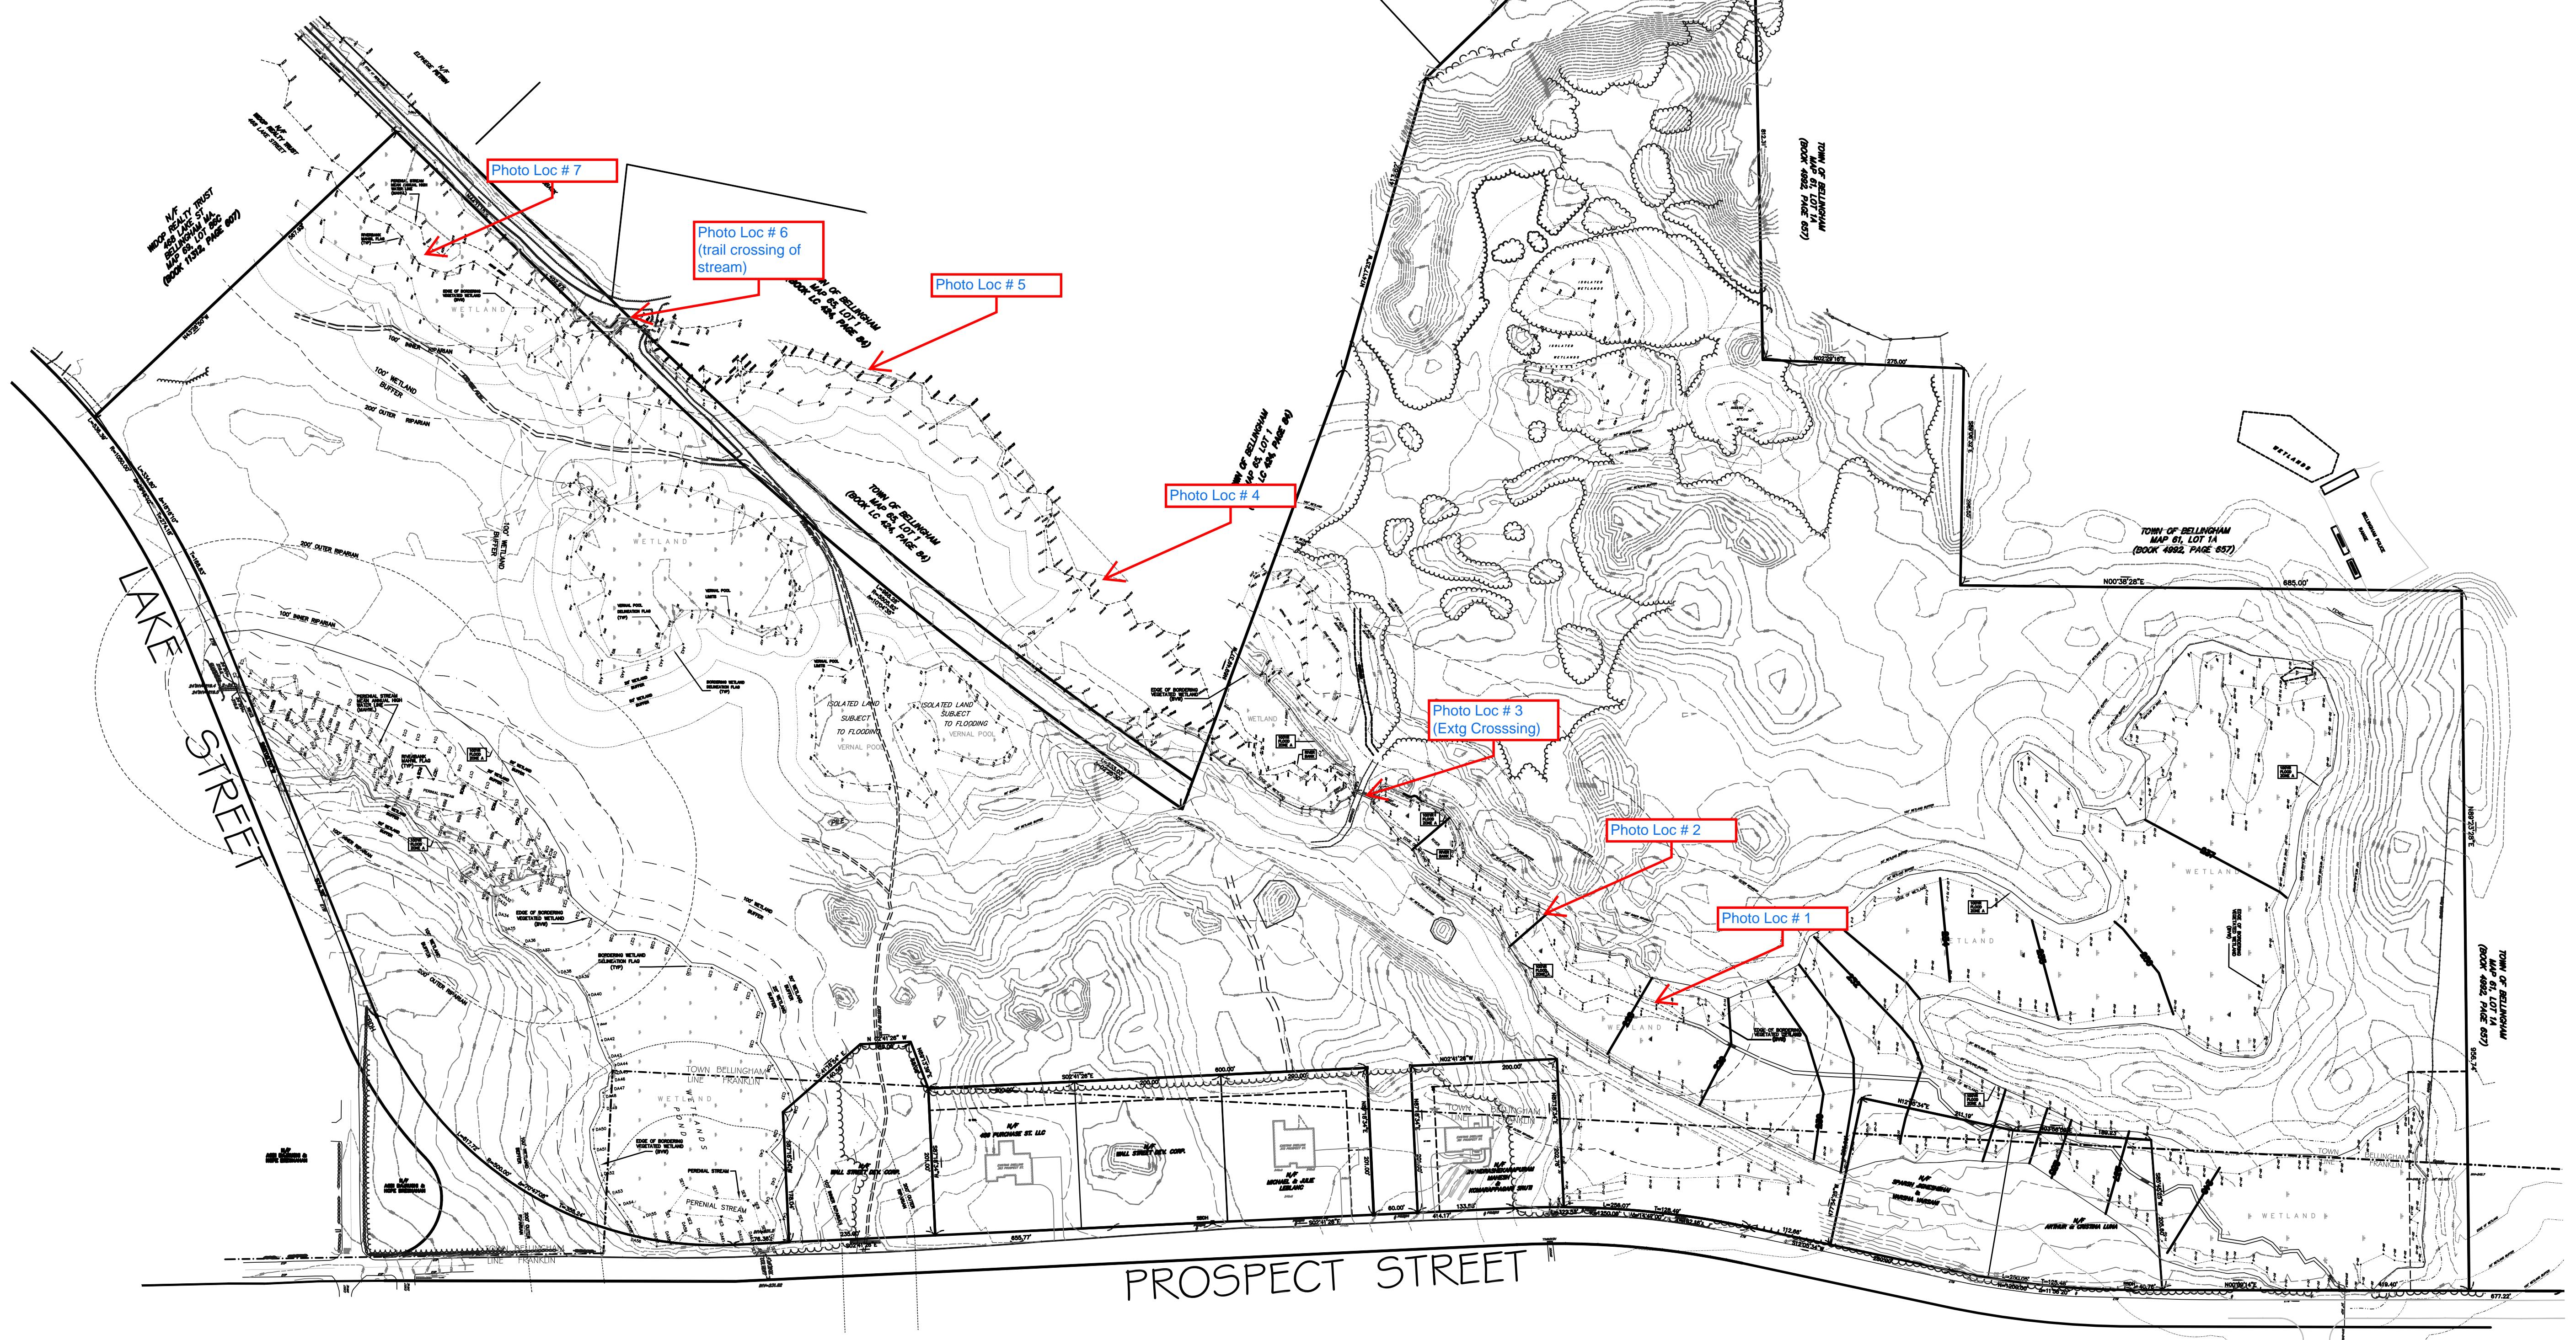
On 9/3/2024 through 9/6/2024, Paul J. McManus, SPWS and Kate O’Donnell, WPIT of EcoTec documented with photographs a lack of flow at seven (7) representative locations across the perennial-mapped stream segment, beginning at the upstream point where the USGS perennial mapping begins. A figure depicting photo locations is appended. Dated photo pages documenting a lack of flow at all photo locations for each date of monitoring (two pages per date) are attached, with a statement of veracity, signed under the pains and penalties of perjury, as required by the Regulations.

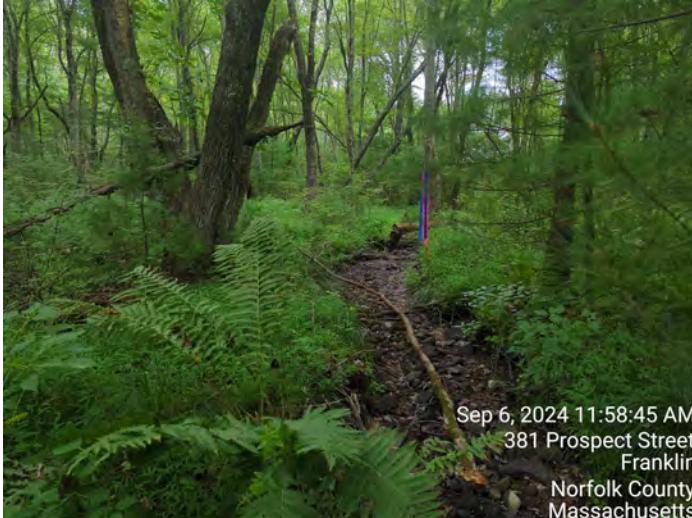
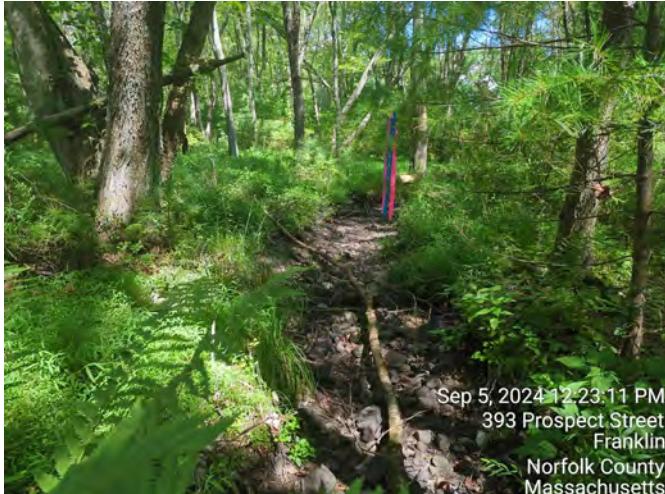
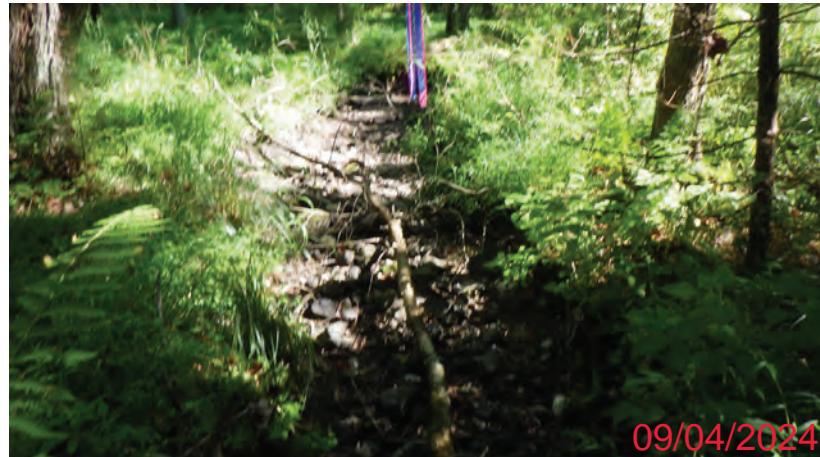
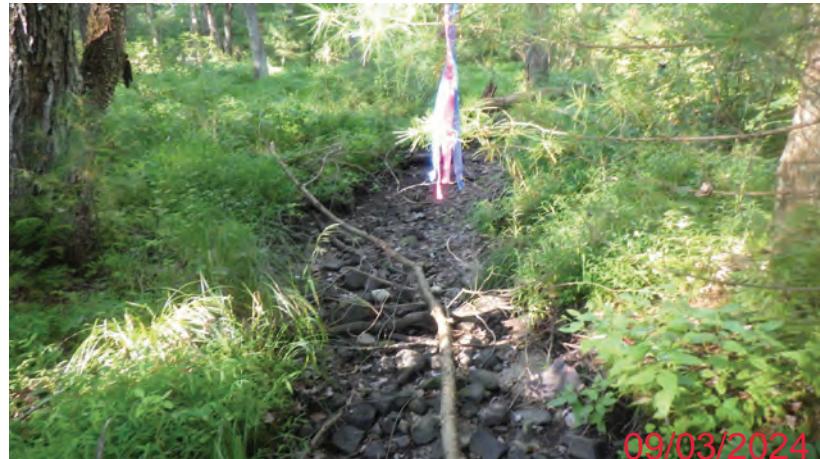
Photo Location #1

The photographs below accurately depict the absence of flow in the subject stream on the date and locations indicated.
Submitted under the pains and penalties of perjury. Kate O'Donnell, WPIT

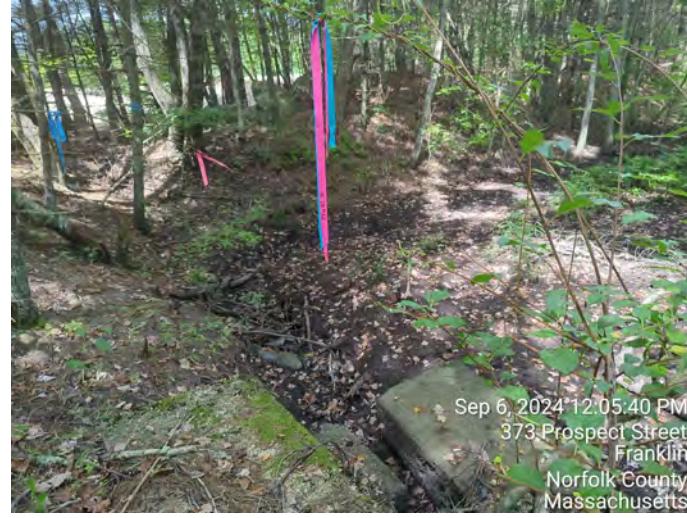
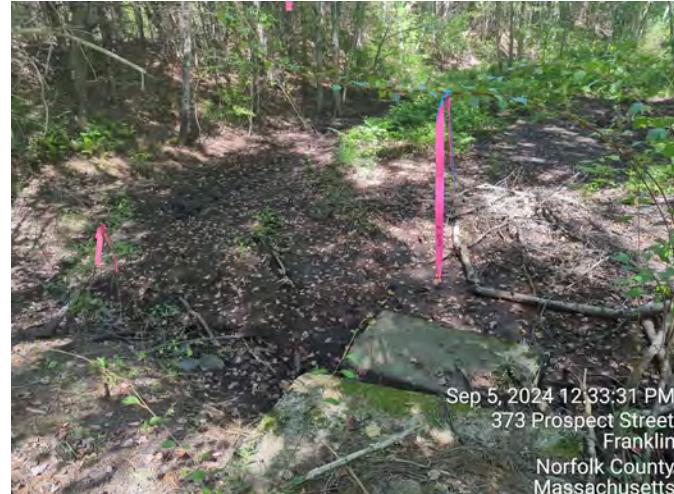
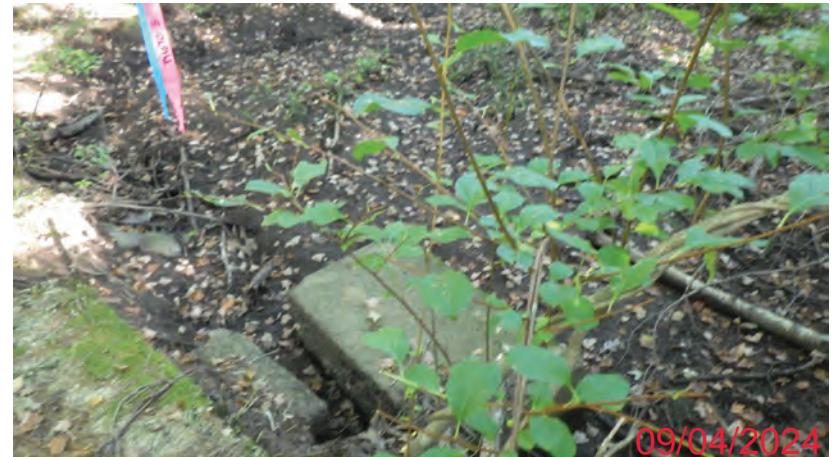
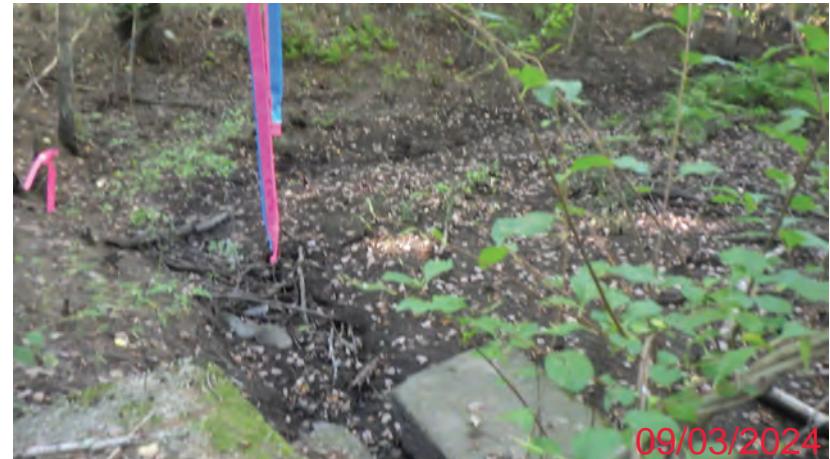
Photo Location #3a: Existing crossing—view upstream

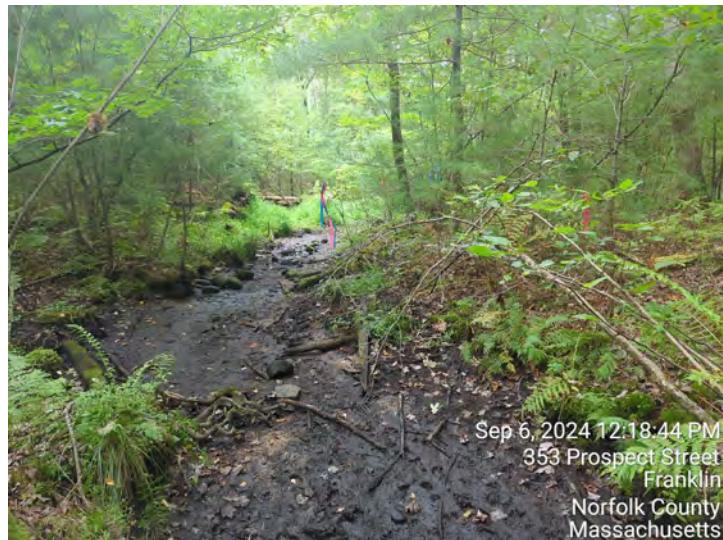
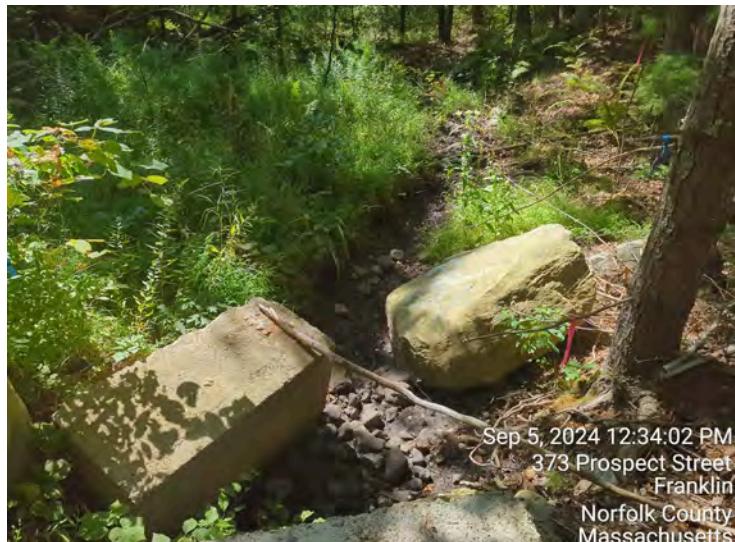
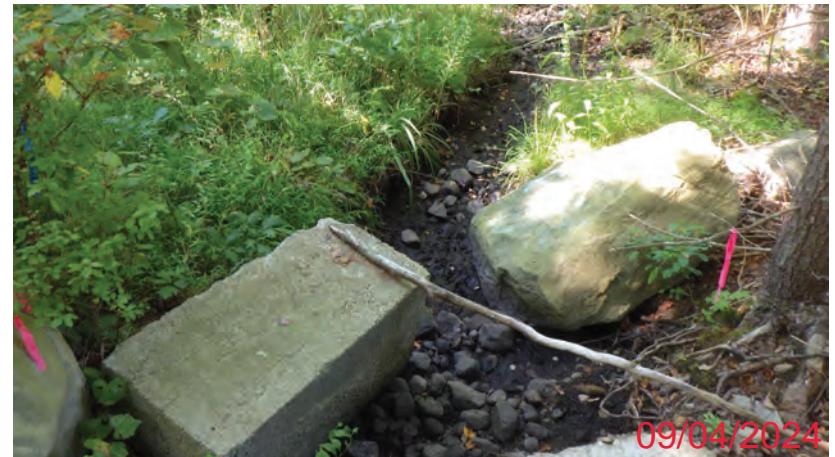
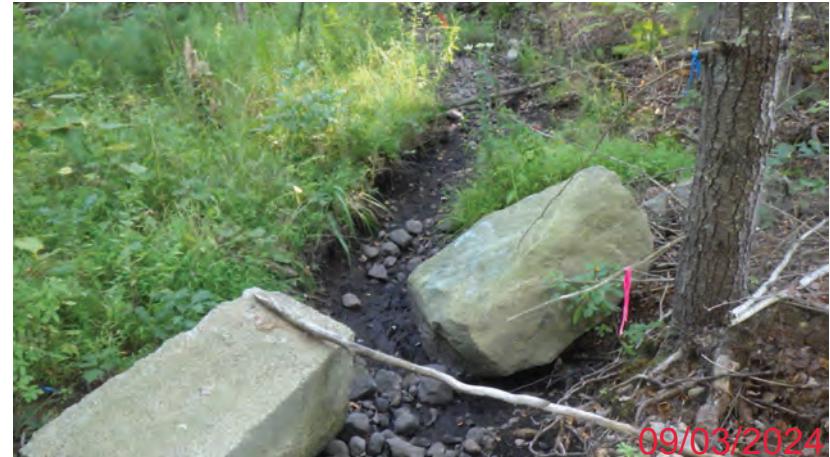
Photo Location #3b: Existing crossing—view downstr.

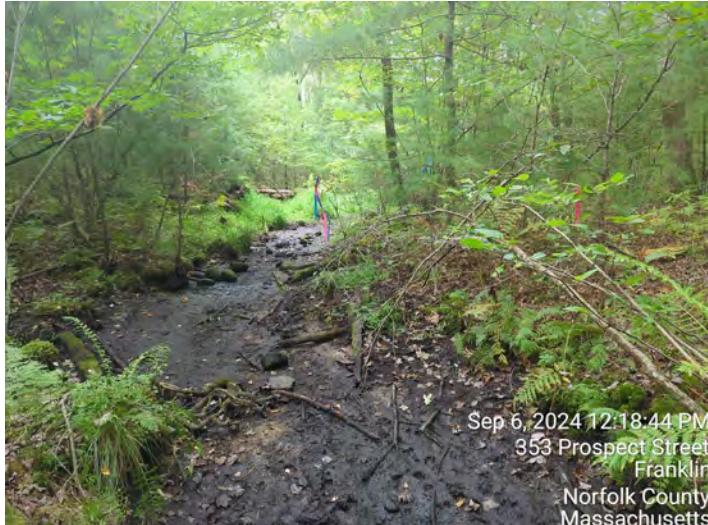
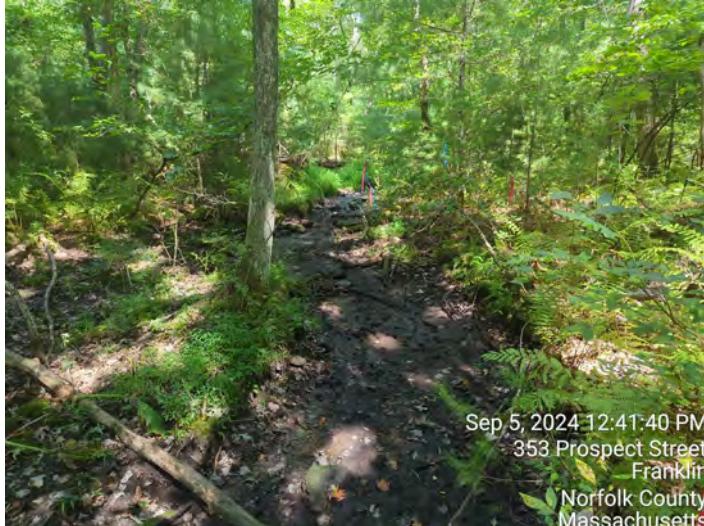
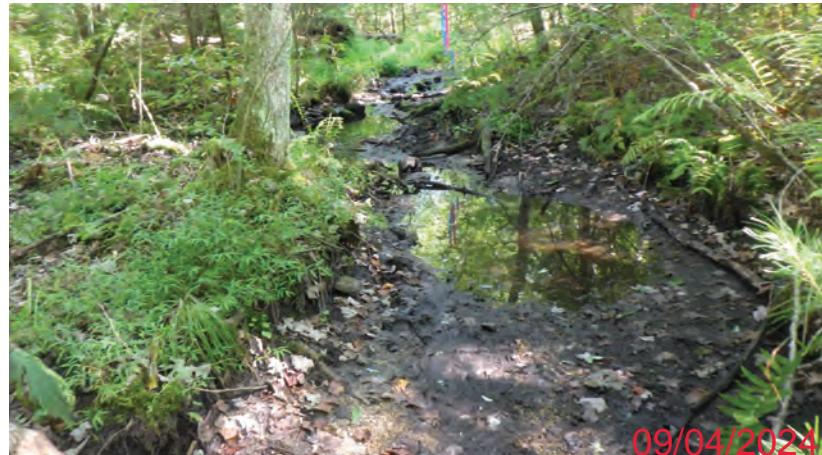
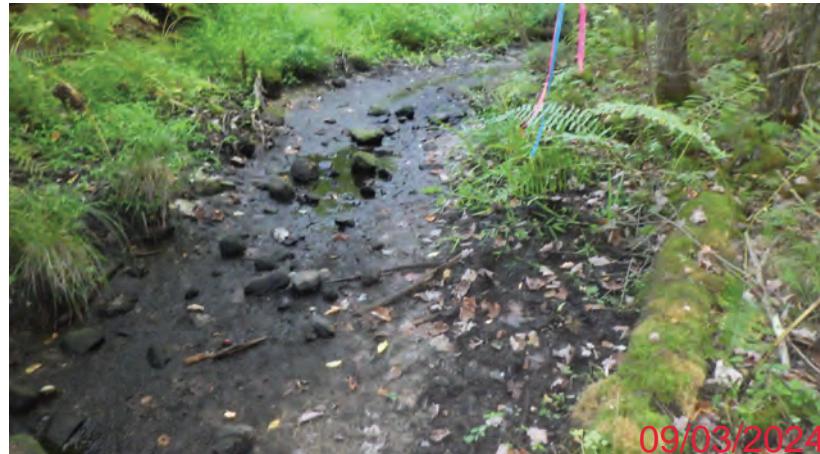
Photo Location #4

The photographs below accurately depict the absence of flow in the subject stream on the date and locations indicated.
Submitted under the pains and penalties of perjury. Kate O'Donnell, WPIT

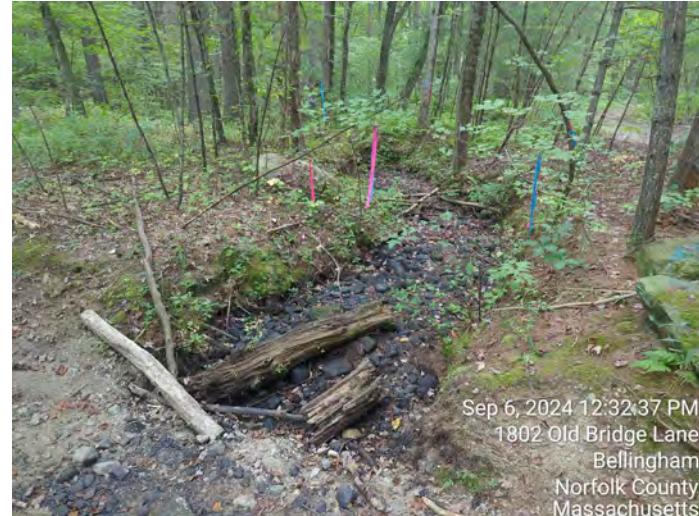
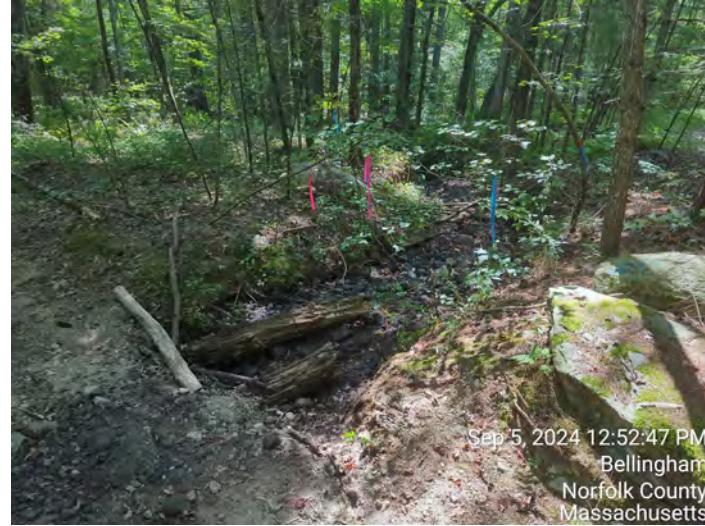
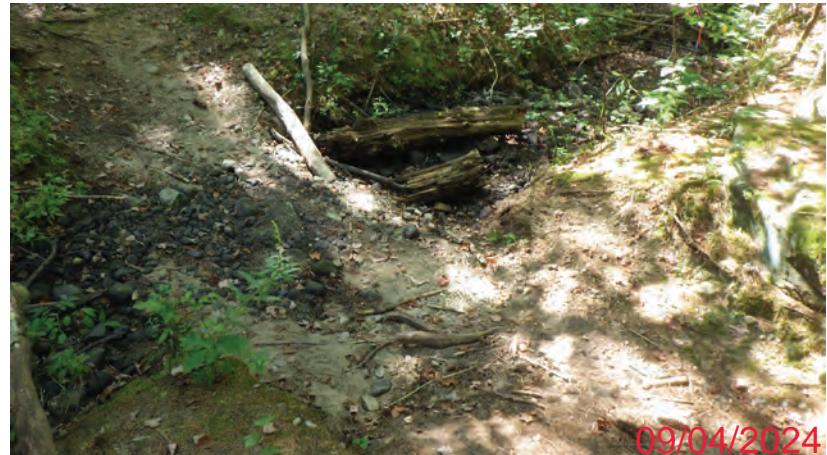
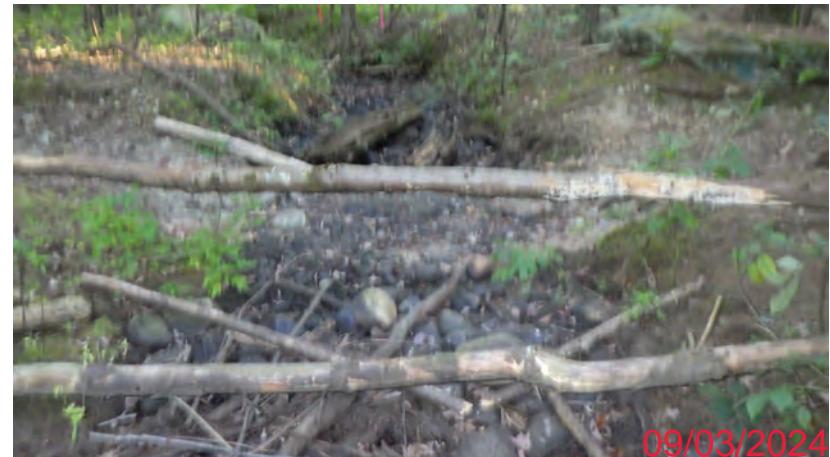
Photo Location #6: existing cart road crossing

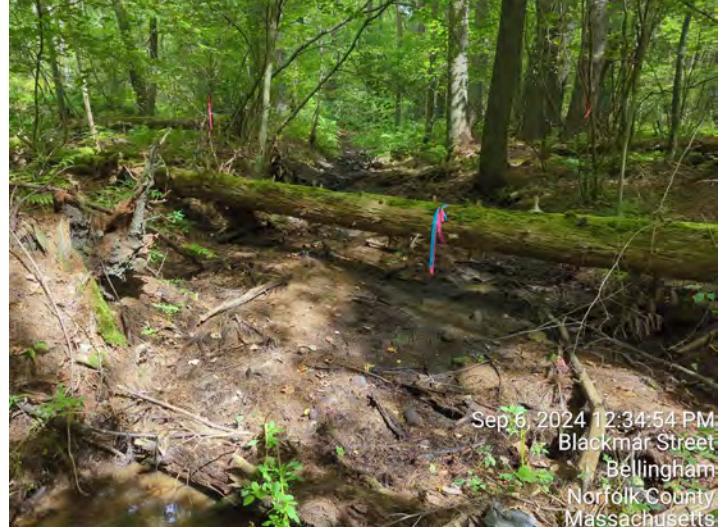
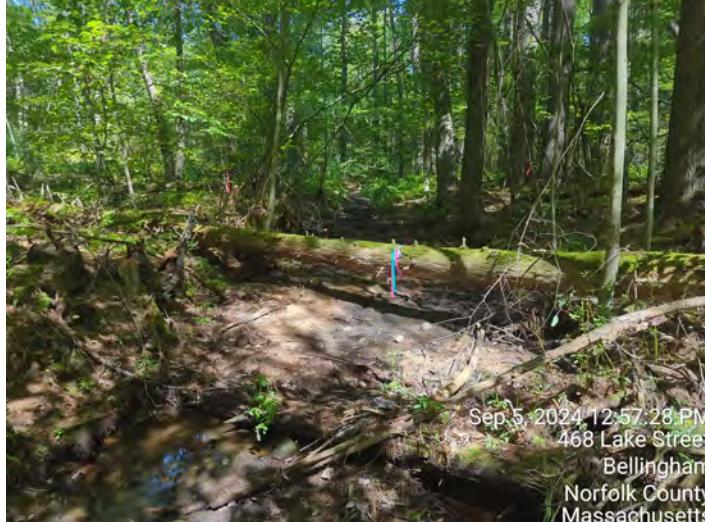
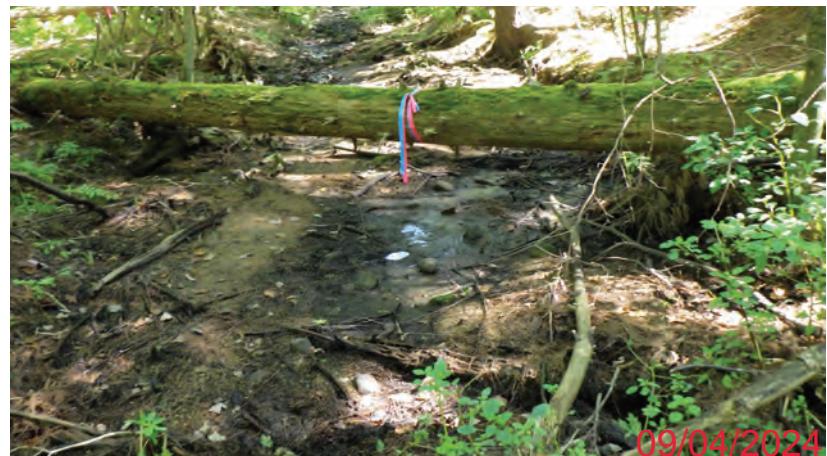
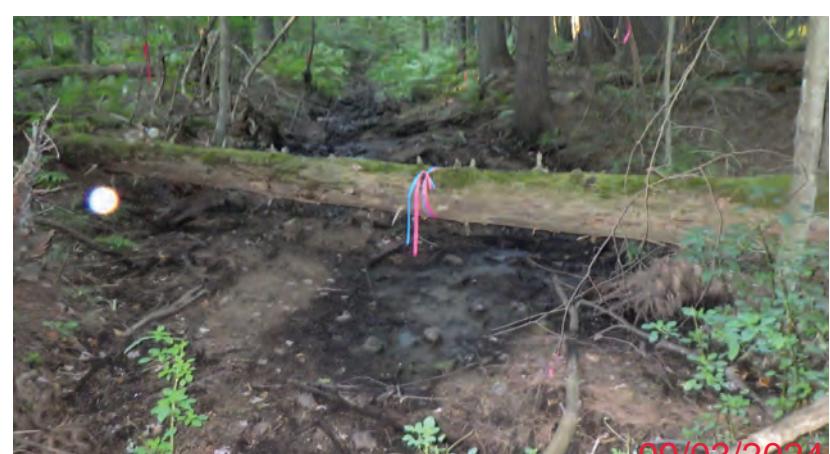
Based upon the documentation contained herein and the Wetland Regulations at 310 CMR 10.58(2)(a)1.d, the area of Hoag Brook upgradient of Photo Location #7 shall be designated intermittent, without any associated Riverfront Area.
