**TITLE: A Tree Died in Bellingham, 7/10/2025**

Narrative to accompany WPA Request for Determination of Applicability application for 287 Lakeshore Drive in Bellingham, Massachusetts, 02019

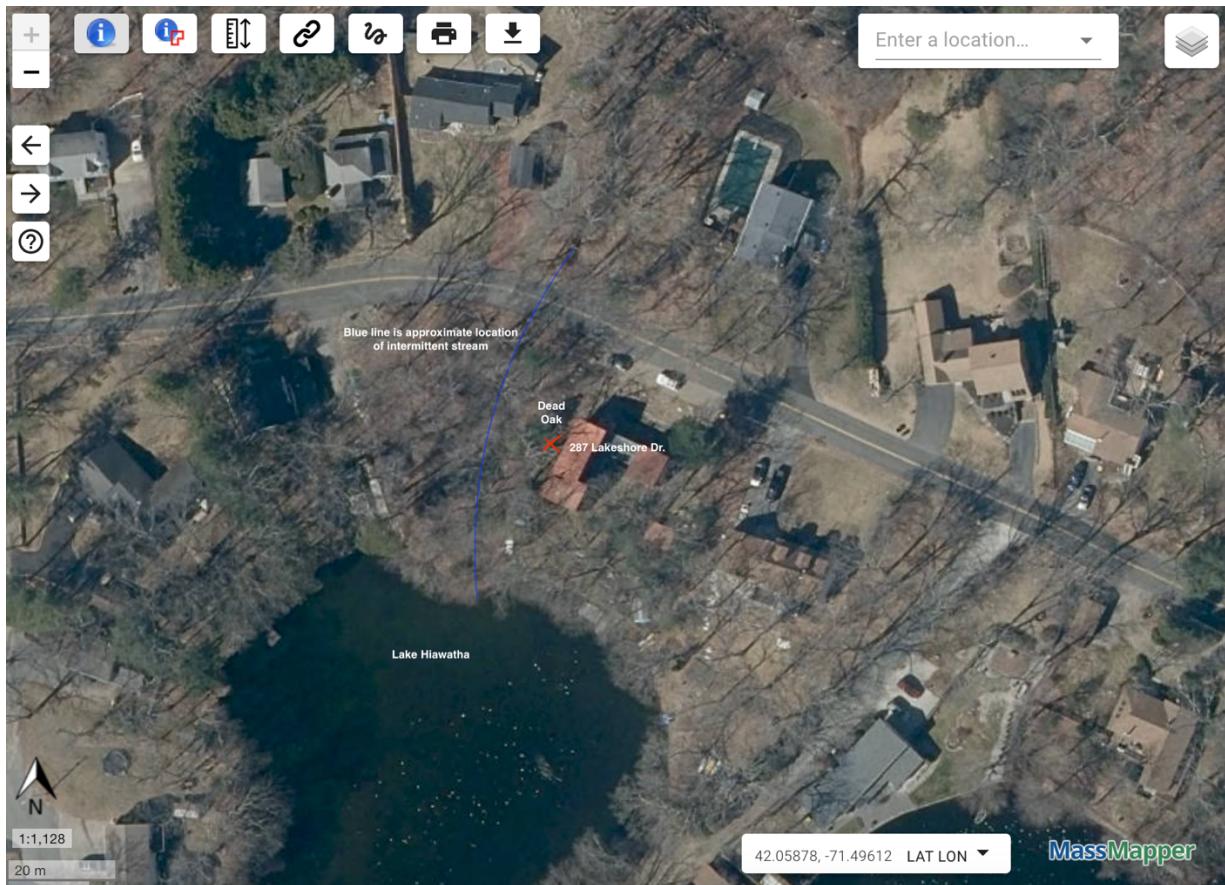
The oak is located in a moss-and-natural-greenery-landscaped area. It is located 69 feet from the bank of Lake Hiawatha and about 20 feet from an intermittent stream. In the aerial view below, the red "X" marks the approximate location of the dead oak tree, and the blue line marks the approximate placement of the intermittent stream. Additionally, the oak tree is within 15 feet of wetland vegetation (skunk cabbage).
