# NOTICE OF INTENT

Pare Project No. 23162.00

## Silver Lake Dam Improvements Maintenance Easement at 80 Cross Street & 10 Dupre Road Bellingham, Massachusetts 02019

DECEMBER 2024

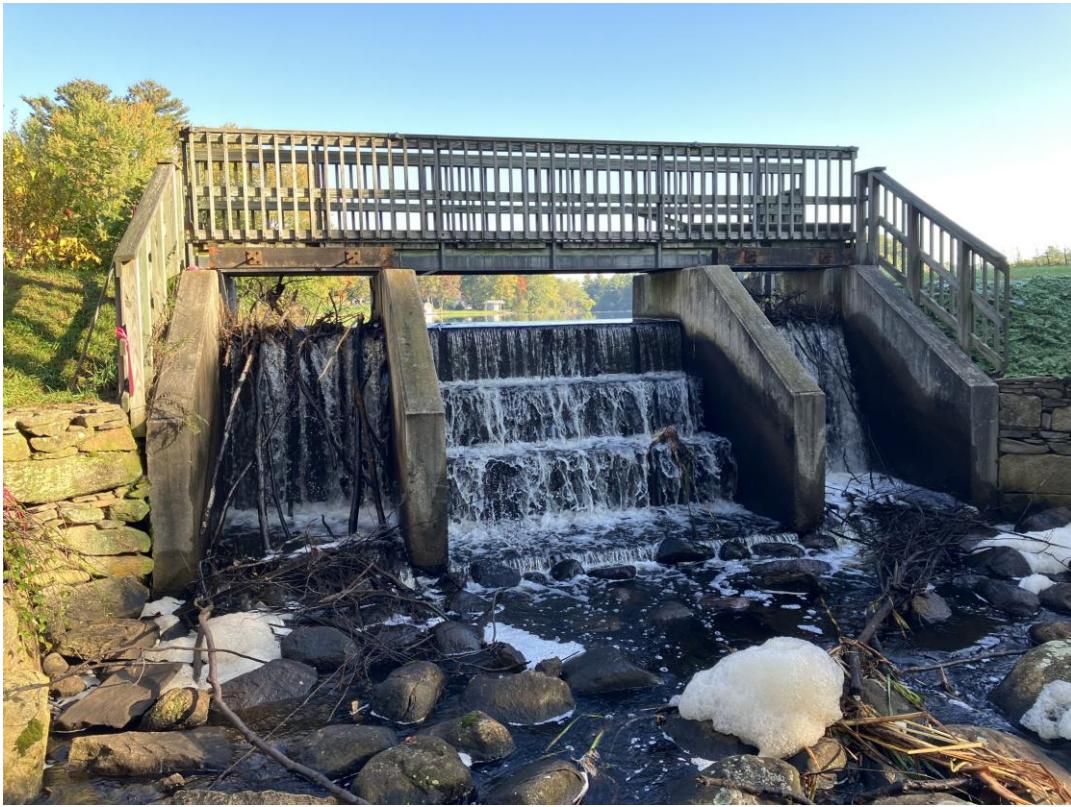
Photo No. 1: View of the Silver Lake dam and spillway facing north.

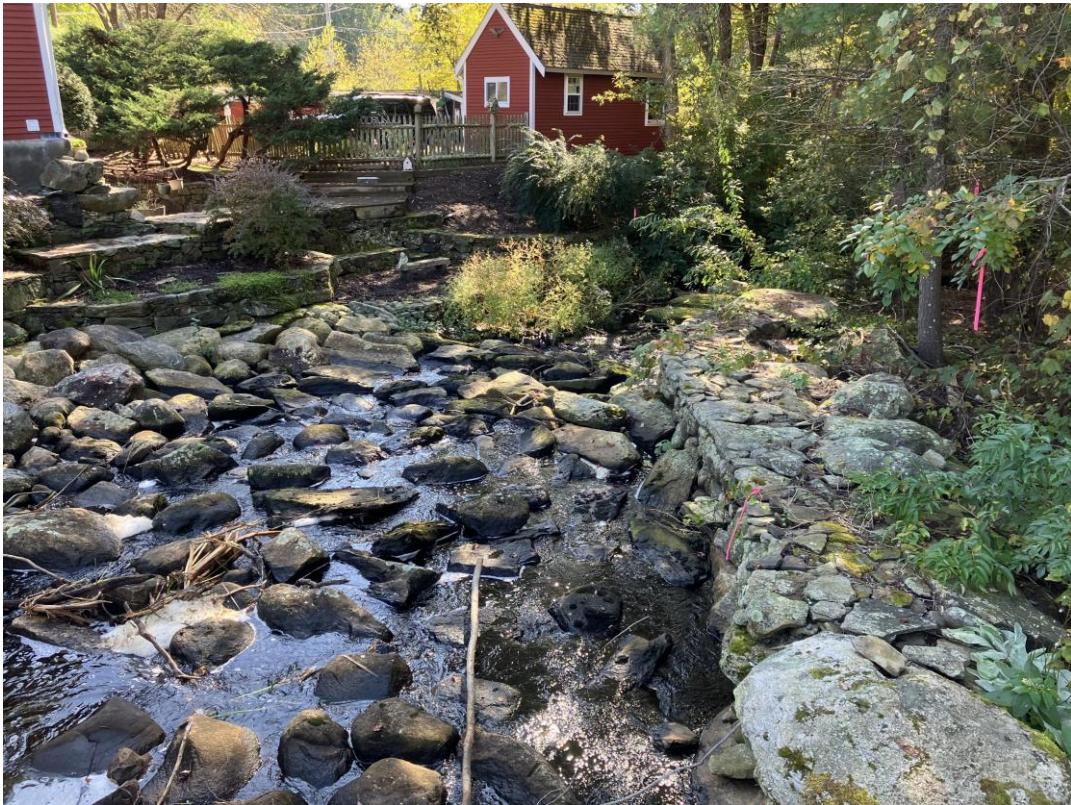
Photo No. 2: View of the Silver Lake dam spillway discharging to Peters River facing south near flag R-3. The eastern bank of the river is masonry retaining walls associated with the residential dwelling.

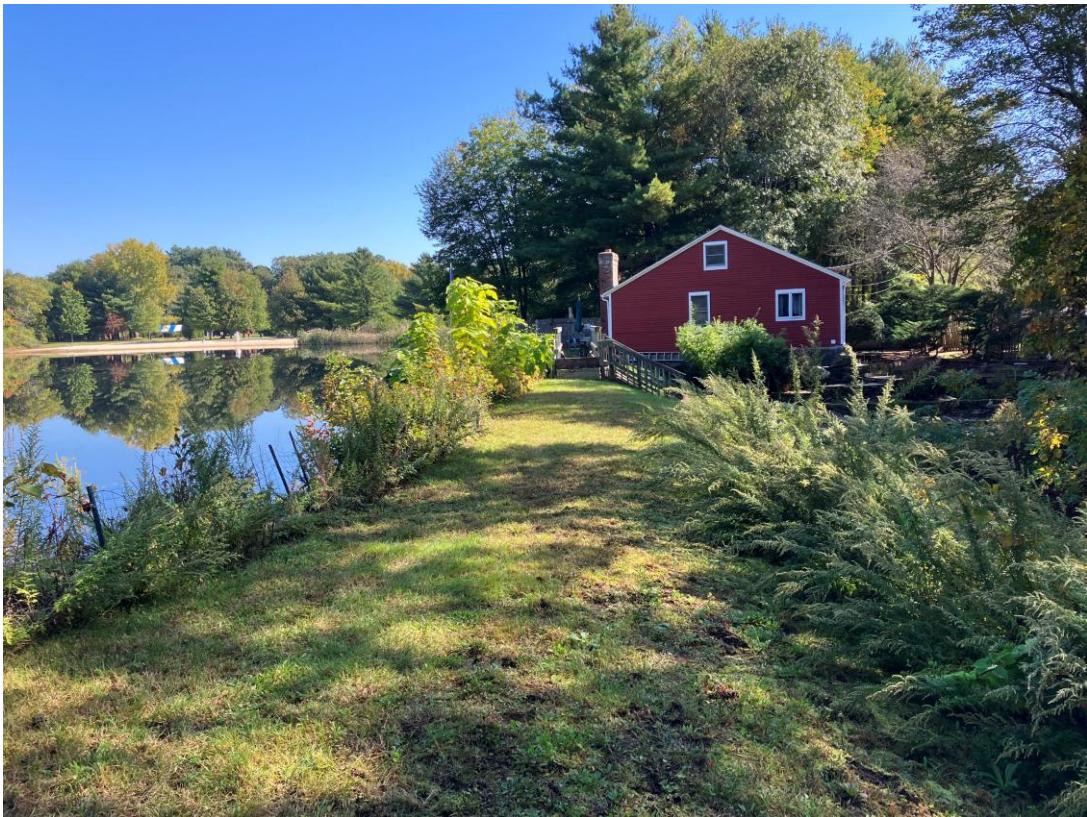
Photo No. 3: View of the dam crest immediately west of the spillway.

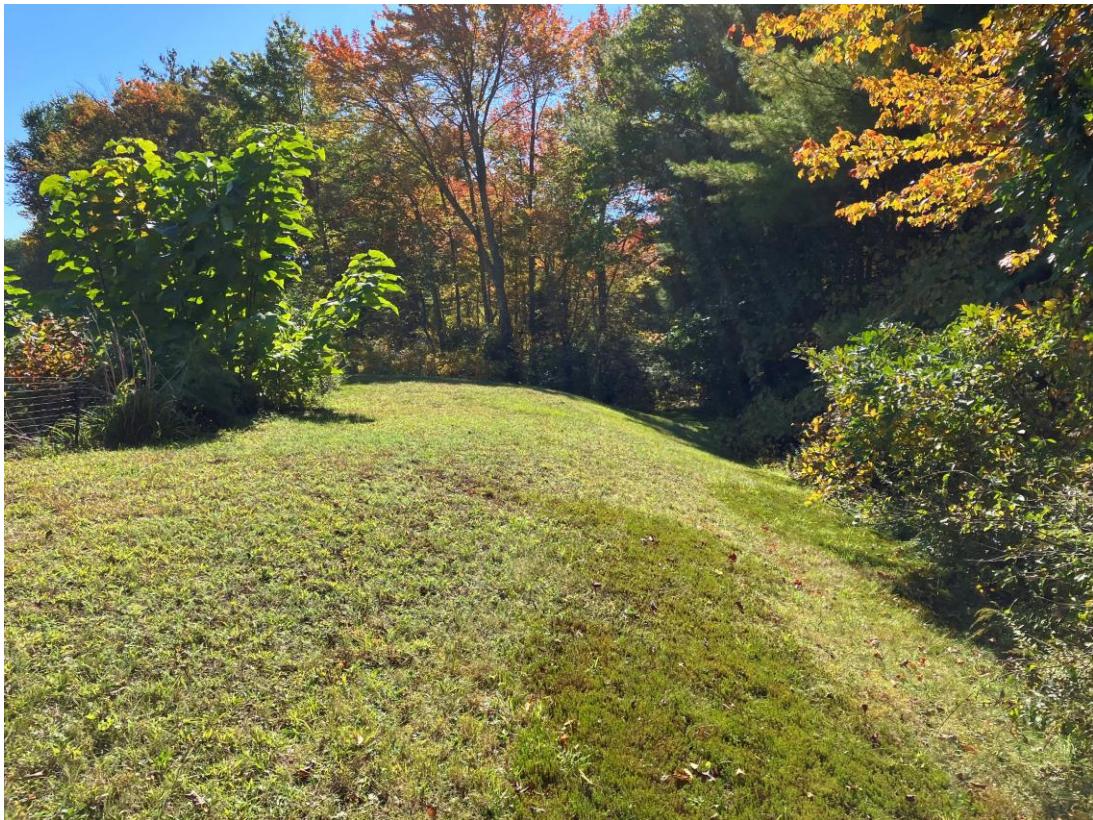
Photo No. 4: View of the downgradient side of the dam crest.

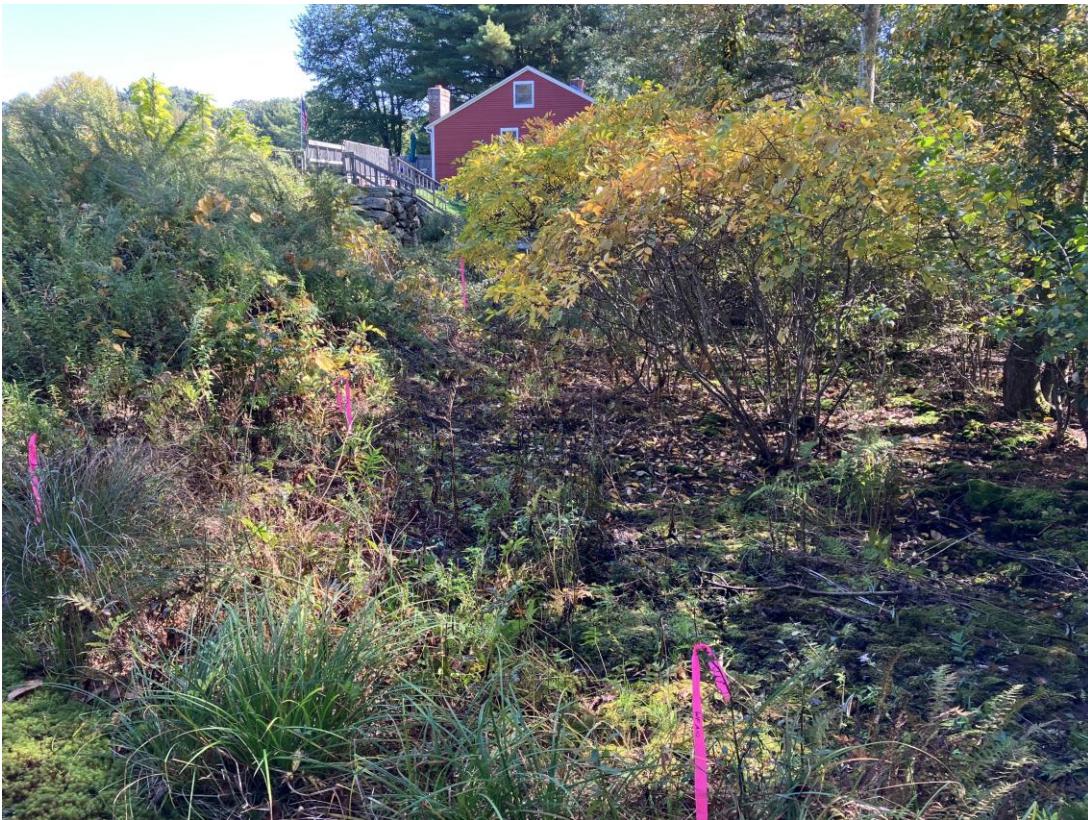
Photo No. 5: View of the location of the proposed toe drain and associated boulder retaining wall.

- Cutting, clearing, and grubbing all trees, vegetation, and roots systems from the Dam;
- Regrading the downstream slope to address stability and seepage concerns as well as to a more uniform and maintainable slope;
- Installation of a toe drain within the downgradient slope to lower the water table within the dam embankment and improved seepage exit conditions at the downstream toe; and
- Fill and compact erosion along the dam embankment in order to ensure bank stability.

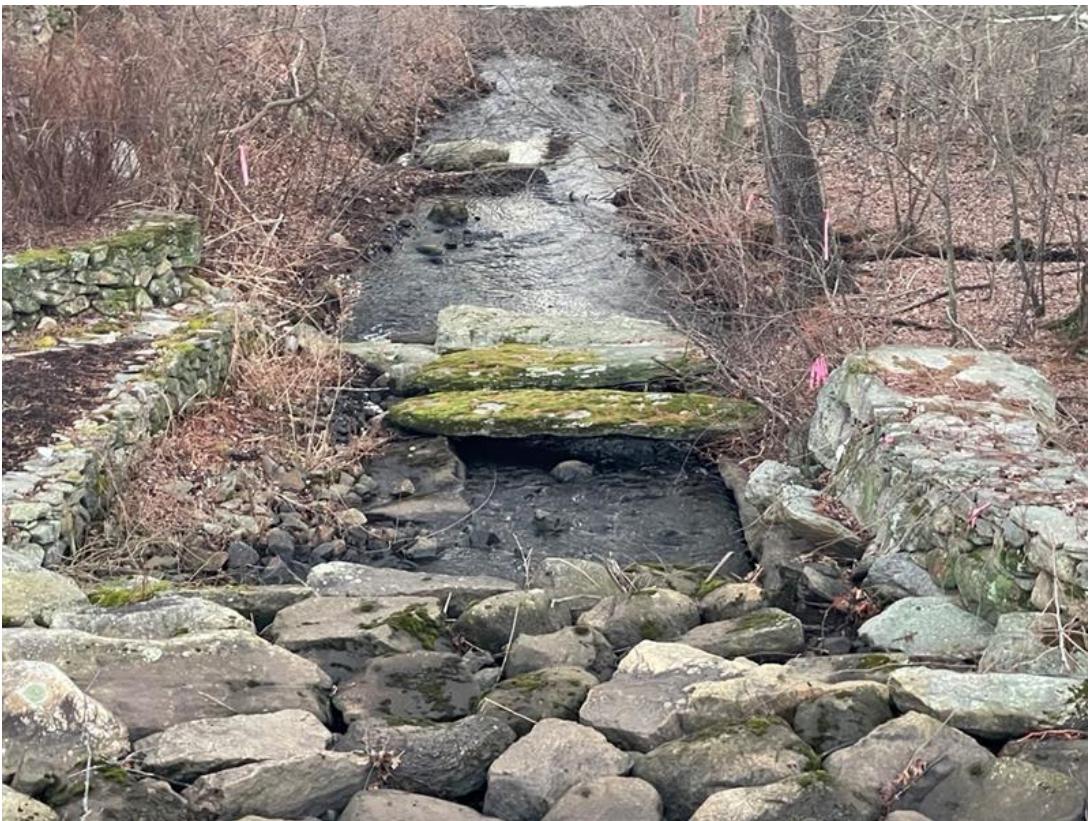
Photo No. 6: View of the stone slabs that are to be removed and replaced for the installation of the toe drain.

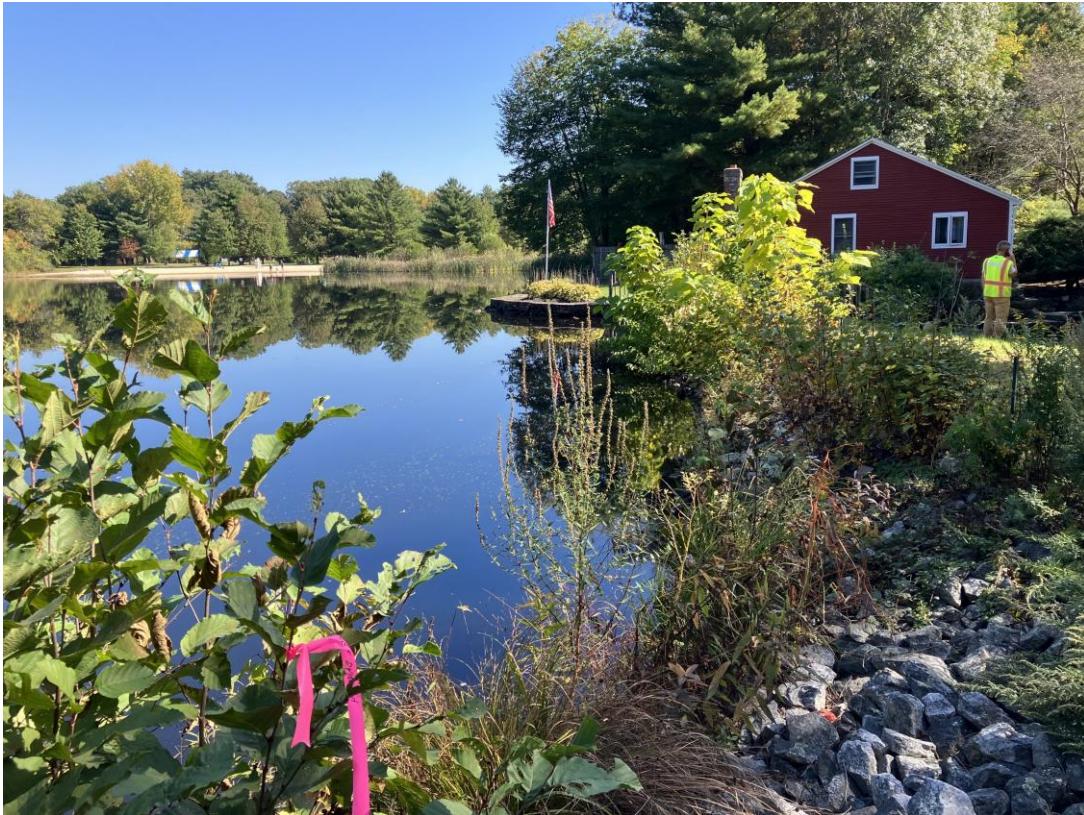
Photo No. 3: View of the southern bank of Silver Lake facing east towards the spillway at flag P-4. Notice the substantial woody growth throughout the rip rap slope.

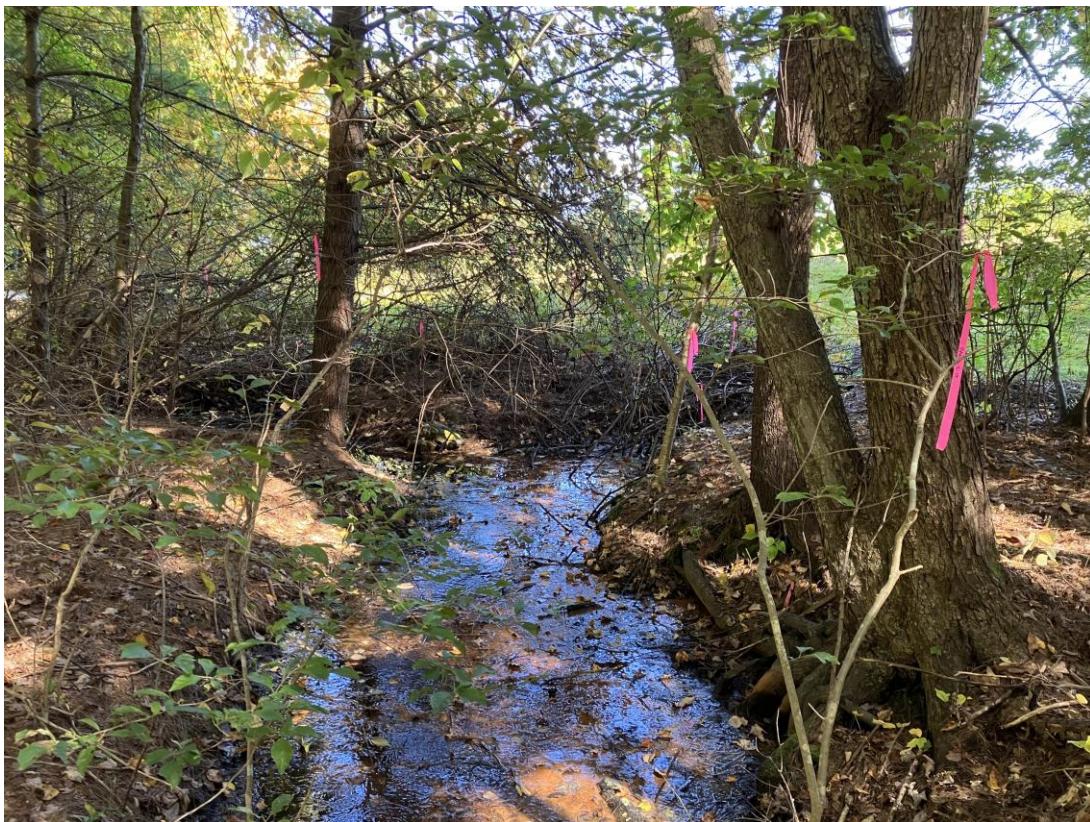
Photo No. 4: View of the intermittent stream facing north at flag S-14. The intermittent stream is hydrologically fed by a low-level outlet associated with the dam.

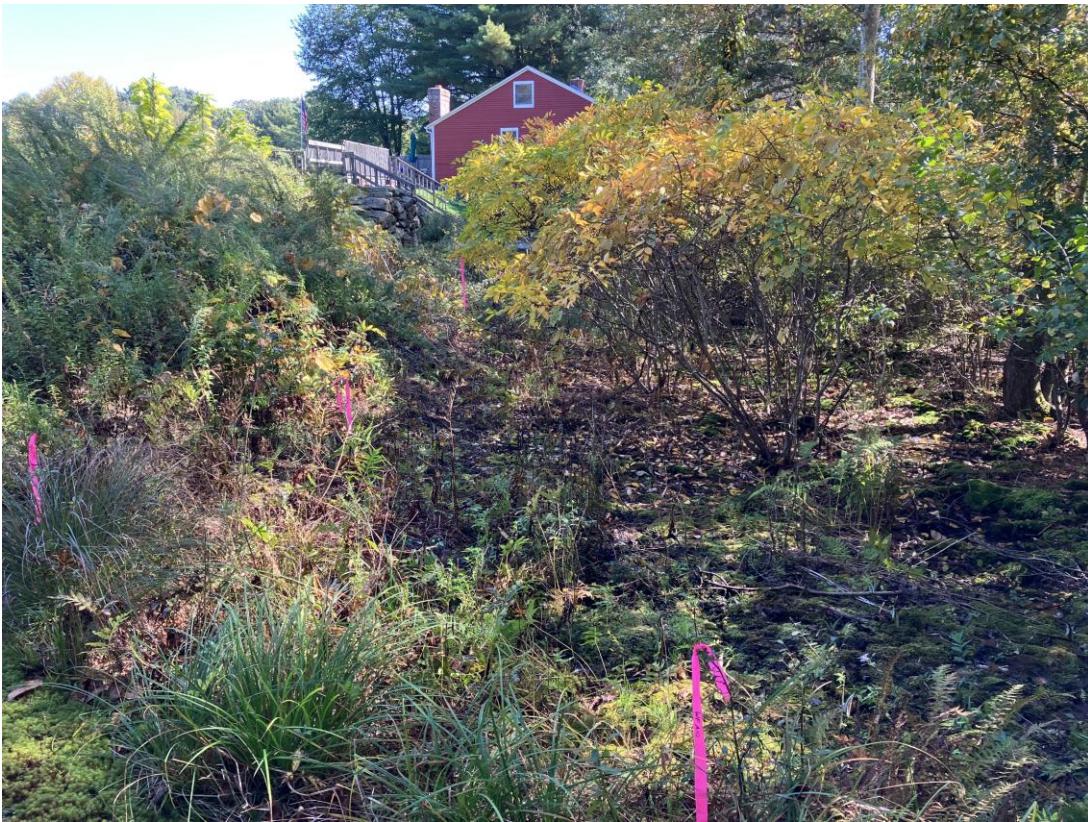
Photo No. 8: View of the A-series BVW at the toe of the dam embankment facing east at flag A-10. The dam and spillway are located on the west side of the photo.

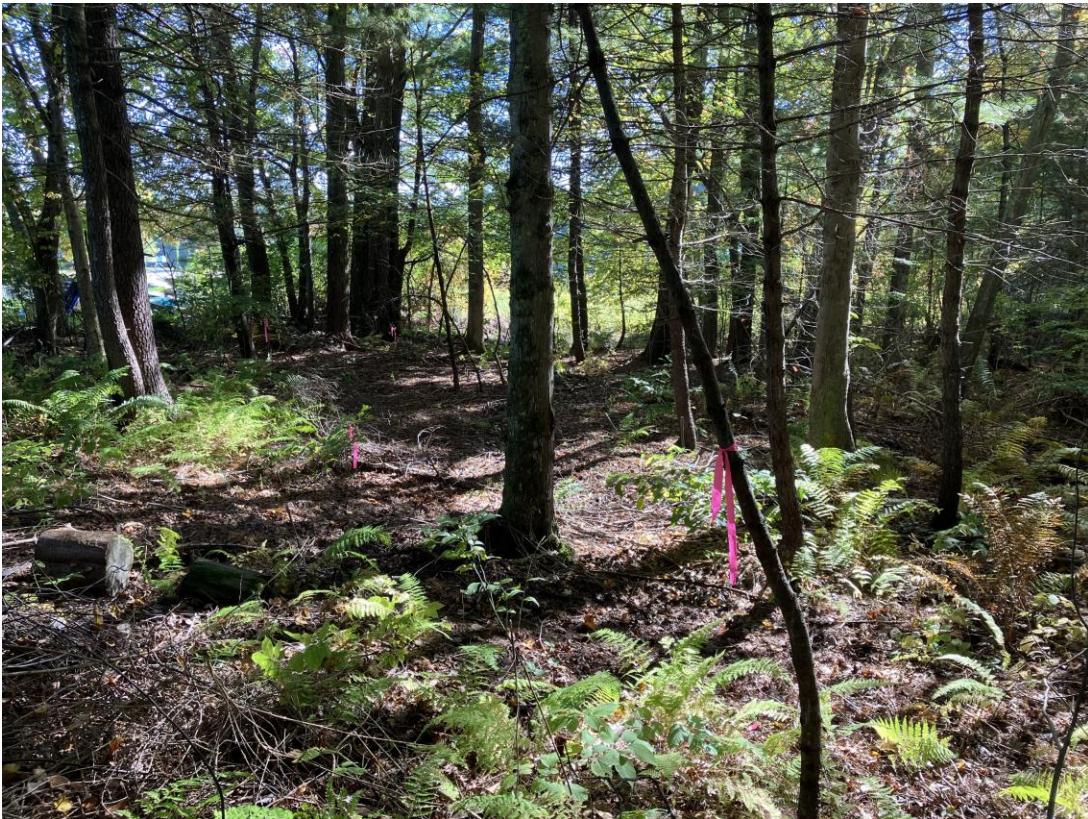
Photo No. 9: View of the A-series BVW facing east at flag A-26. The wetland edge exists at the toe of a forested slope.

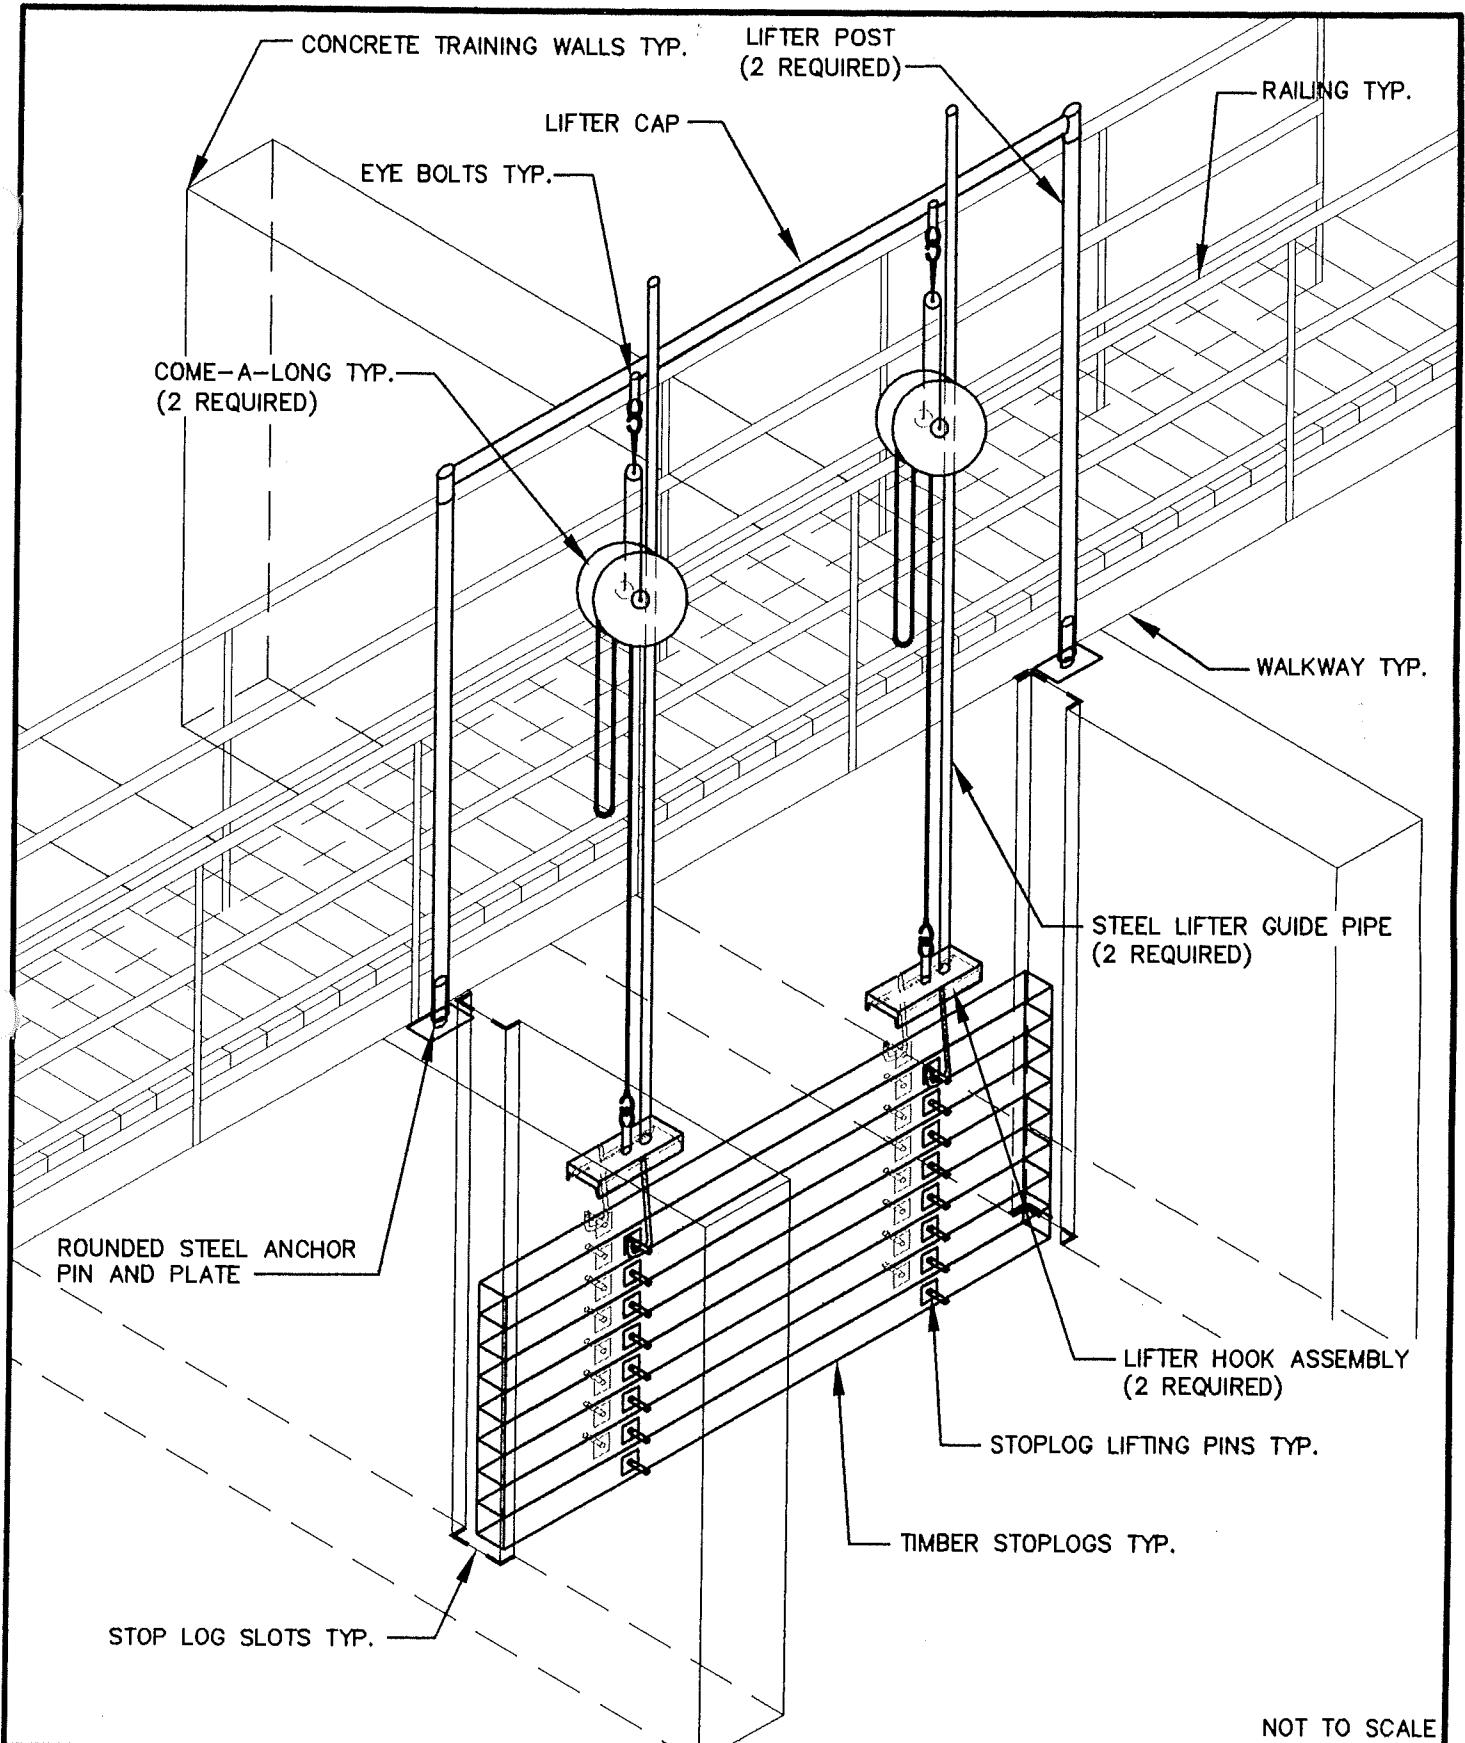
FIGURE 1	GENERAL SITE PLAN
FIGURE 2	GENERAL SPILLWAY PLAN
FIGURE 3	STOPLOG SIFTING SYSTEM AND LIFTER DEVICE

The spillway system consists of a fixed crest weir and two sluiceways each equipped with an adjustable stack of stoplogs. The timber stoplogs are stacked on top of each other within slots formed within the concrete walls of each sluiceway and the spillway. The flow through the dam is controlled by removing or adding timber stoplogs. The stop logs are fitted with lifter pins that can be grabbed with the lifter mechanism designed for this structure. This lifter mechanism attaches to the piers and bridge and is used to remove and place the stoplogs when necessary (see Figure 3). In the event that work is required on the stoplog system, a second set of slots are located near the upstream end of the piers so that additional timber stoplogs can be installed to prevent flow and permit maintenance activities.
