**Fire Building Feasibility Study Committee**  
**Tuesday, April 22, 2025, at 10:00 am**  
**Station 2**  
**28 Blackstone Street, Bellingham, MA 02019**

## Program and Space-Use Analysis Matrix

## FIRE COMPANY #1 - EXISTING CONDITIONS ASSESSMENT

## FIRE COMPANY #2 - EXISTING CONDITIONS ASSESSMENT

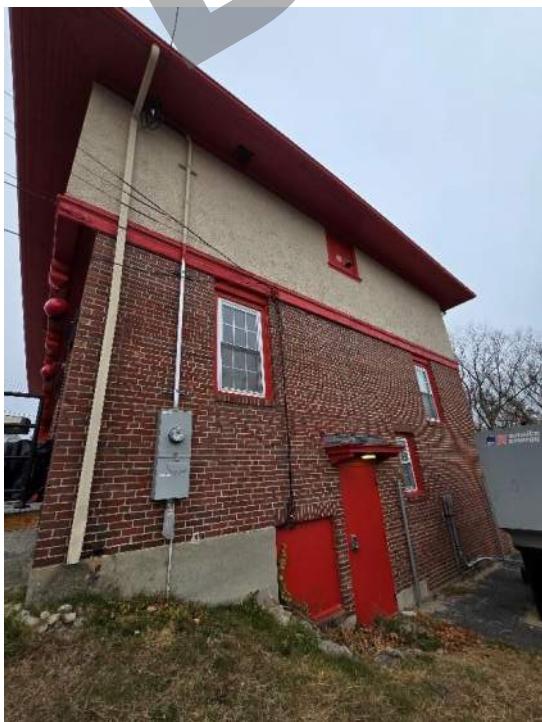
Photo 2: South façade.

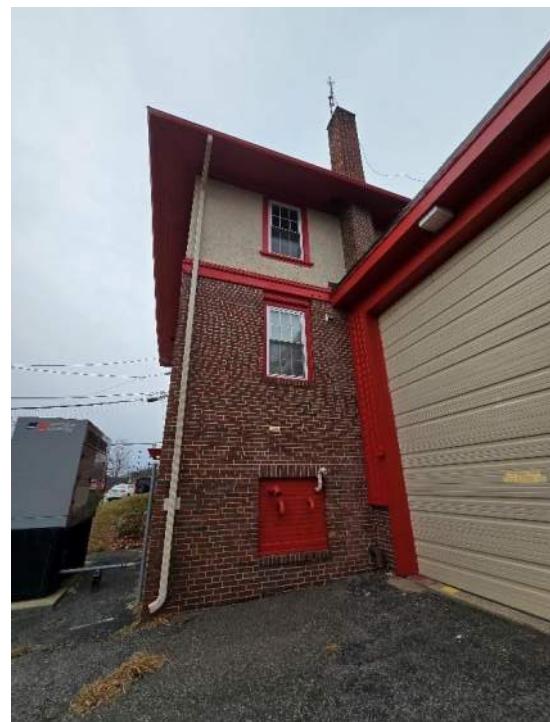
Photo 3: Partial East façade.

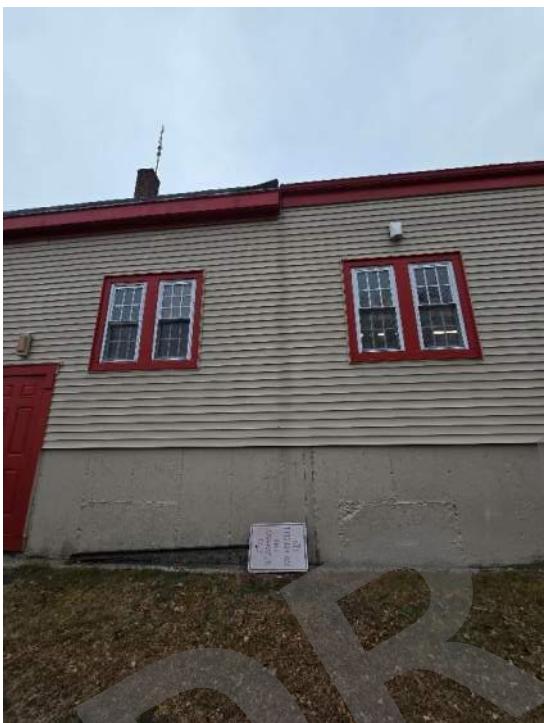
Photo 4: Partial East façade (vinyl siding).

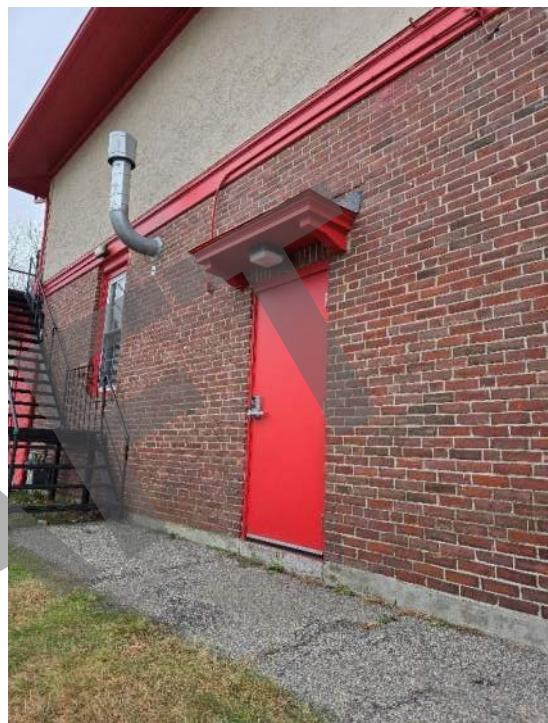
Photo 5: North façade.

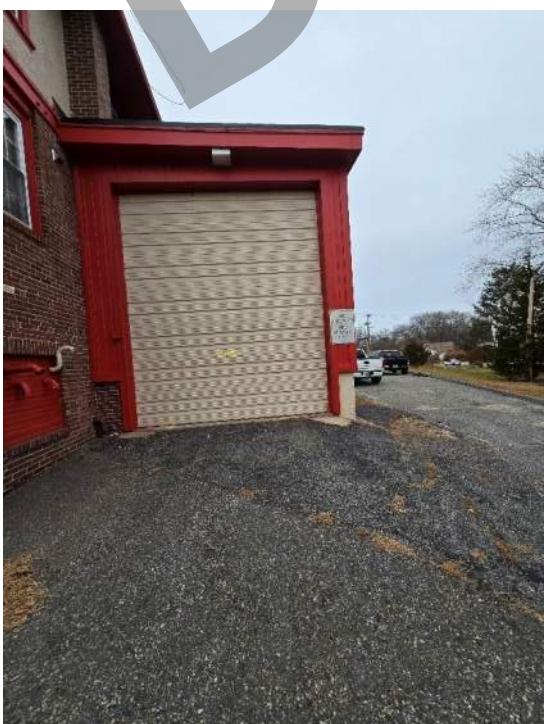
Photo 6: Rear Apparatus Bay (West).

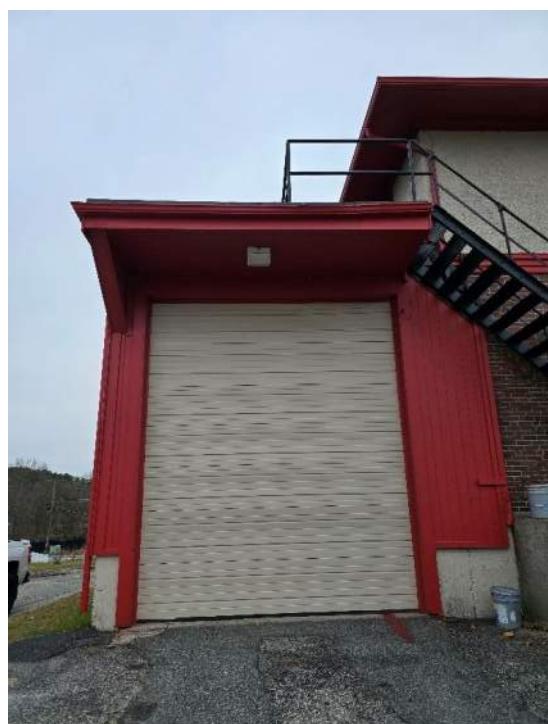
Photo 7: Rear Apparatus Bay (East).

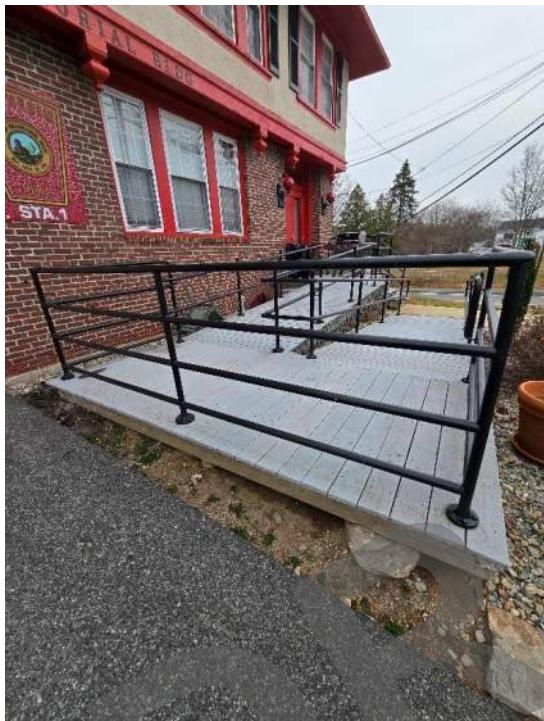
Photo 8: Main Entry Ramp.

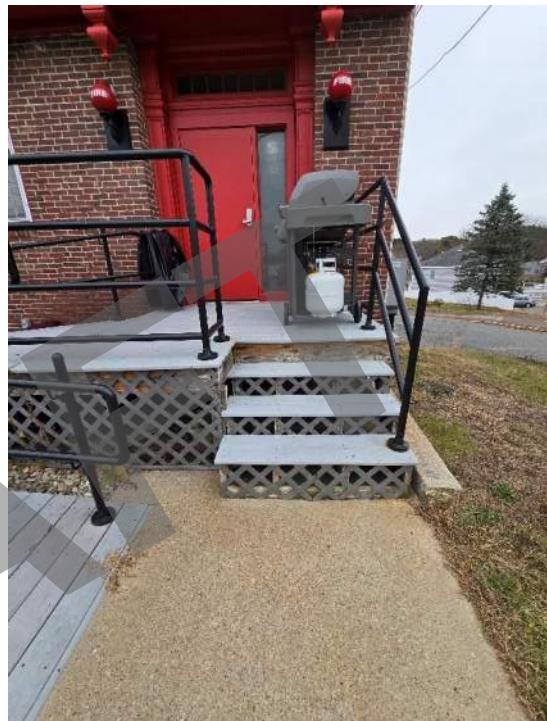
Photo 9: Main Entry Stair.

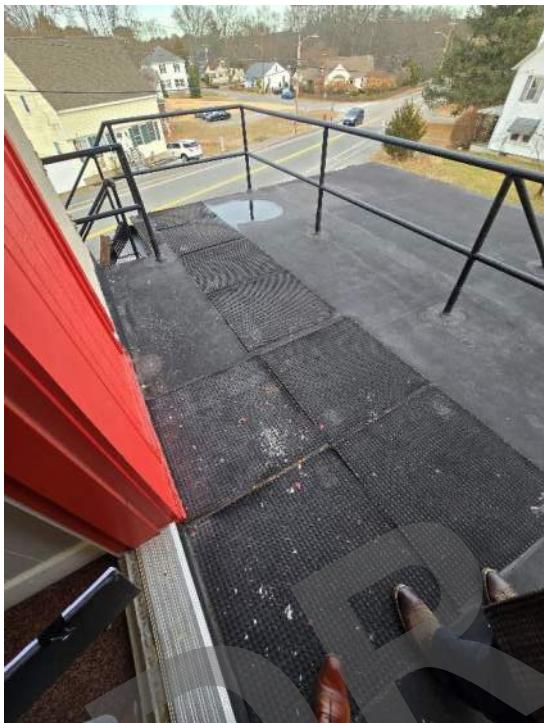
Photo 13: Fire Escape.

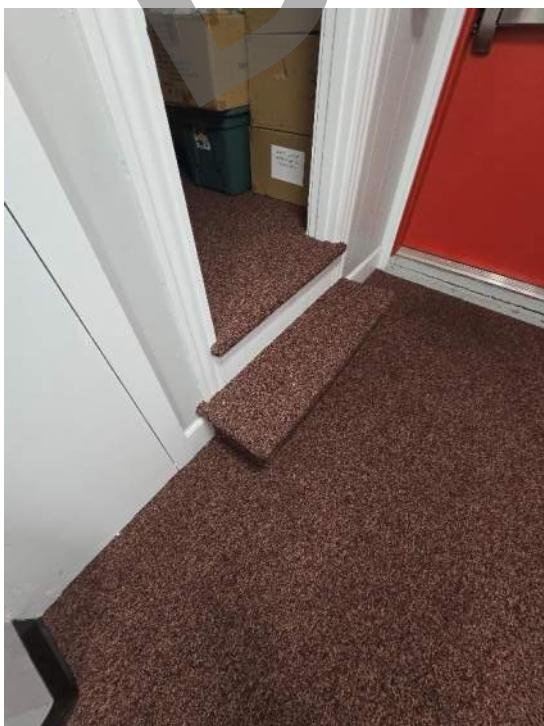
Photo 15: Day Room/Step-up to Fitness.

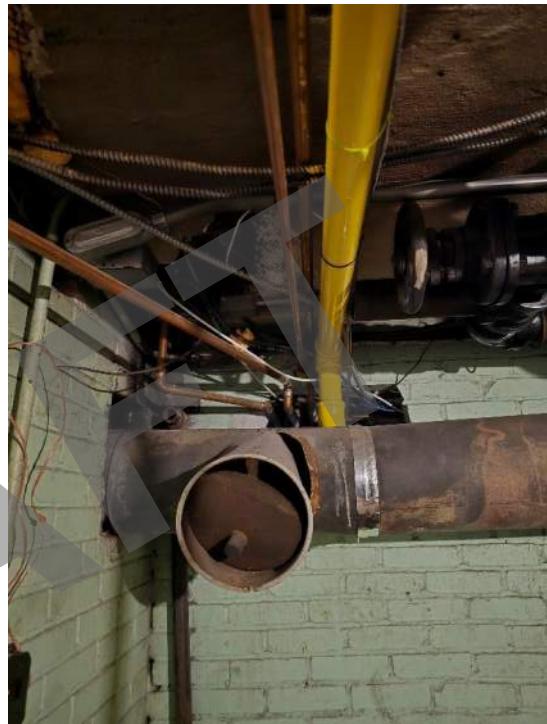
Photo 41: Abandoned ductwork/  
Unsupported masonry penetrations.

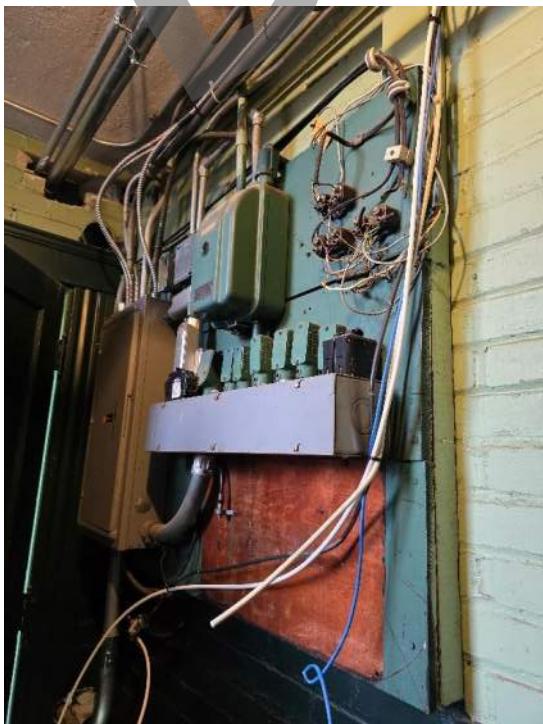
Photo 42: Electrical Panel.

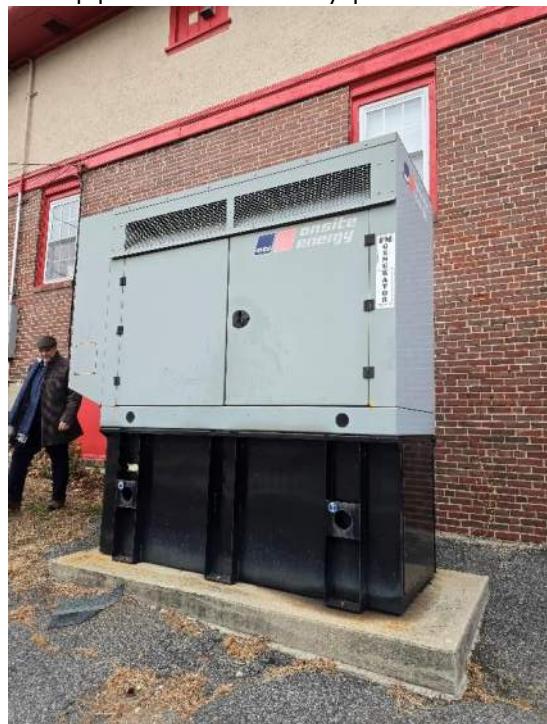
Photo 43: Diesel generator.

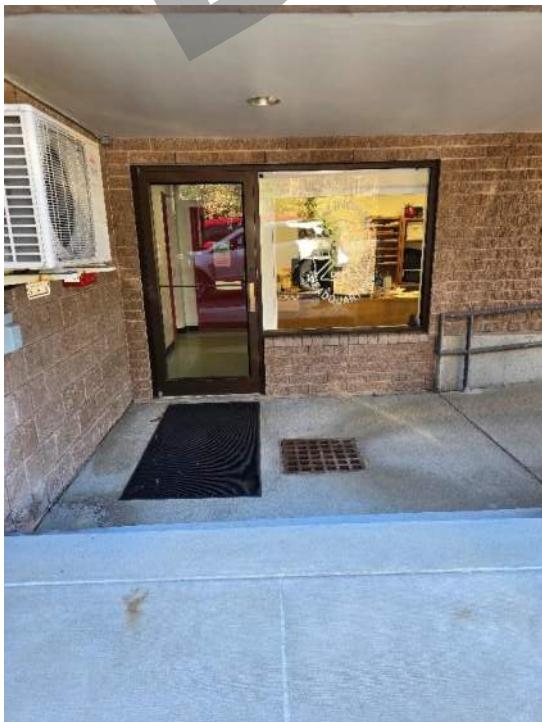
Photo 2: Main Entrance.

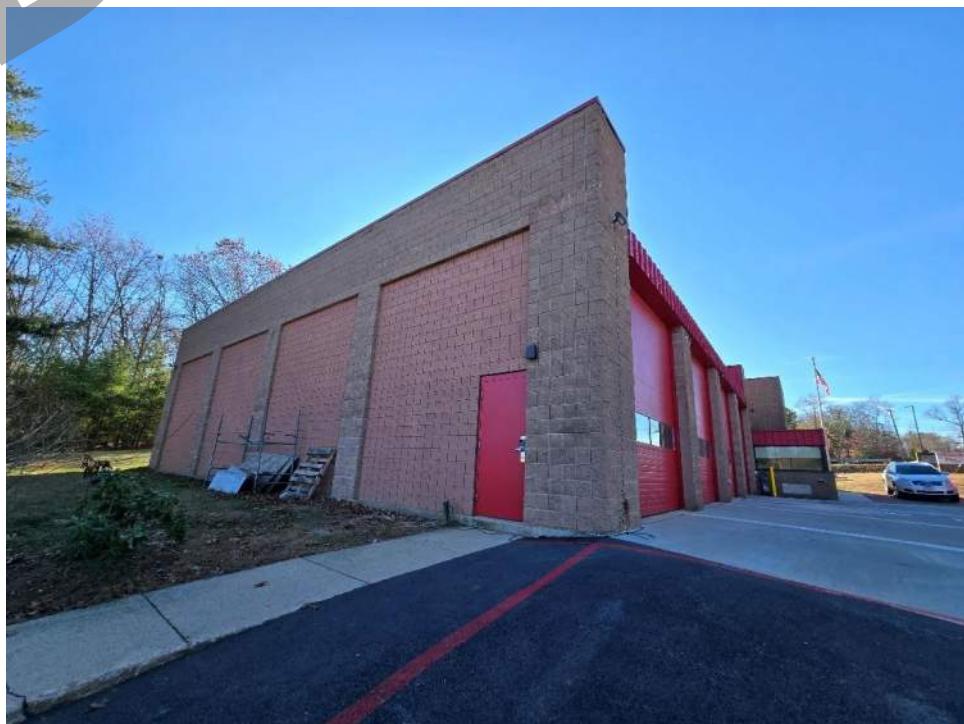
Photo 5: Northeast façade.

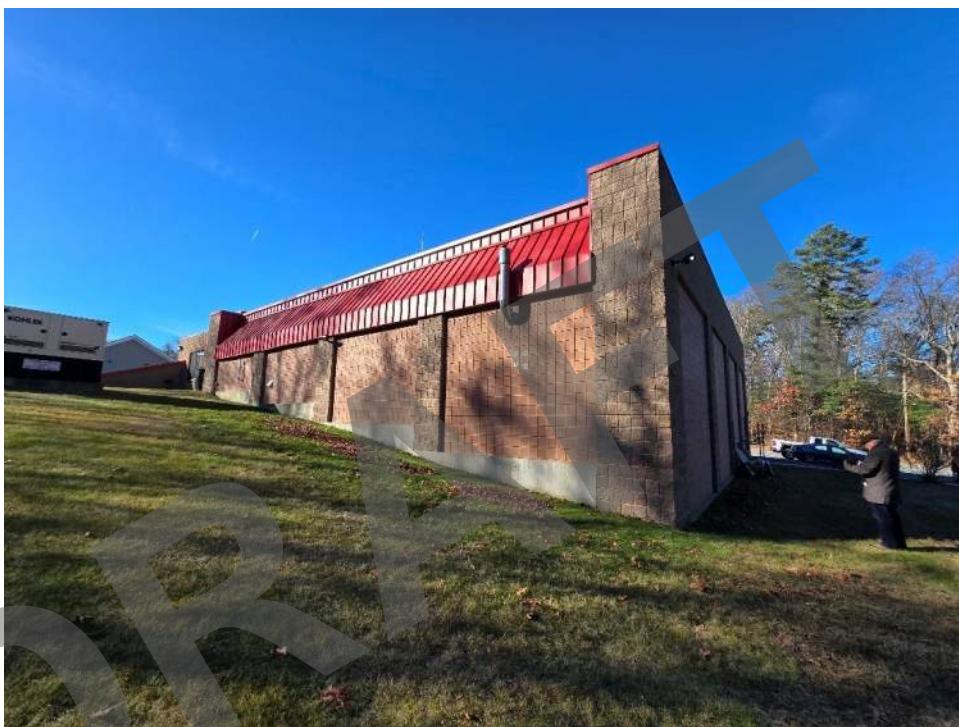
Photo 6: Partial Southeast façade.

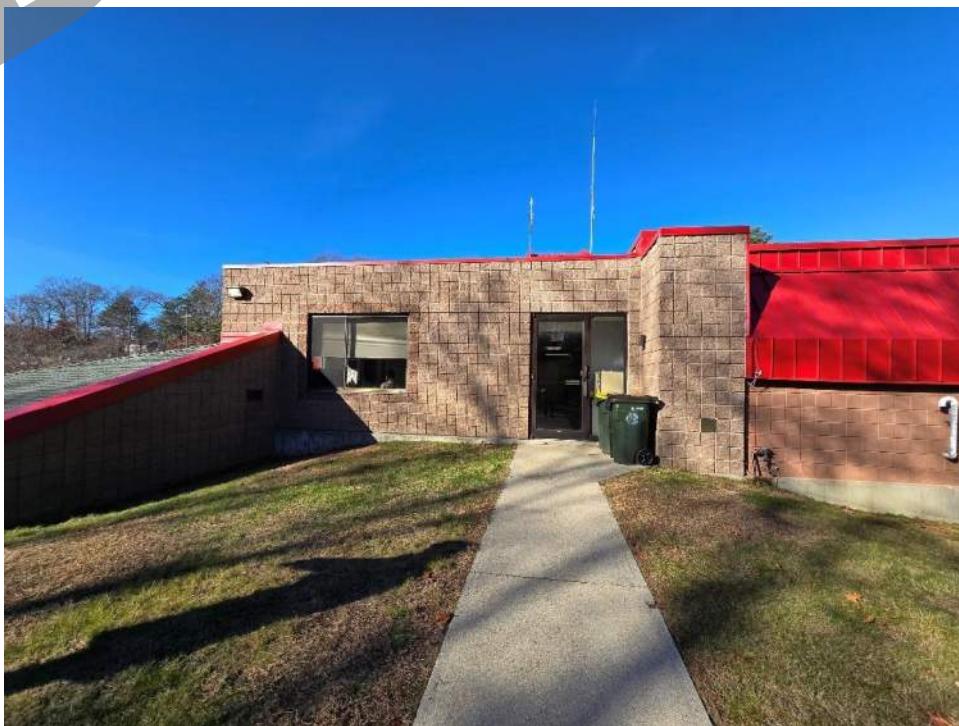
Photo 7: Partial Southeast façade.

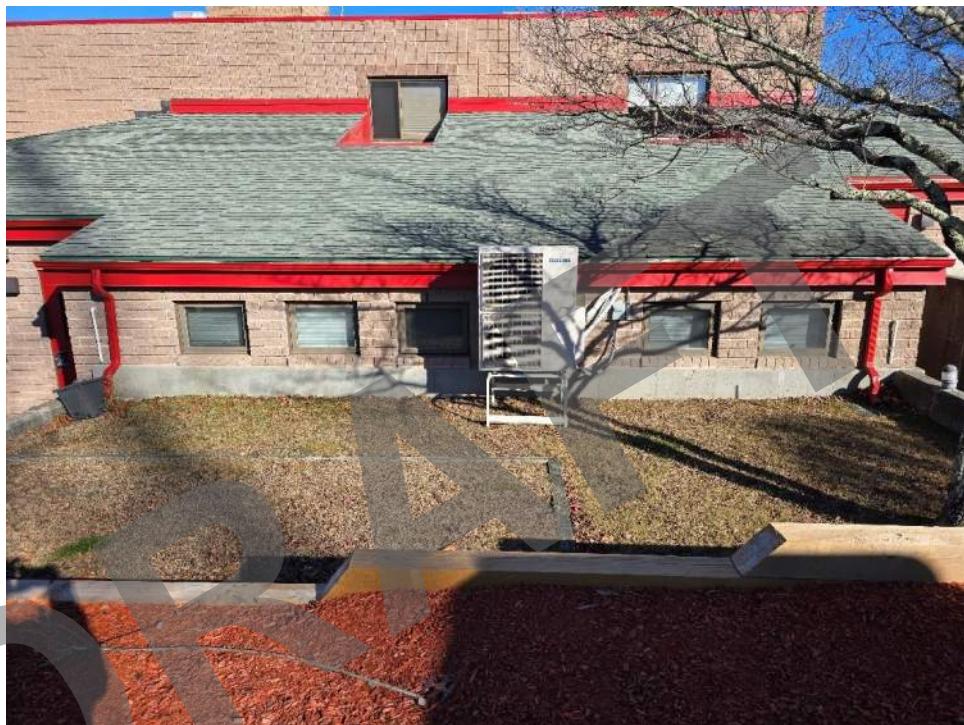
Photo 8: Partial Southwest façade.

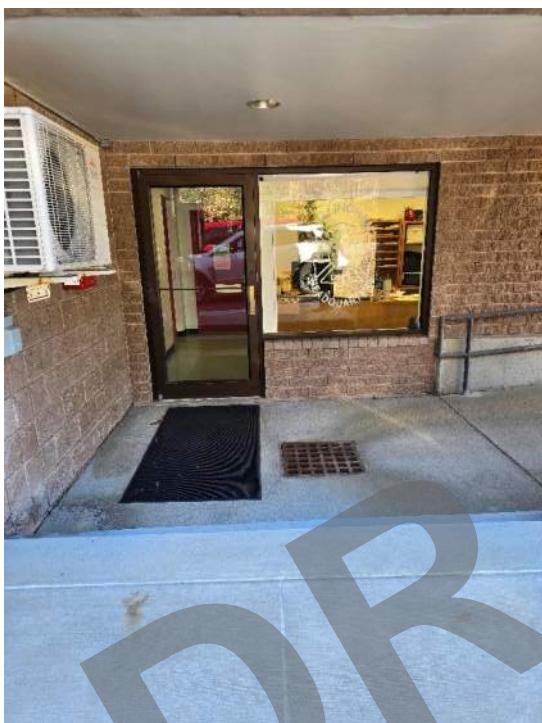
Photo 14: Main Entrance door.

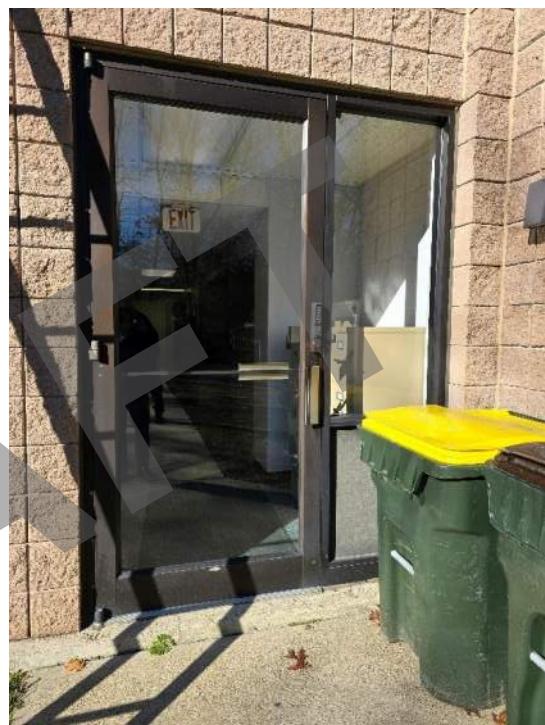
Photo 15: Upper level rear entrance.

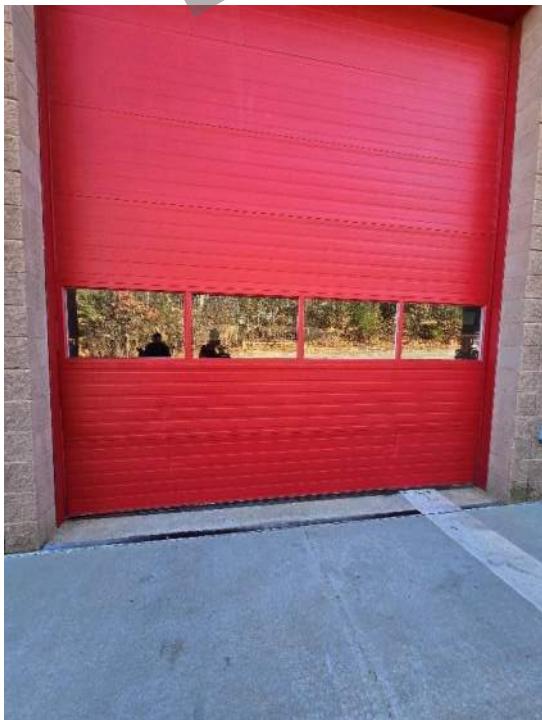
Photo 16: Apparatus Bay overhead doors.

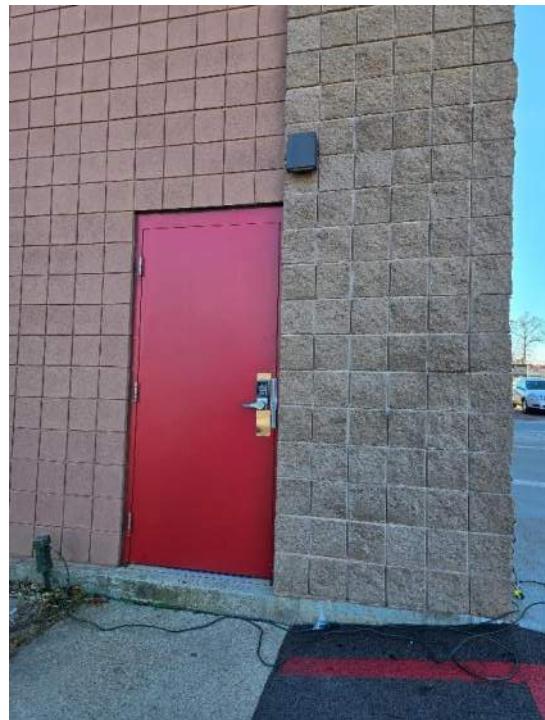
Photo 17: Apparatus Bay swing door.

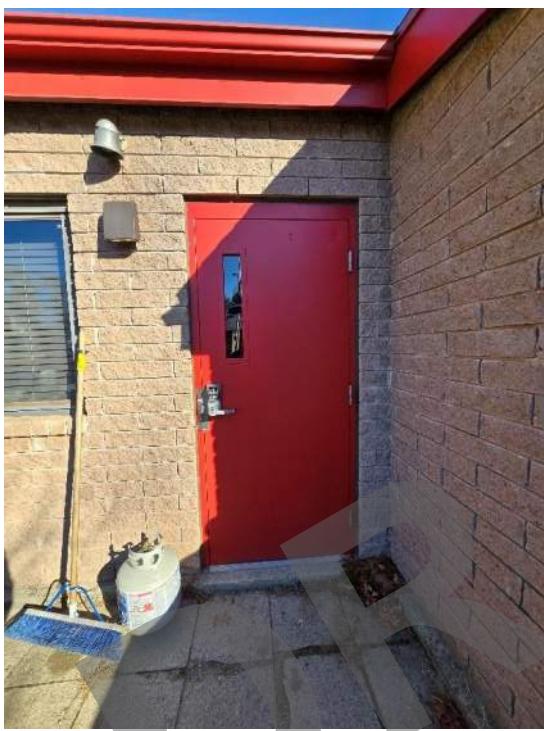
Photo 18: Sunken patio swing door.

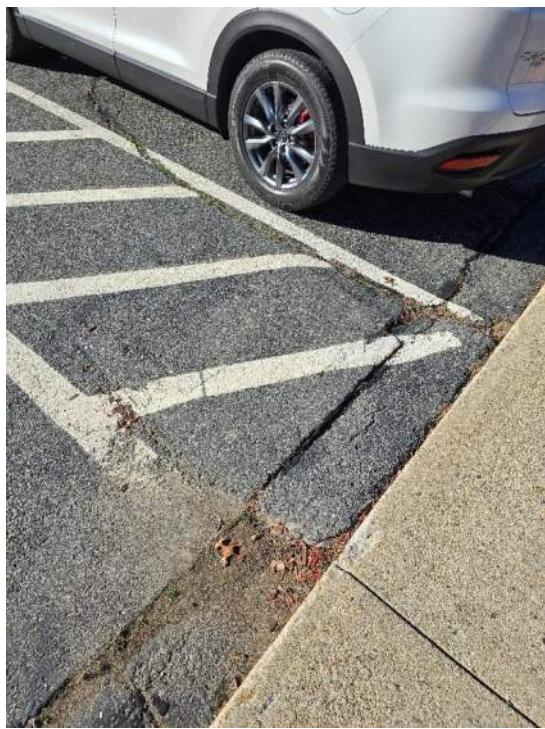
Photo 21: Ramped parking access.

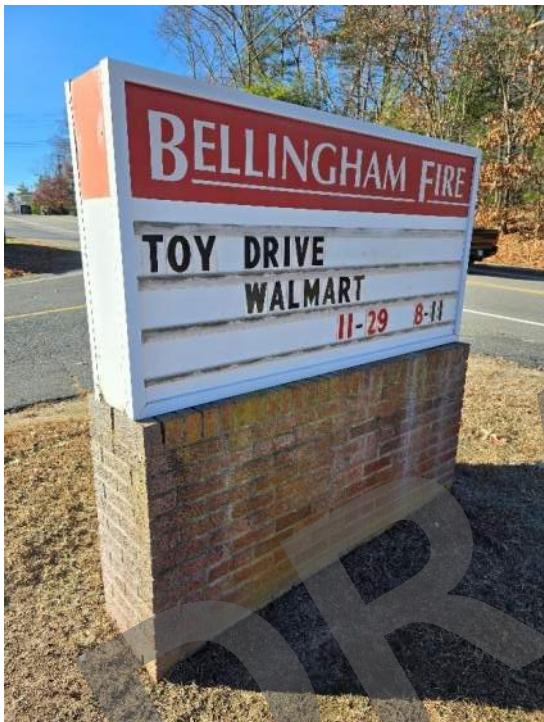
Photo 22: Site signage.

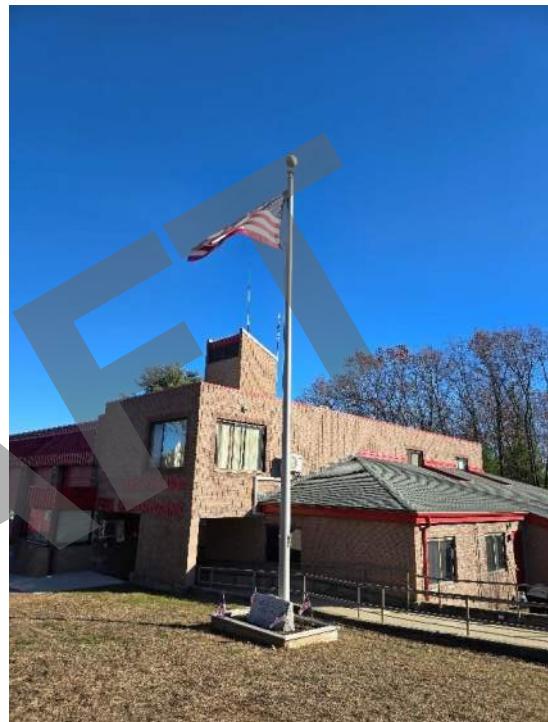
Photo 23: Flagpole.

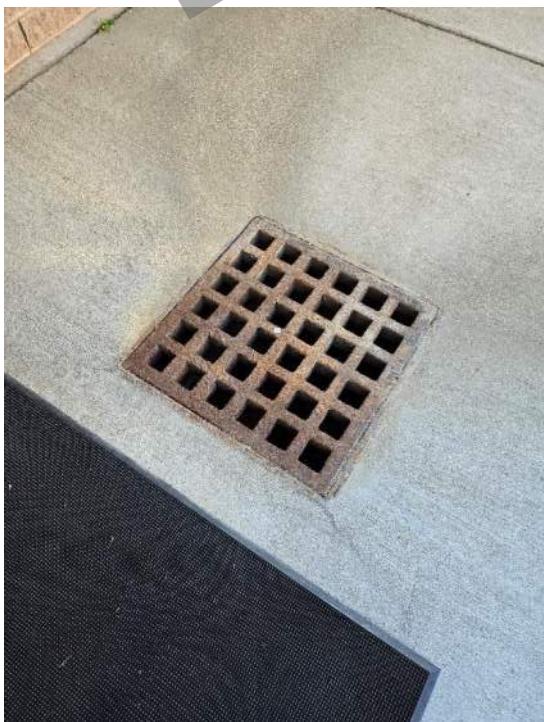
Photo 24: Grate at main entry.

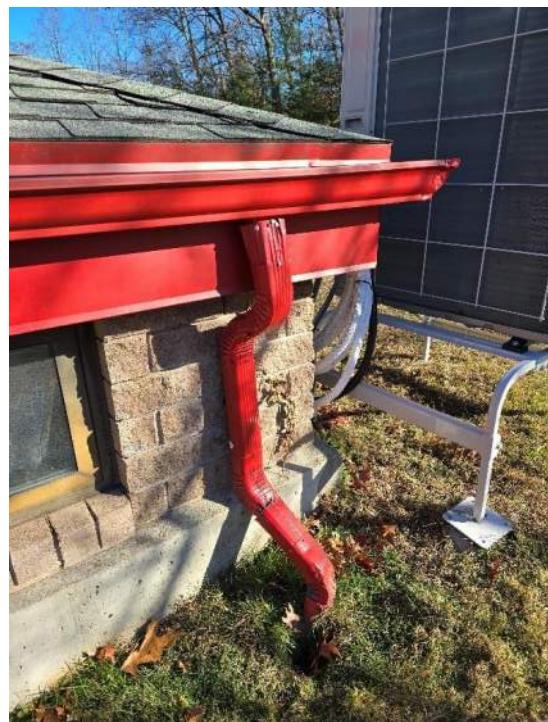
Photo 25: Low roof gutter and rainwater leader.

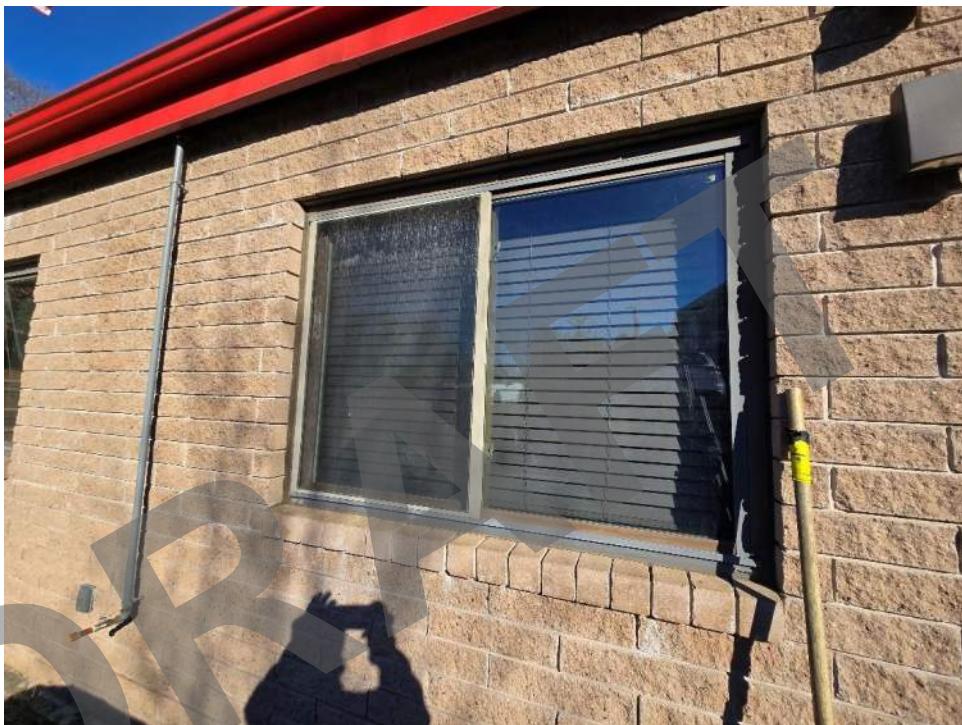
Photo 26: Metal windows.

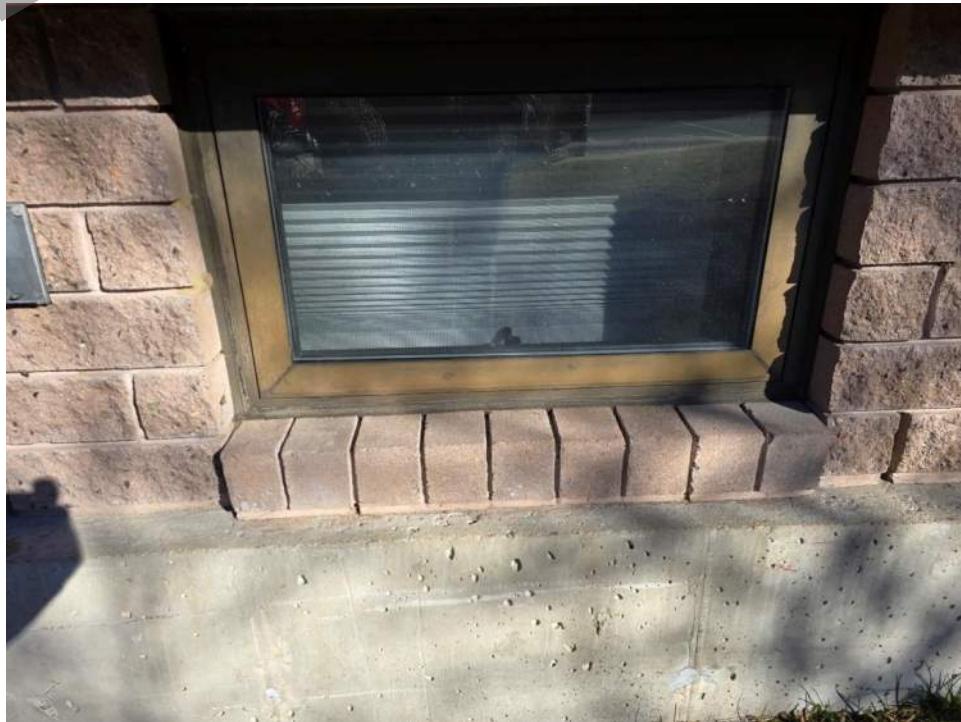
Photo 29: Metal windows.

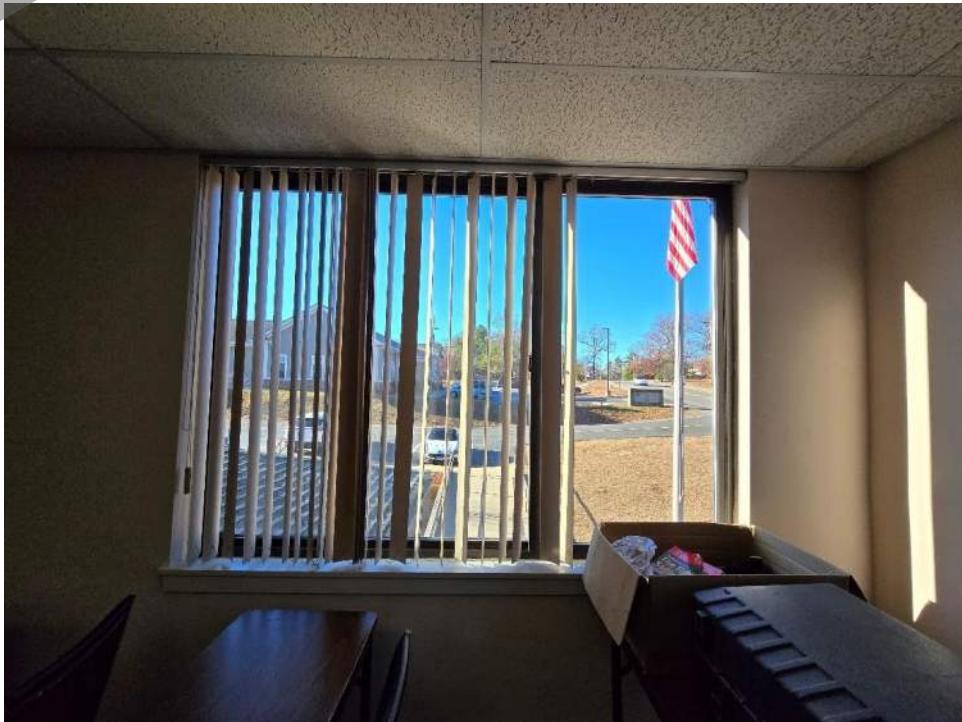
Photo 37: Training Room window.

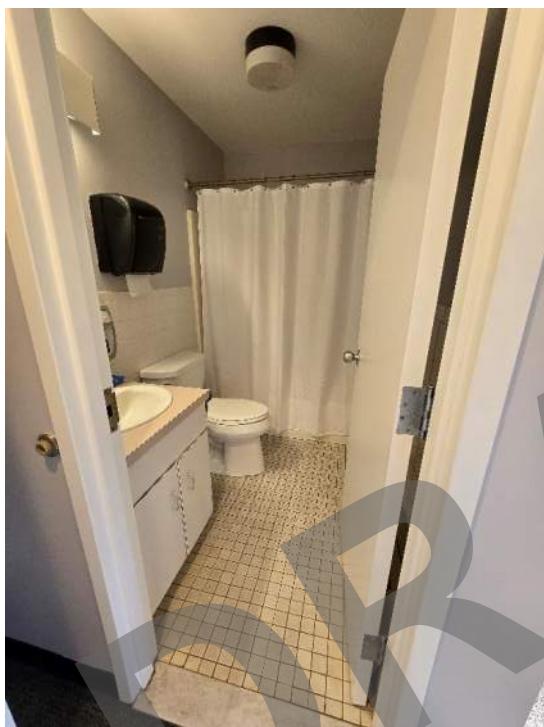
Photo 38: Chief's Toilet

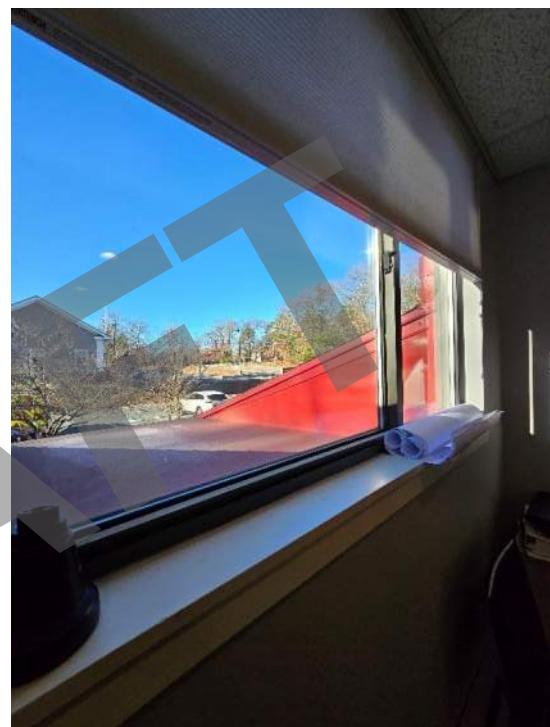
Photo 39: Chief's window.

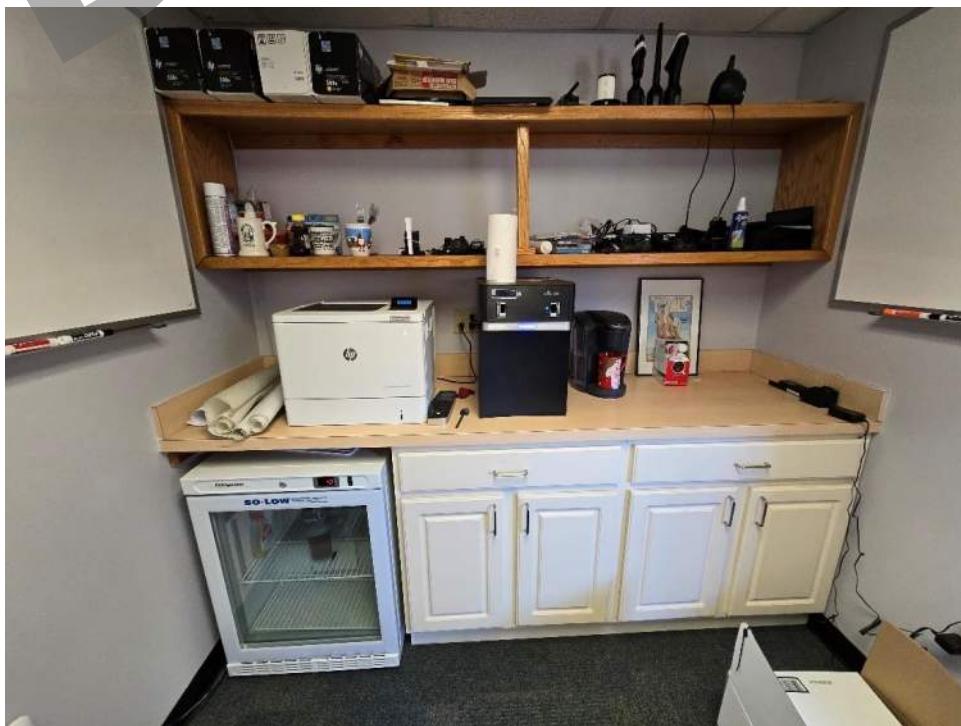
Photo 40: Kitchenette/Storage at offices

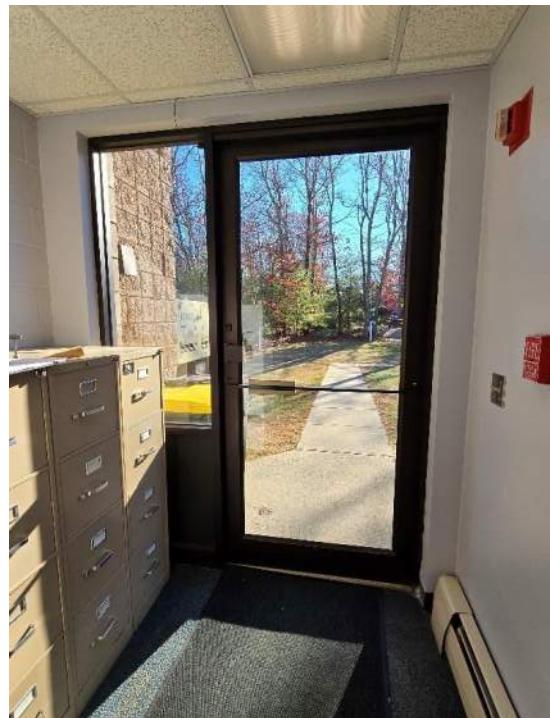
Photo 43: Upper-level entry/file storage.

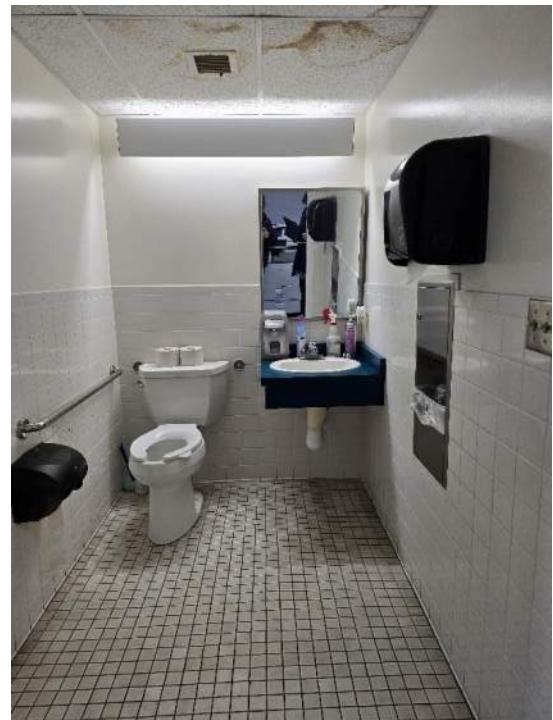
Photo 46: Upper-level Toilet room.

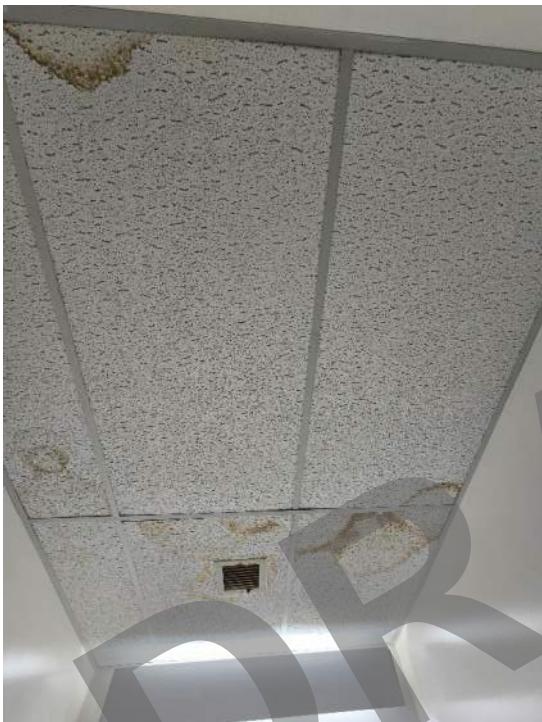
Photo 47: Upper-level Toilet room ceiling.

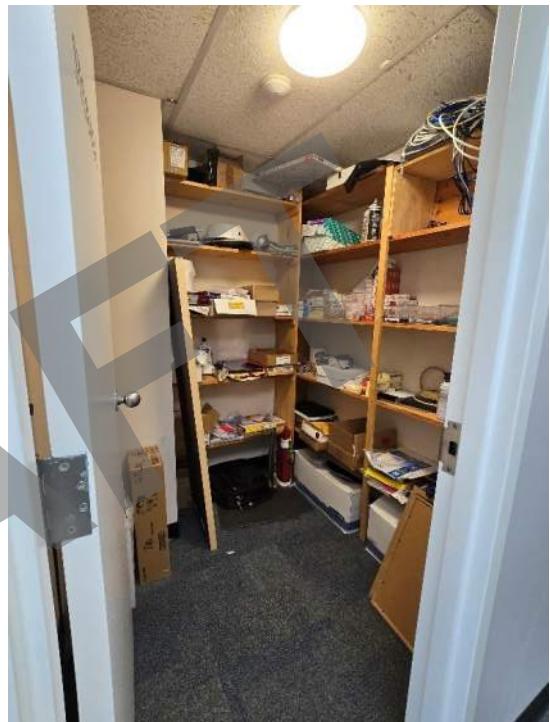
Photo 48: Storage Room (former hose tower).

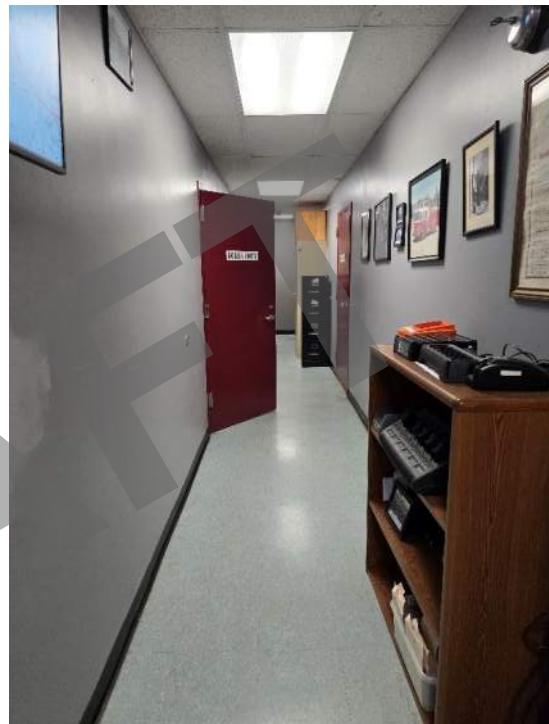
Photo 52: Lower-level circulation corridor.

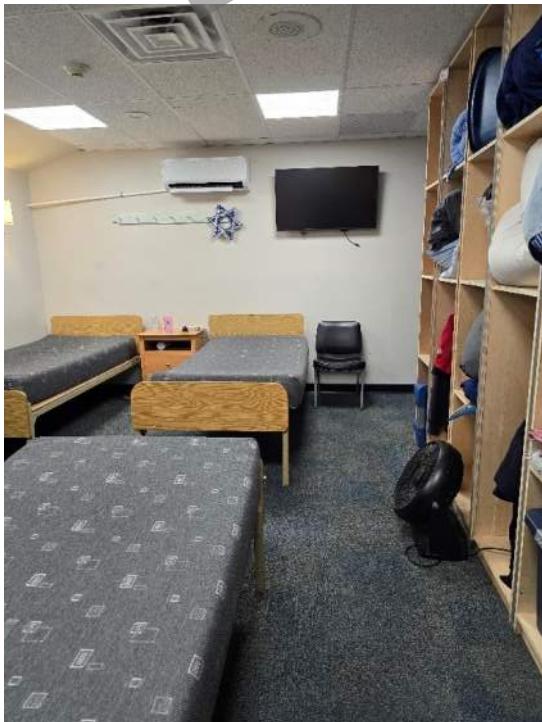
Photo 53: Male Bunk Room.

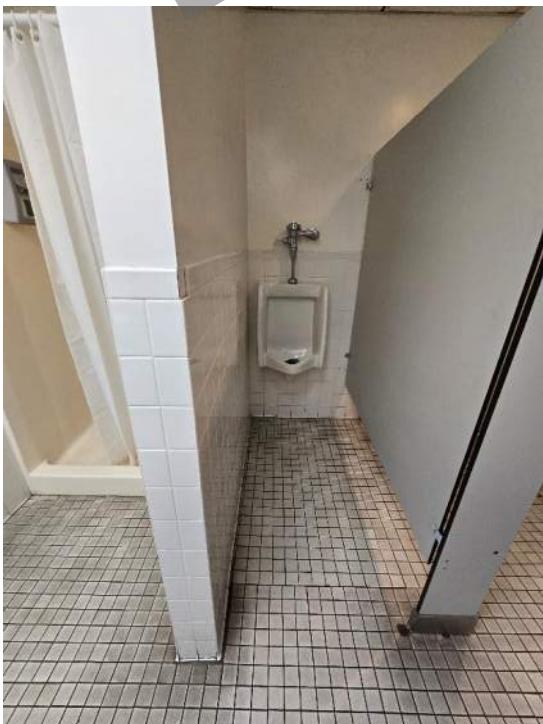
Photo 57: Male Shower/Toilets.

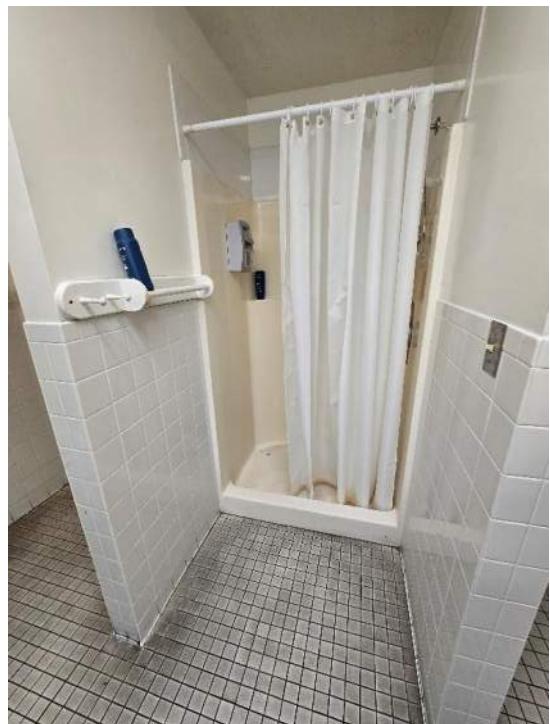
Photo 58: Male Shower/Toilets.

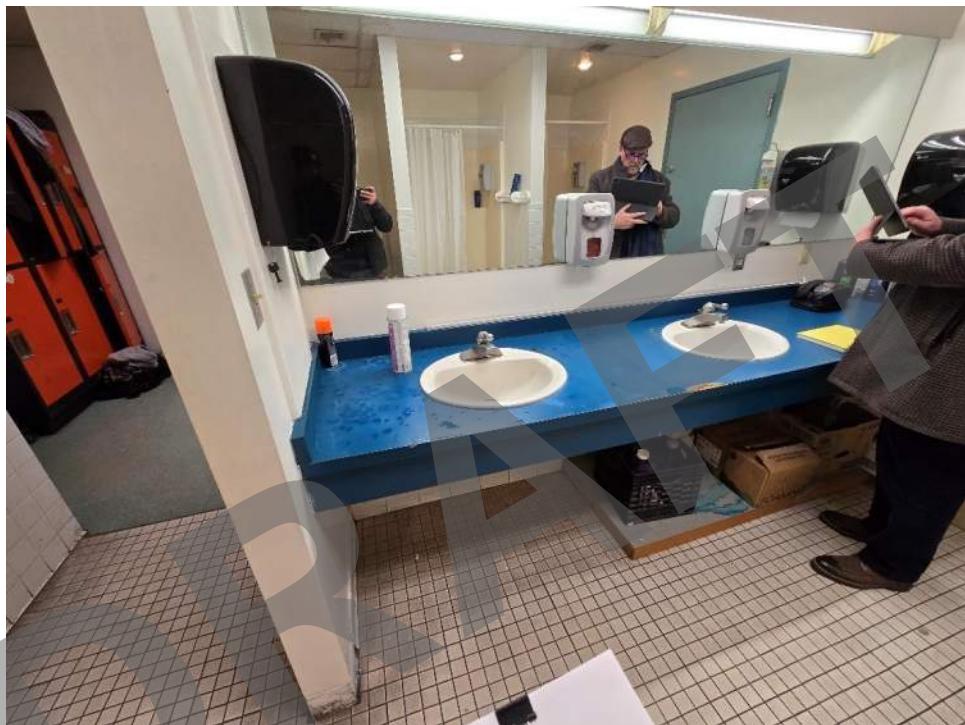
Photo 59: Male Shower/Toilets.

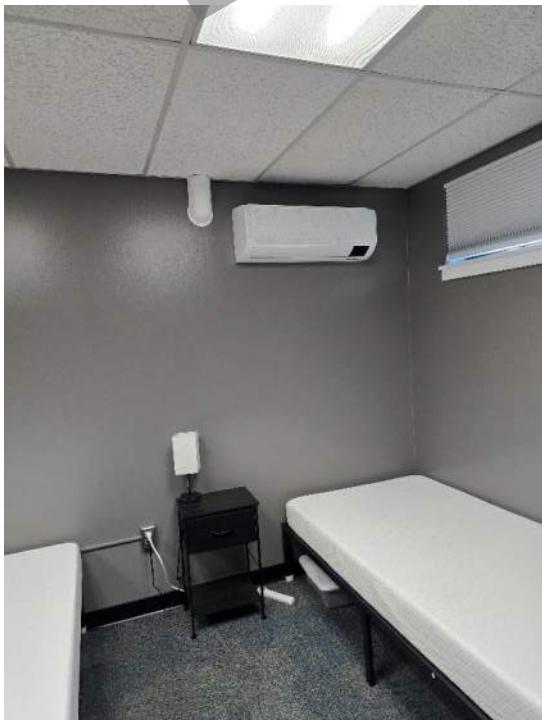
Photo 60: Female Bunk Room.

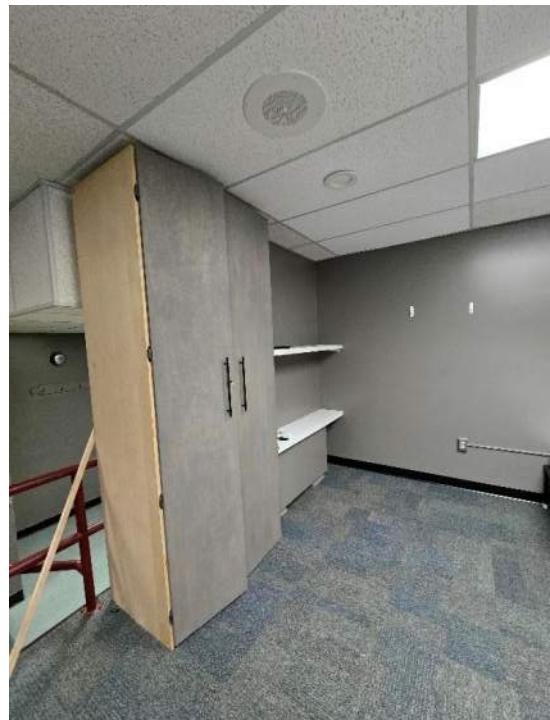
Photo 61: Female Bunk Room storage.

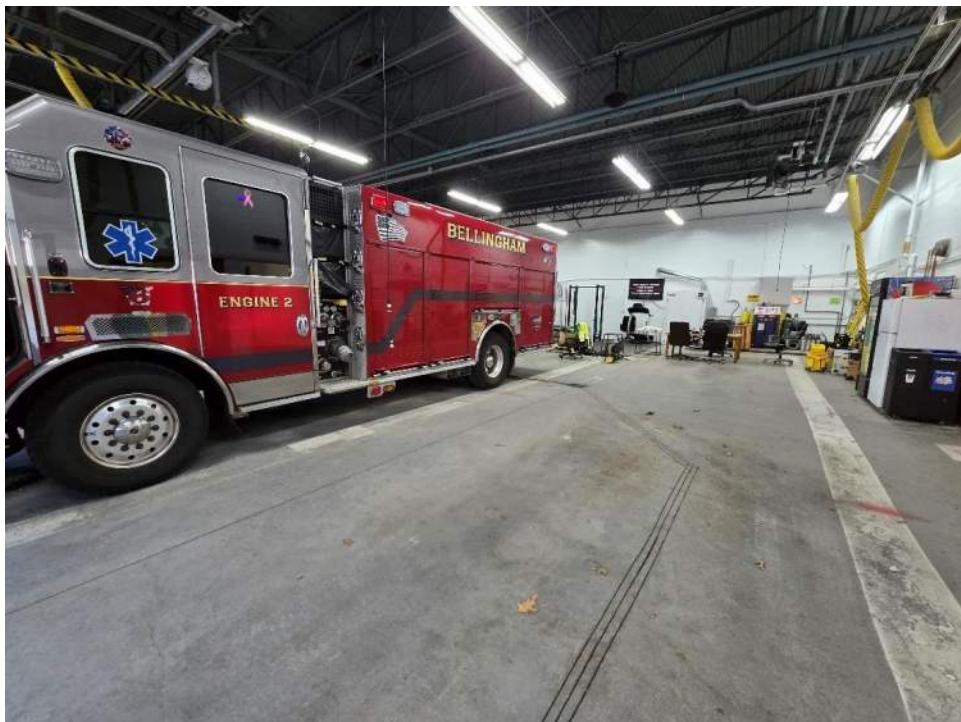
Photo 64: Apparatus Bays.

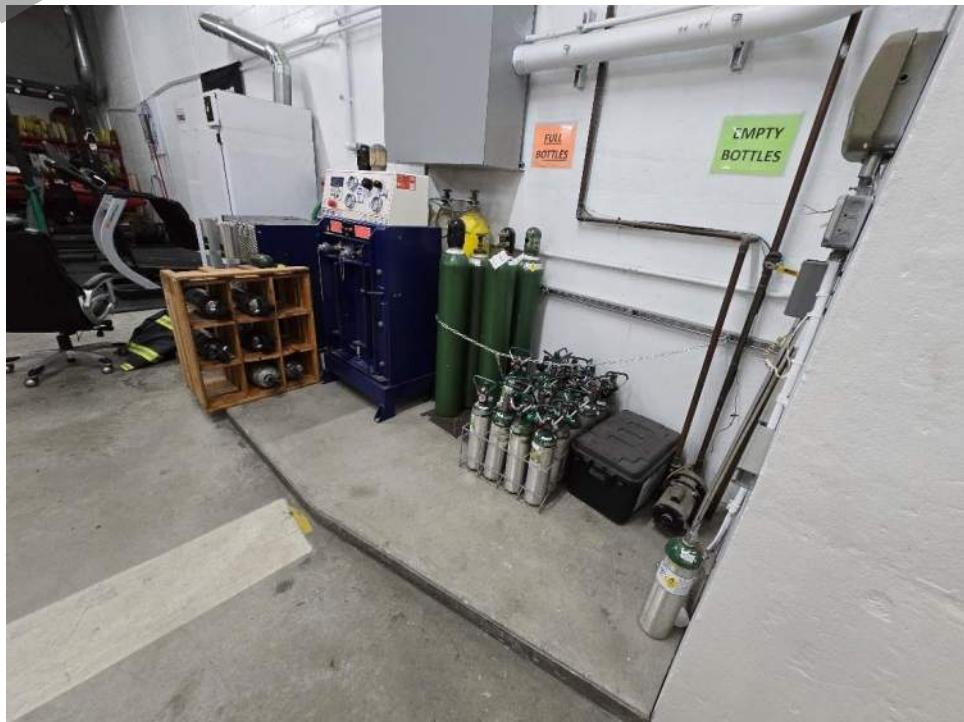
Photo 66: SCBA and storage (within Apparatus Bays).

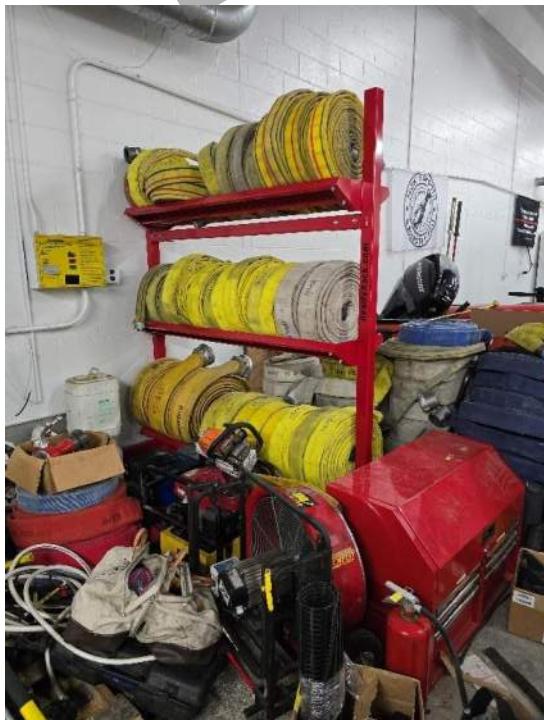
Photo 67: Hose storage (within Apparatus Bays).

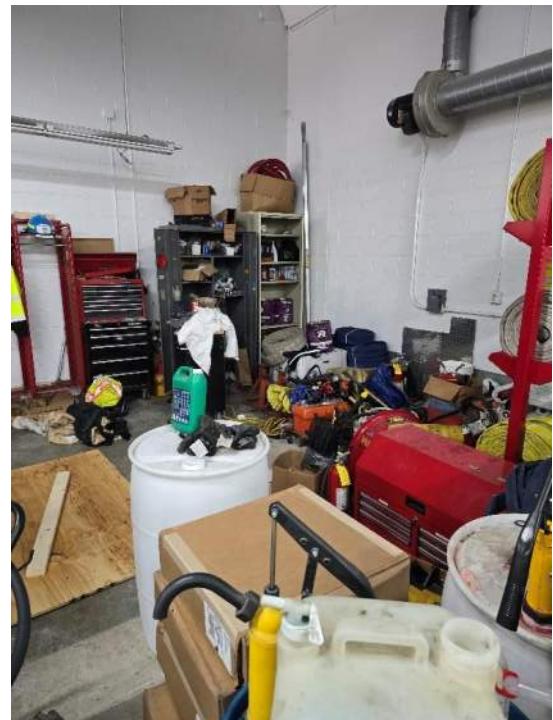
Photo 68: Maintenance (within Apparatus Bays).
