**Fire Building Feasibility Study Committee**  
**Tuesday, April 22, 2025, at 10:00 am**  
**Station 2**  
**28 Blackstone Street, Bellingham, MA 02019**

## Program and Space-Use Analysis Matrix

## FIRE COMPANY #1 - EXISTING CONDITIONS ASSESSMENT

## FIRE COMPANY #2 - EXISTING CONDITIONS ASSESSMENT

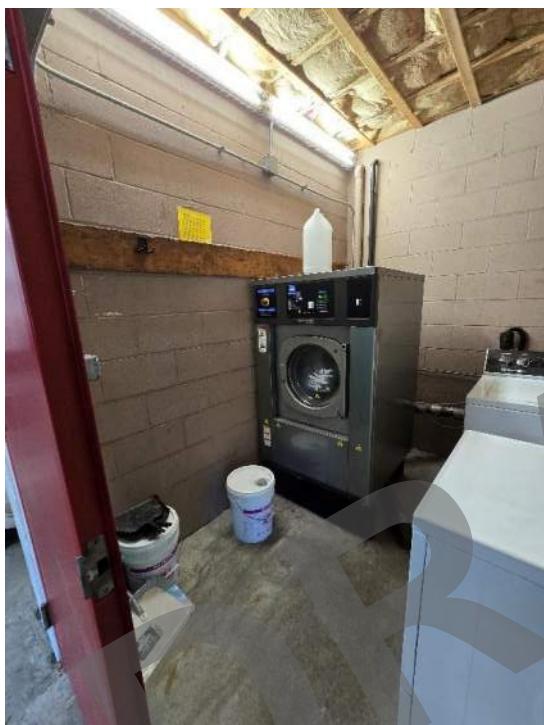
Photo 69: Decontamination

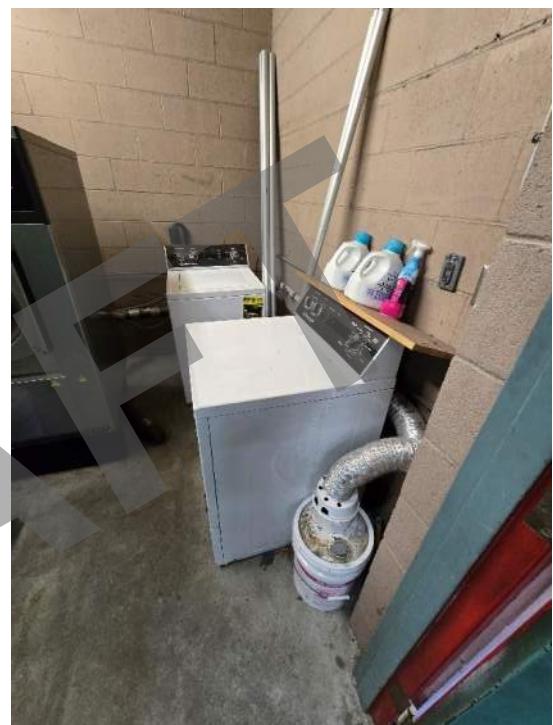
Photo 70: Decontamination

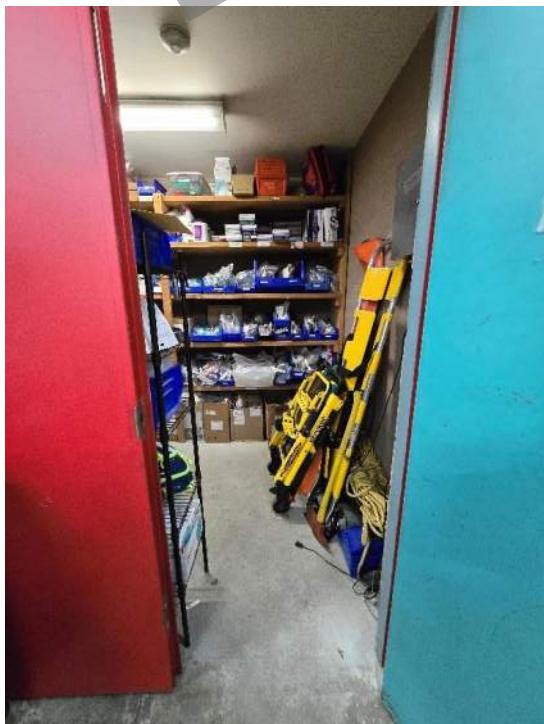
Photo 71: EMS Storage.

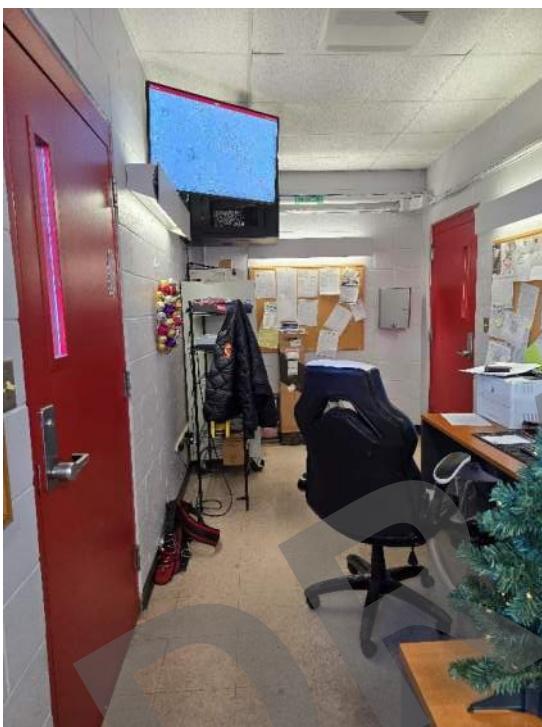
Photo 73: Dispatch.

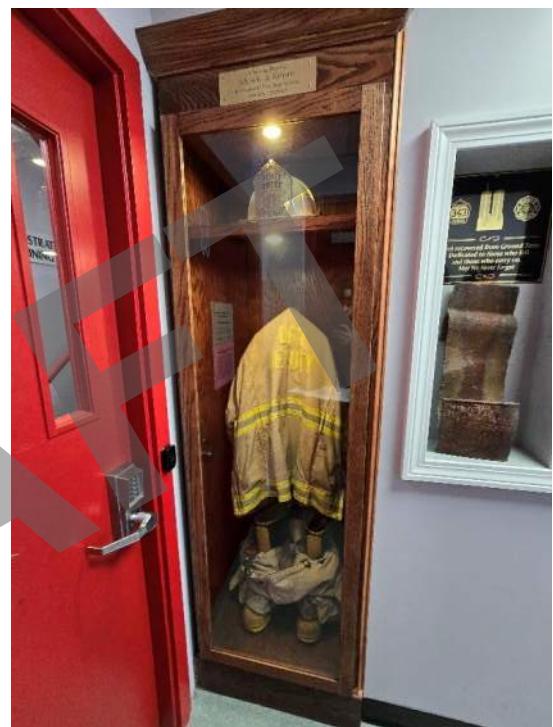
Photo 74: Lobby display cases.

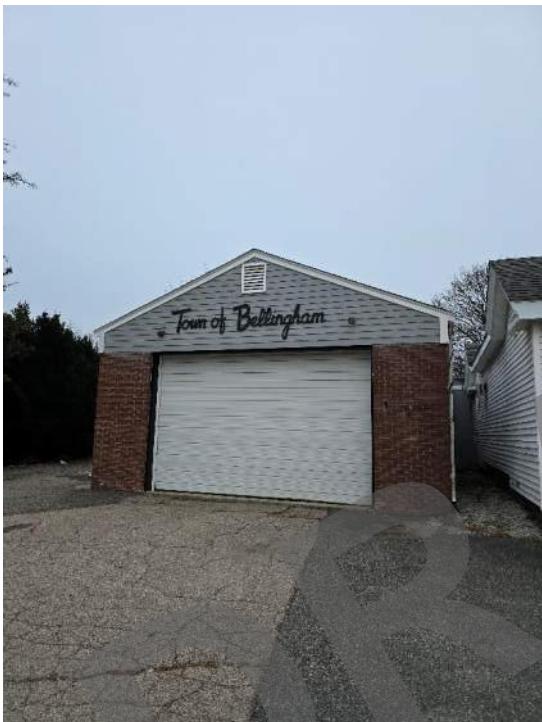
Photo 1: West façade & apron.

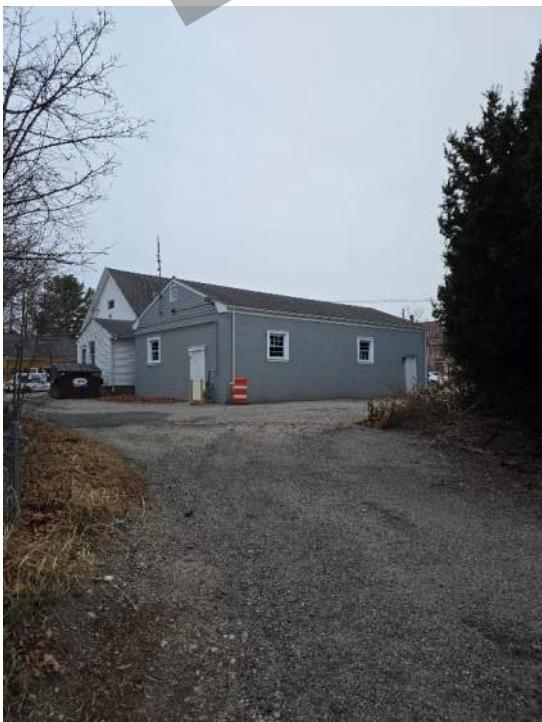
Photo 3: North façade.

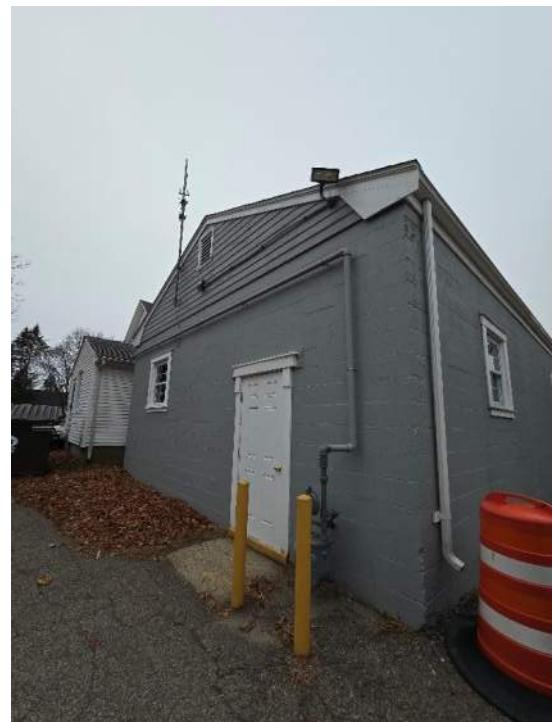
Photo 4: East façade.

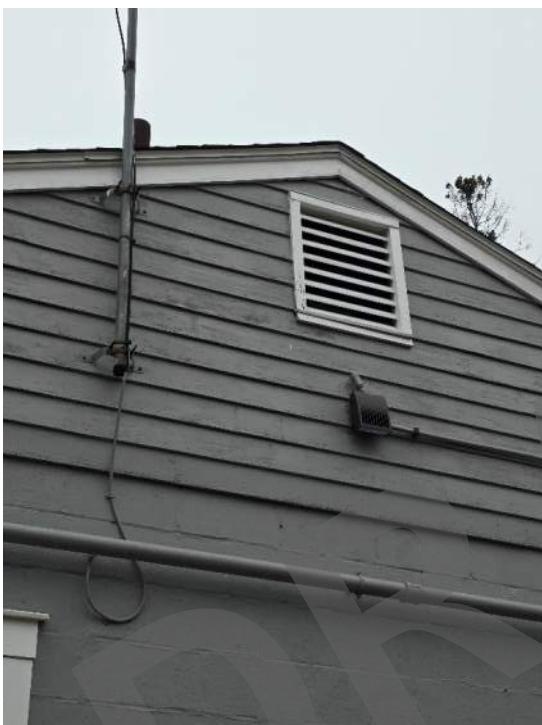
The building envelope is in fair condition. The main façade is made up of a mix of 4" brick veneer to the top of the garage door and wood siding up to the roof line. The wood siding is in fair condition. Minor masonry repair and repointing is recommended at the exterior brick. The other facades appear to be constructed of an uninsulated single-wythe concrete masonry unit (CMU). The CMU was observed to have multiple areas along the North side where previous water infiltration was evident. It is unclear if the water infiltration was still occurring.

Photo 5: Wood siding and gable vent.

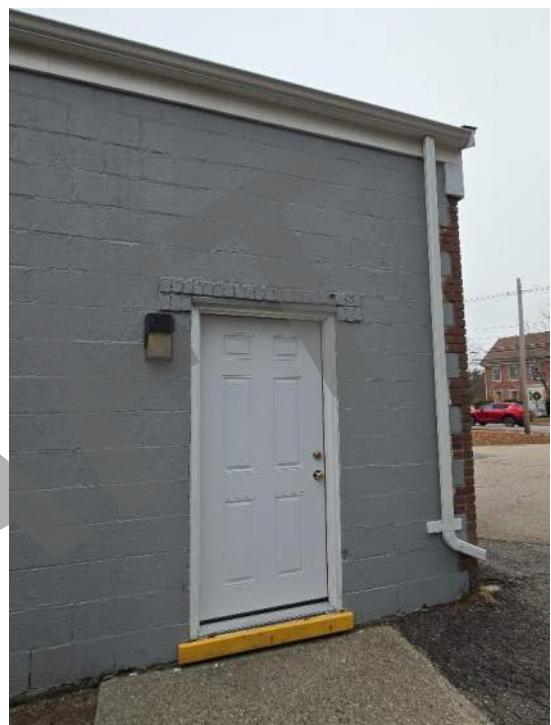
Photo 6: Rear swing door.

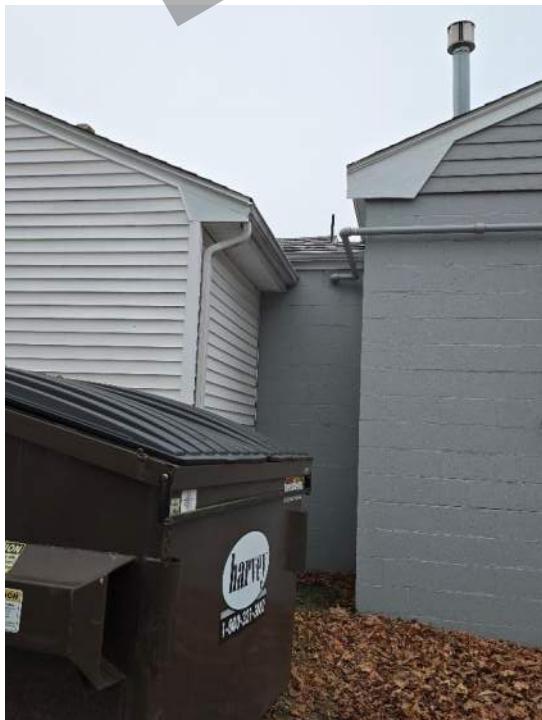
The roof consists of an architectural asphalt shingle gable-style roof with gutters and downspouts on the North and South. The roof appears to be reasonably new. Downspouts empty directly onto the drive aisle and into the gravel alleyway between the garage and the Community Center. This could cause potential icing issues around the swing doors and across the apron. The attic is assumed to be insulated at the ceiling plane; however, this was inaccessible and not observed.

Photo 11: Building joint and downspout.
